**Limited Asbestos Survey
16th Floor, 16E Renovation Area
Grady Hospital
80 Jesse Hill Jr. Drive SE
Atlanta, Georgia 30303**

**Prepared by:
Strategic Environmental Solutions LLC
2774 Cobb Parkway NW
Kennesaw, GA 30152**

June 2, 2022

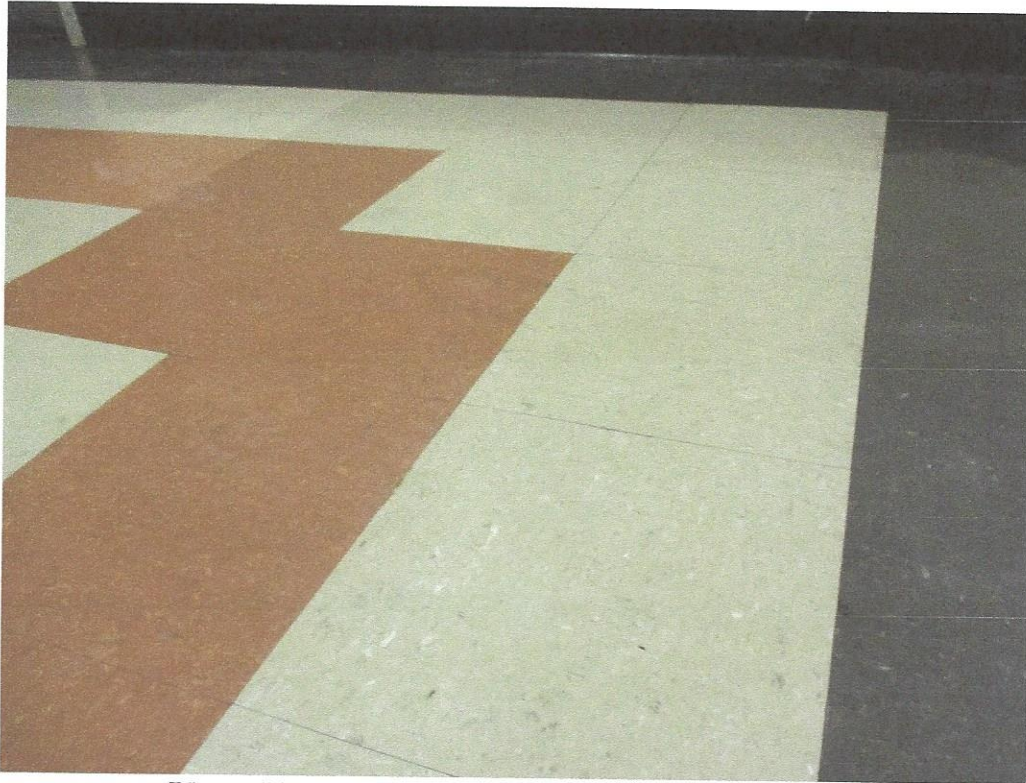
Photo #1 – 12x12 black floor tile with black mastic

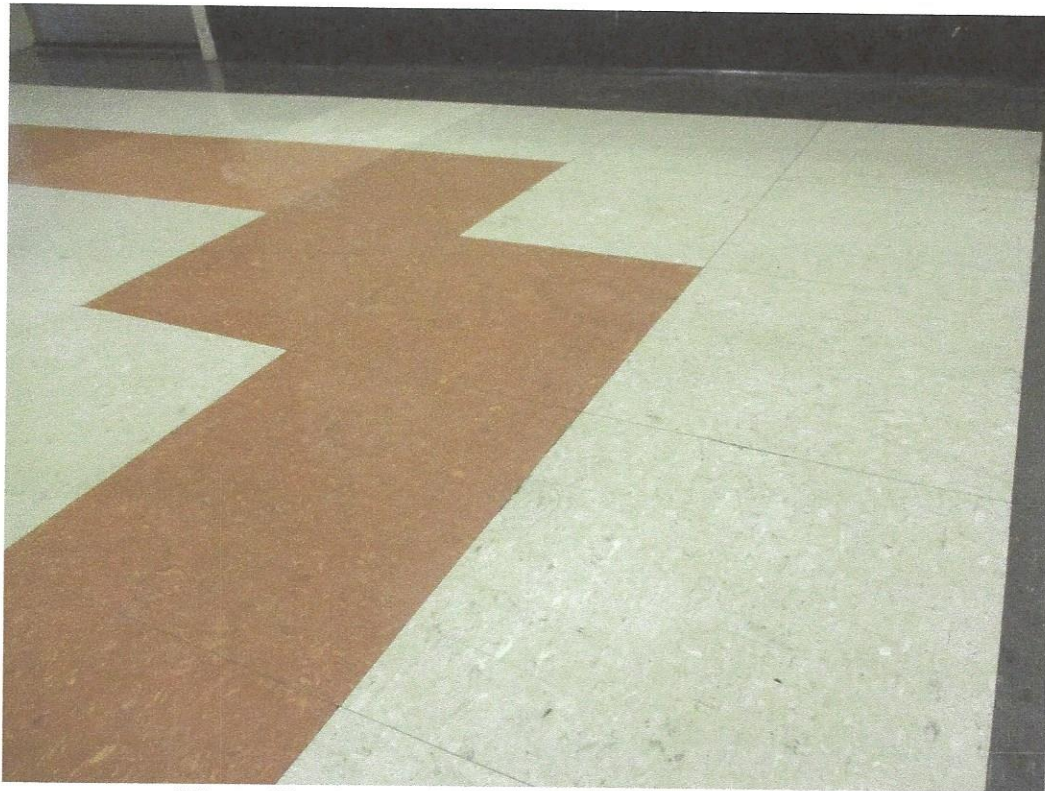
Photo #2 – 12x12 white floor tile with black mastic

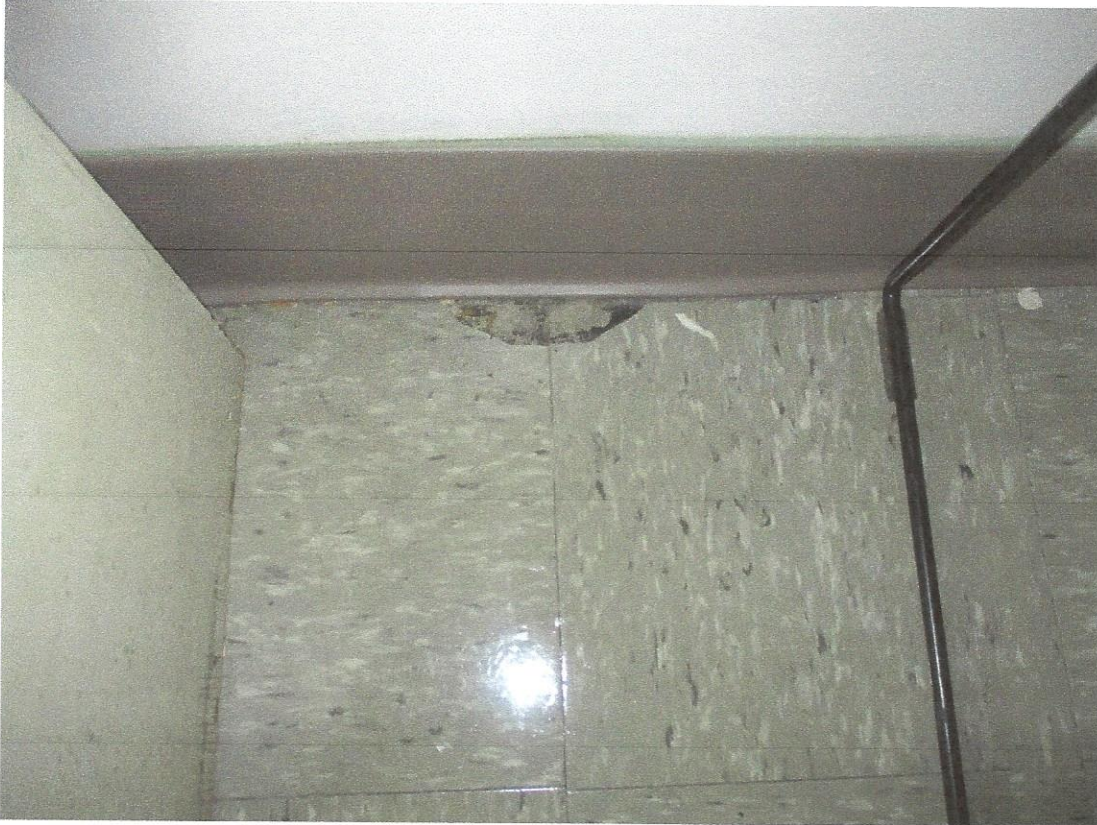
Photo #3 – 12x12 gray floor tile with black mastic

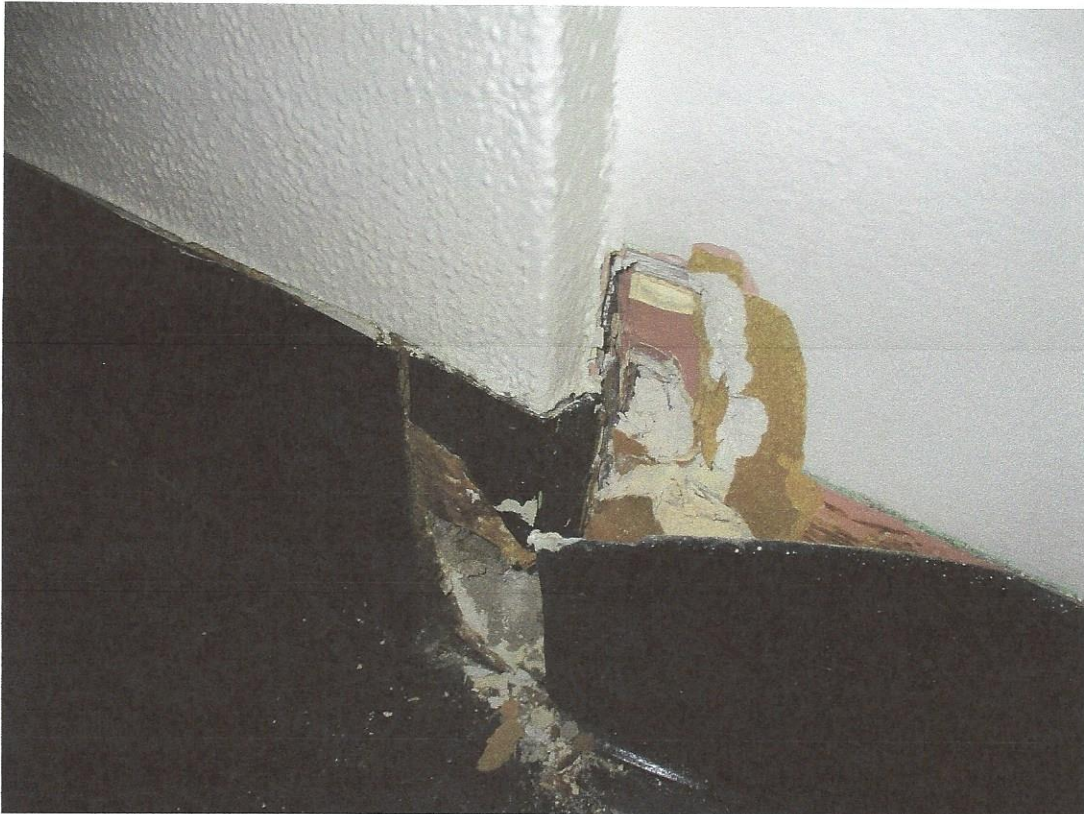
Photo #4 – Wallboard with red backing and joint compound

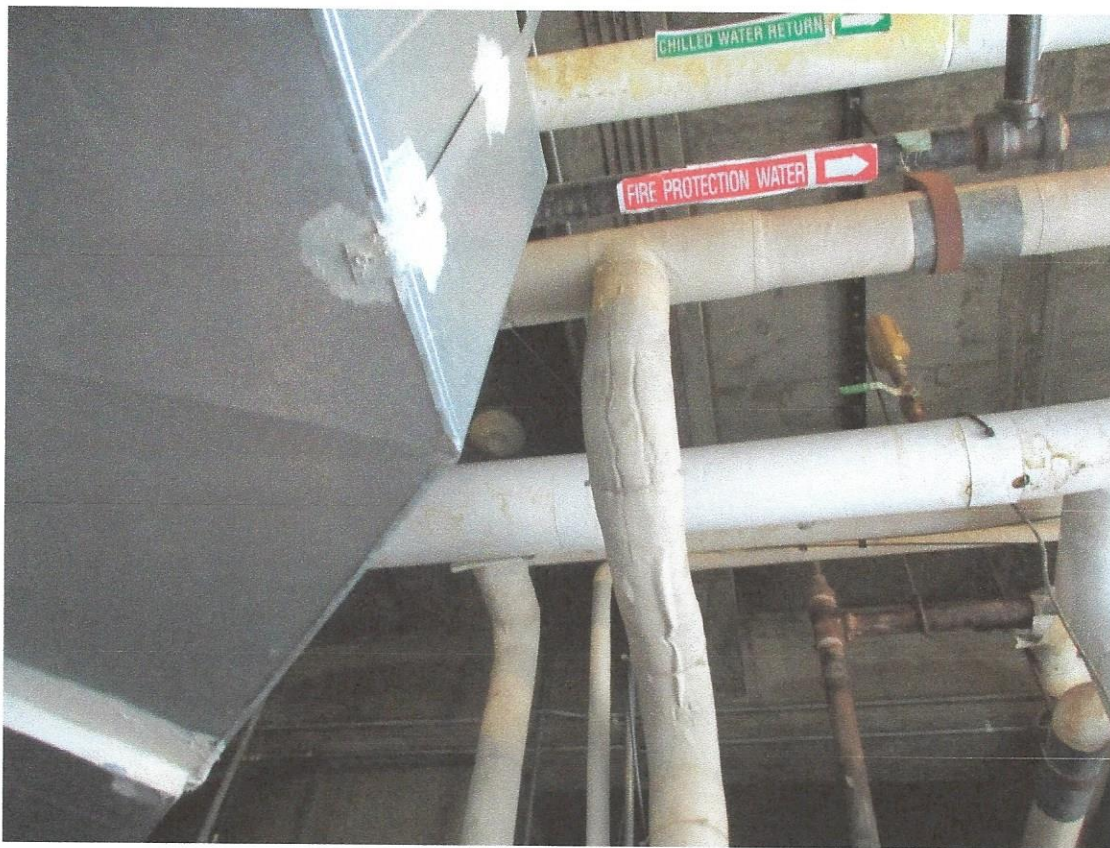
Photo #5 – TSI, piping and pipe fittings, cementitious - PACM*

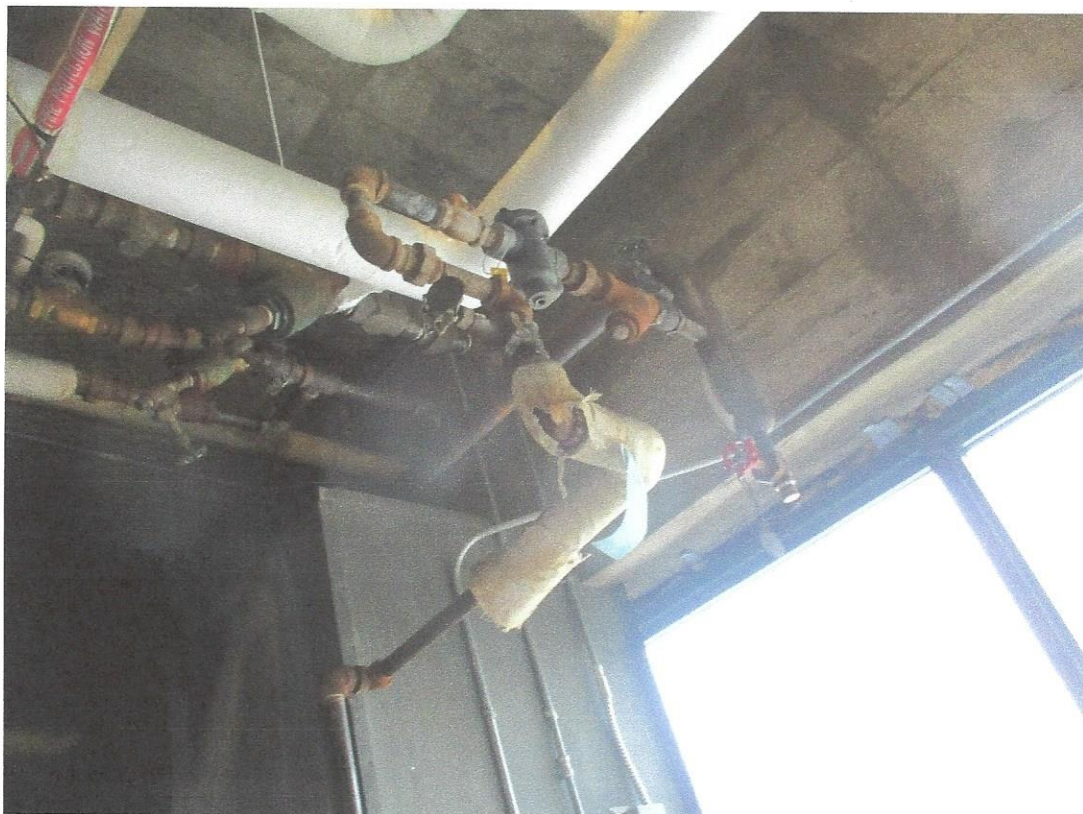
Photo #6 – TSI, piping and pipe fittings, cementitious - PACM*

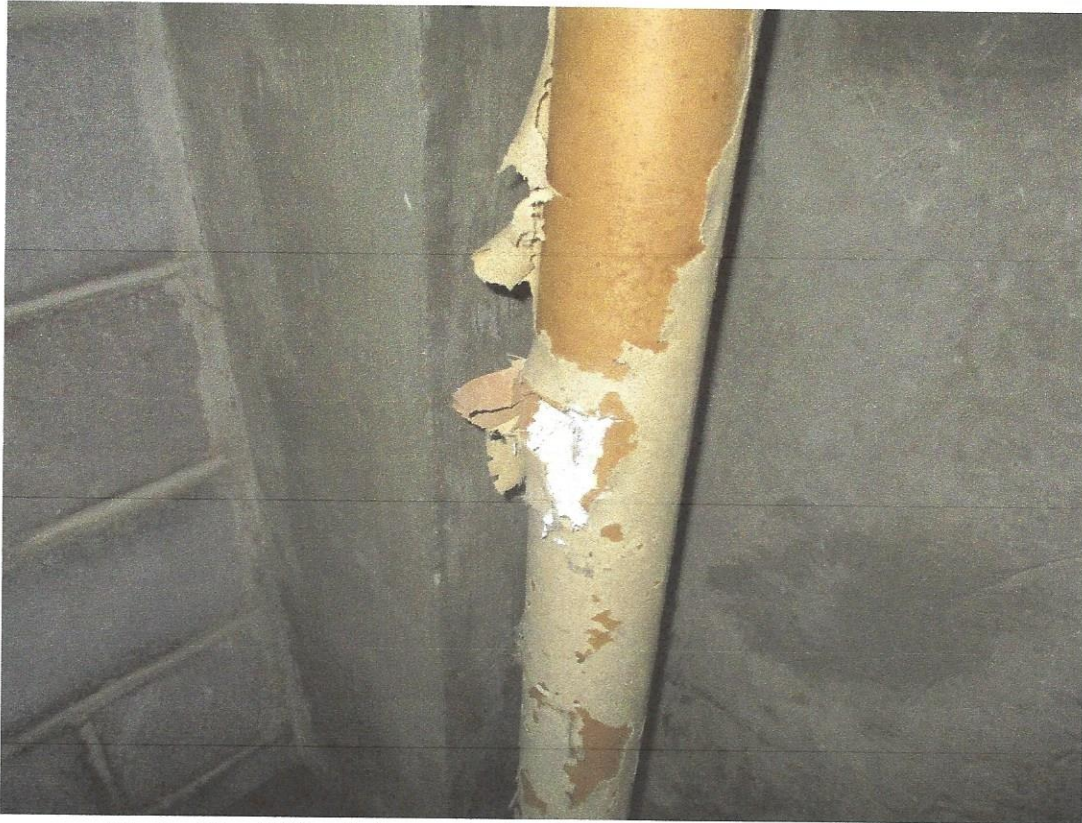
Photo #7 – TSI, piping and pipe fittings, cementitious - PACM*

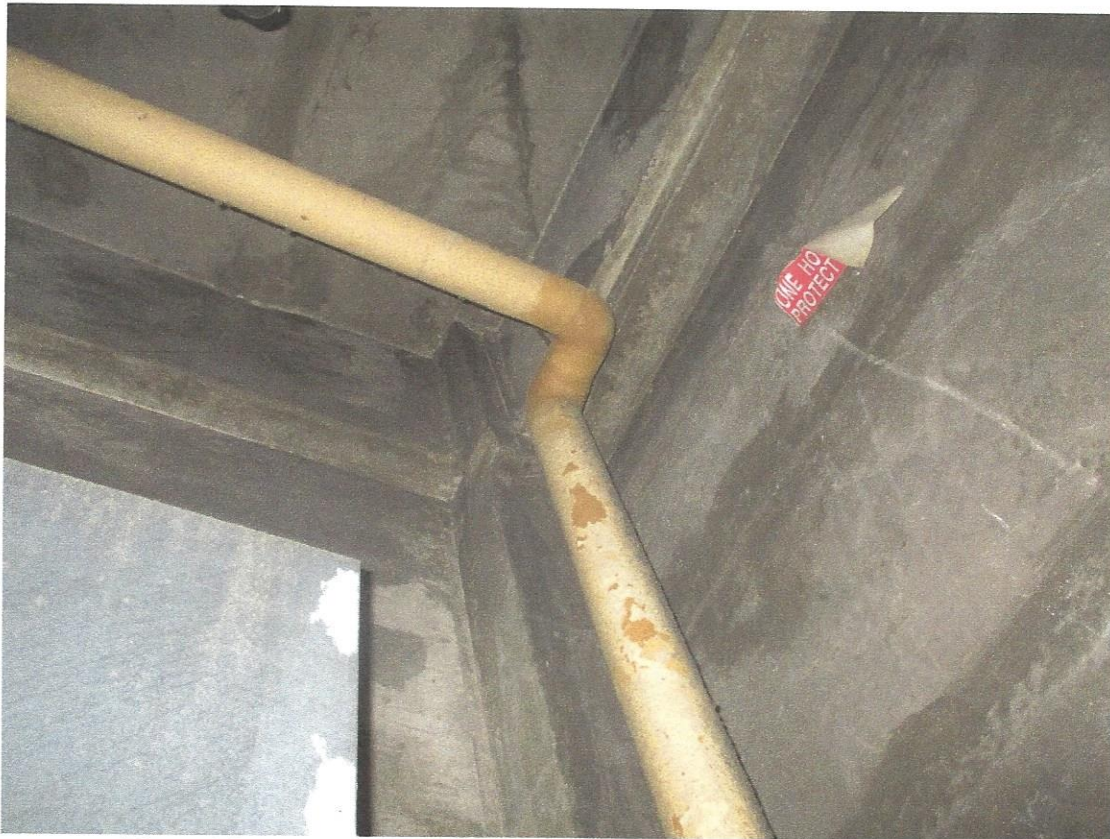
Photo #8 – TSI, piping and pipe fittings, cementitious - PACM*

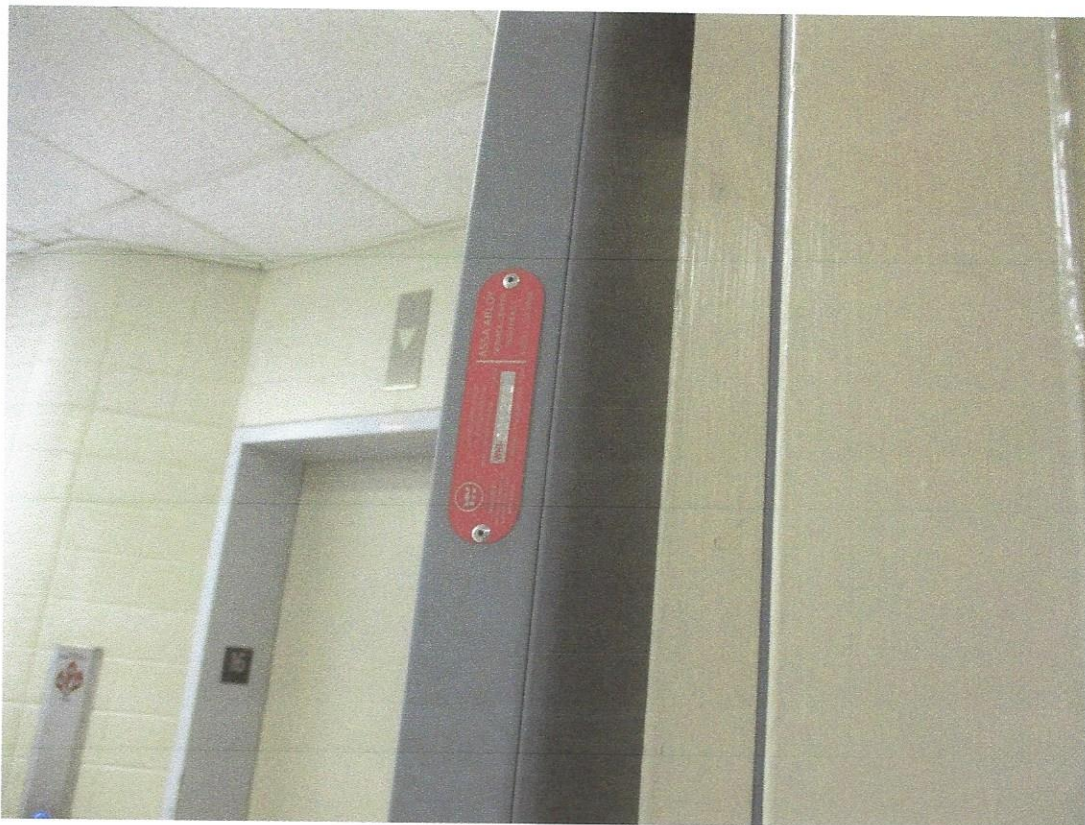
Photo #9 – Fire Doors - PACM*

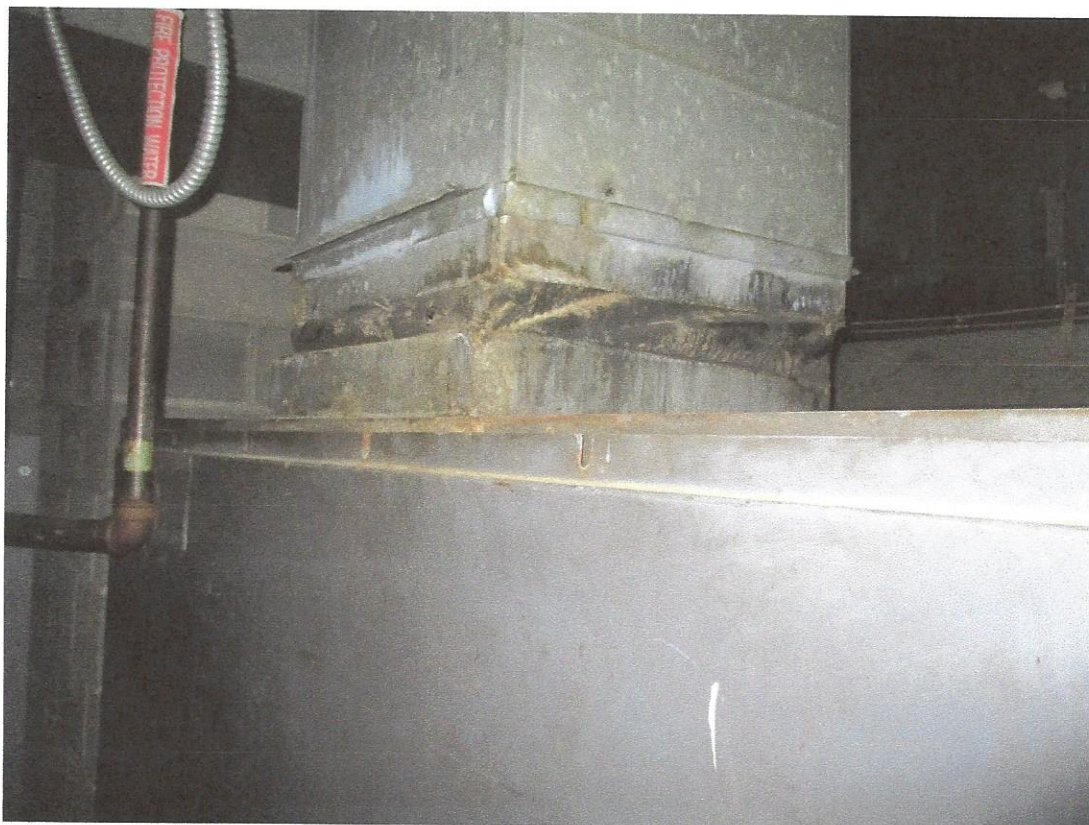
Photo #10 – Vibration dampeners - PACM*
