## Ponce De Leon Center

### Visual Condition Assessment

341 Ponce De Leon Avenue NE  
Atlanta, Georgia

July 28, 2025  
WJE No. 2025.1974

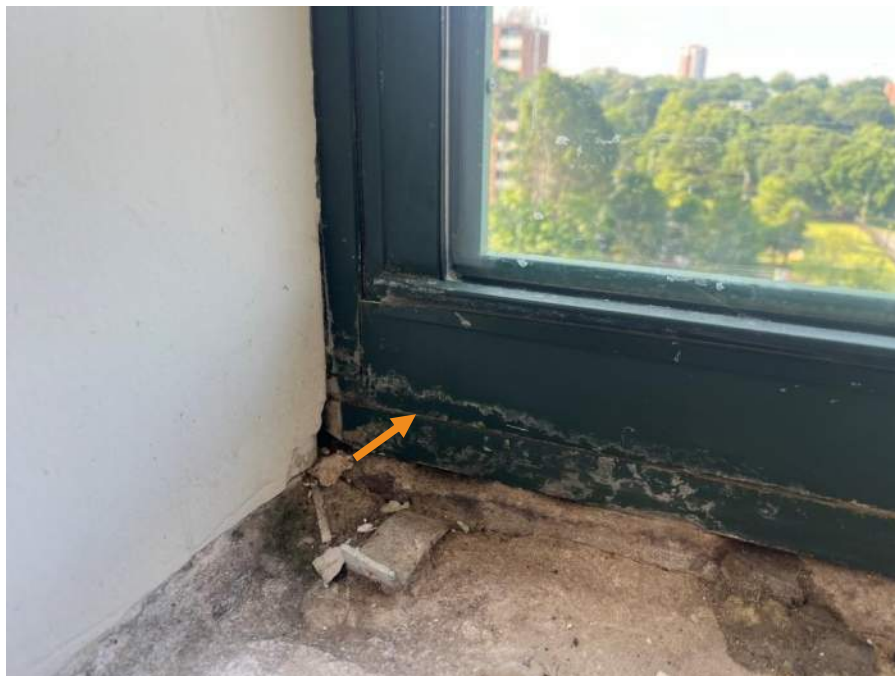
- White staining (Figure 4) and separated/peeling interior finishes (Figure 5) at window perimeters, frame joints, or on stool trim elements was noted at most building windows observed during the visit. The most significant staining and distressed finishes typically occurred in the stairwell windows (Figure 6).

Figure 4. White staining at window frame joint.

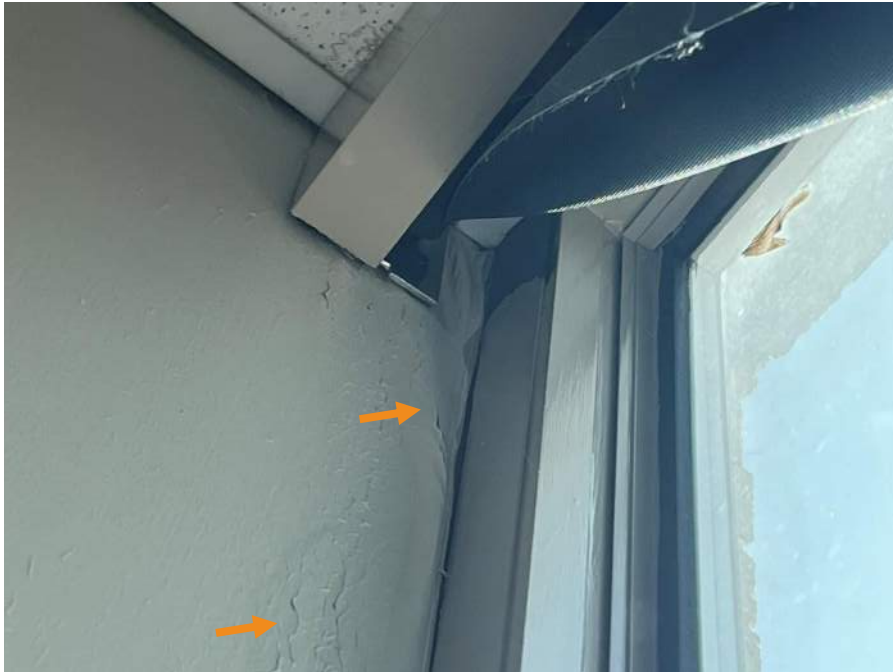
Figure 5. Separated and peeling interior finishes adjacent to window.

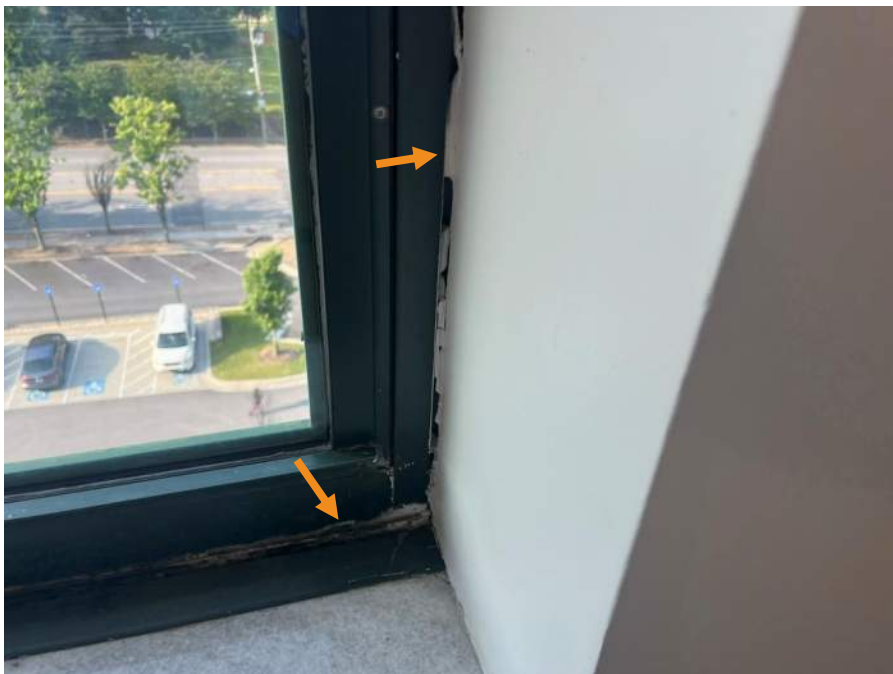
Figure 6. Stained and separated finishes at stairwell window.

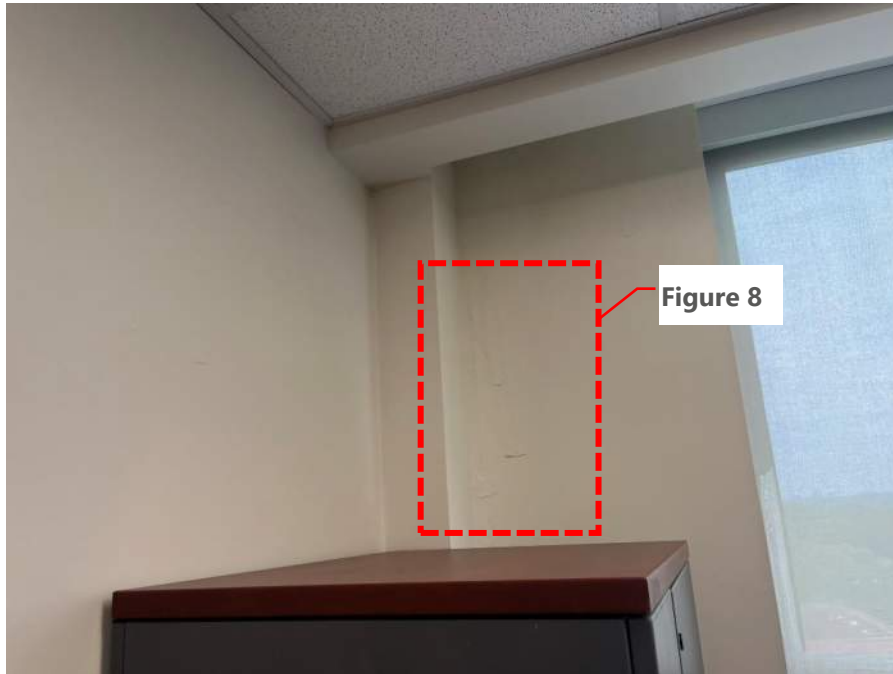
Figure 7. Interior finish coating peeling at northwest corner of Office 6022.

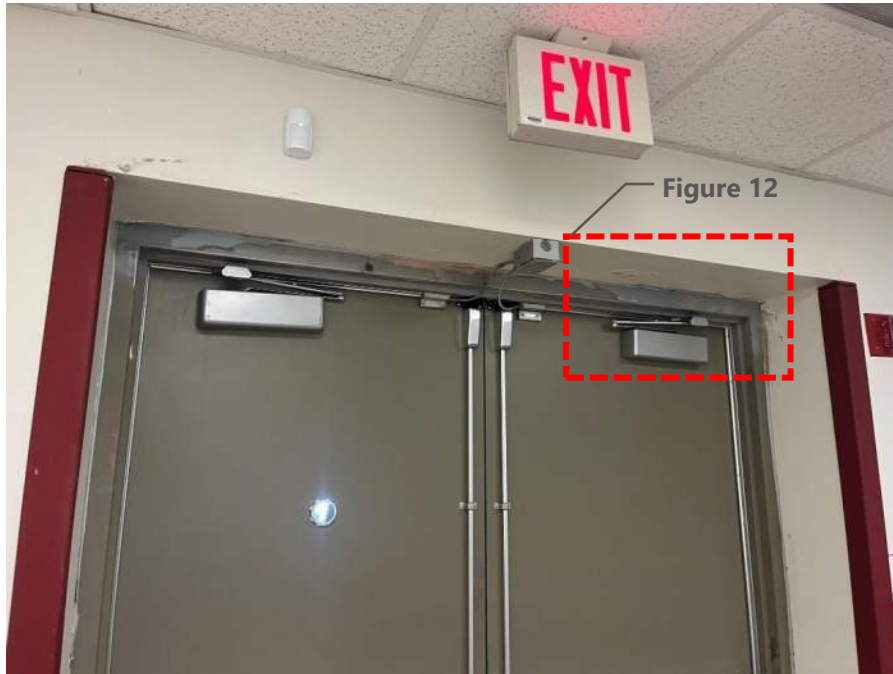
Figure 11. Peeling finishes and staining at ambulance bay entrance.

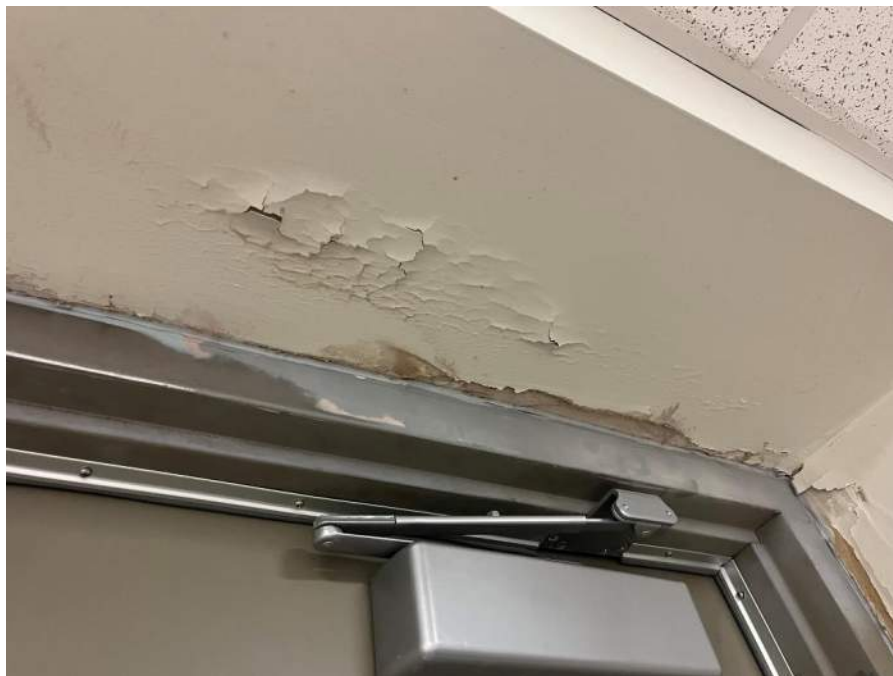
Figure 12. Close-up view of peeling and stained finishes in Figure 11.

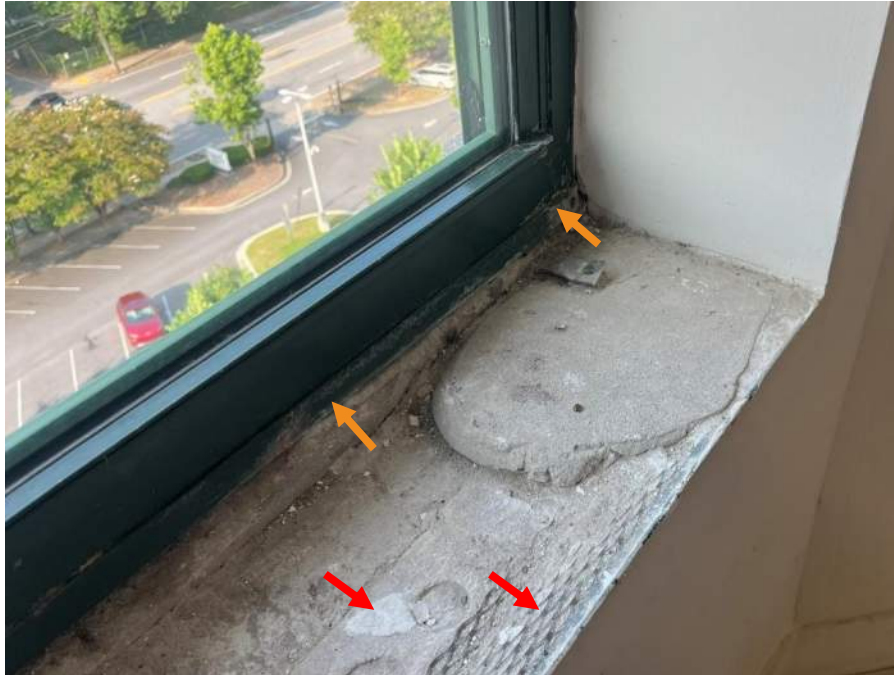
- The window stool was missing from Level 6 east stairwell window, exposing metal lath extending from plaster finishes and inside surface of the brick backup wall. Staining was noted along the base of the window frame (Figure 13).

Figure 13. Staining along base of window frame (orange arrows) exposing metal lath extending from plaster finishes and inside surface of the brick backup wall (red arrows)

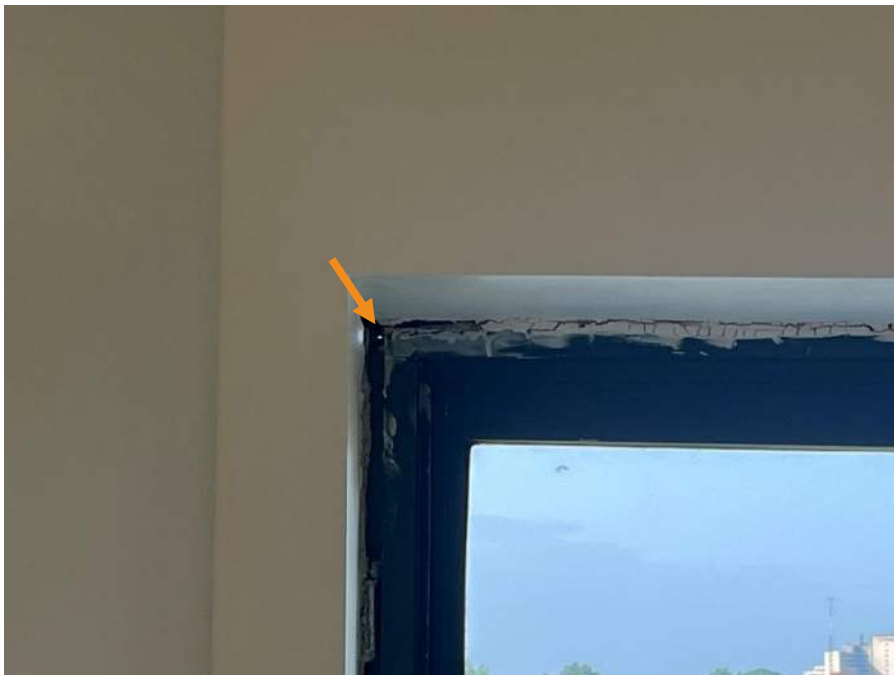
Figure 14. Daylight visible between window head-jamb corner and interior finishes.

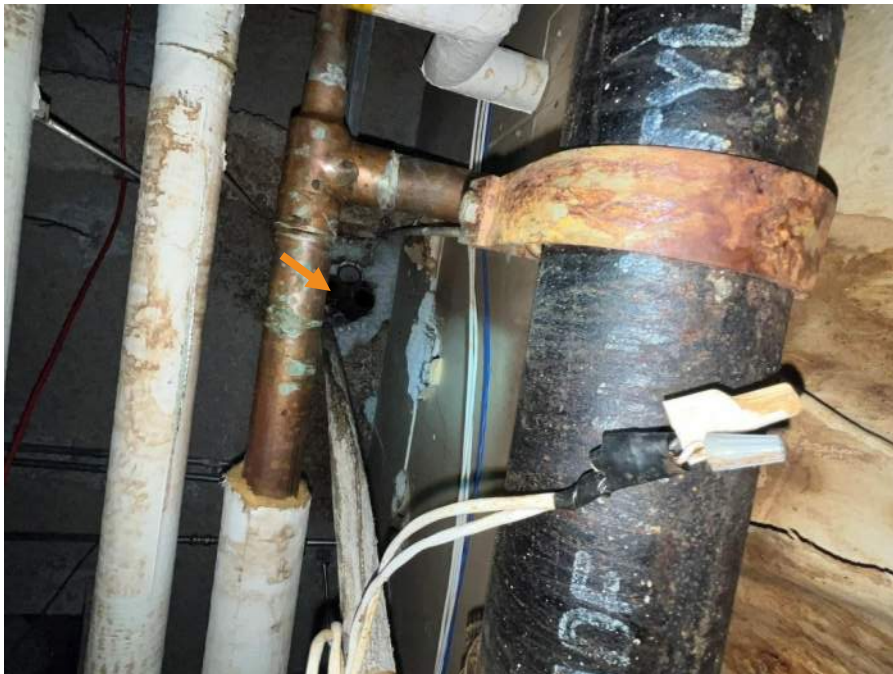
- Water-stained ceiling tiles were observed in the Infusion Hallway (Area 128), located at the first floor of the east wing. WJE accessed the interstitial space above the stained ceiling tiles and observed a pipe sleeve containing numerous abandoned conduits (Figure 18 and Figure 19), located beneath a rooftop mechanical unit.

Figure 18. Pipe sleeve (orange arrow) and water staining at concealed roof space.

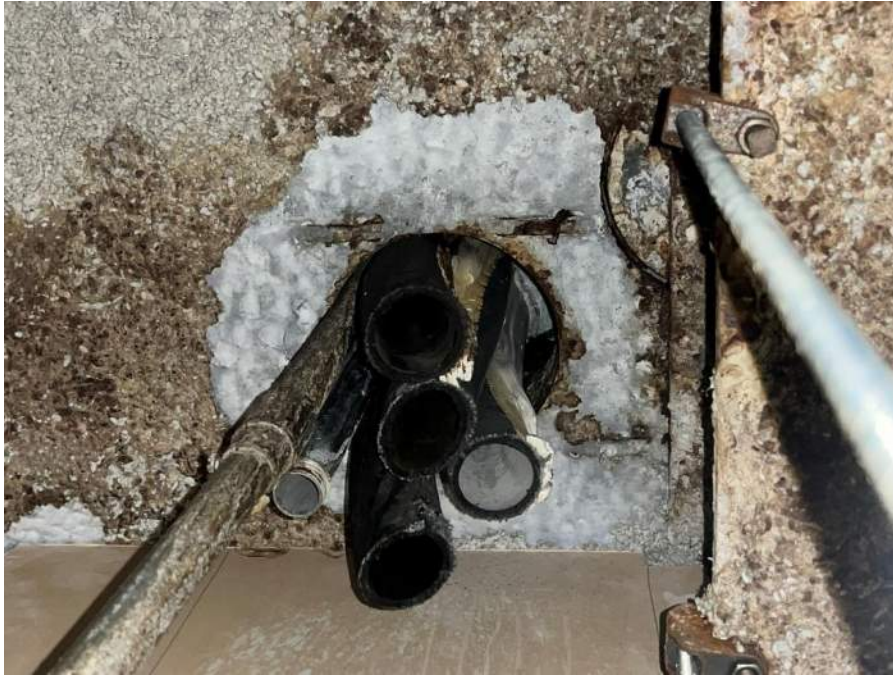
Figure 19. Water staining surrounding a pipe sleeve with numerous abandoned conduits

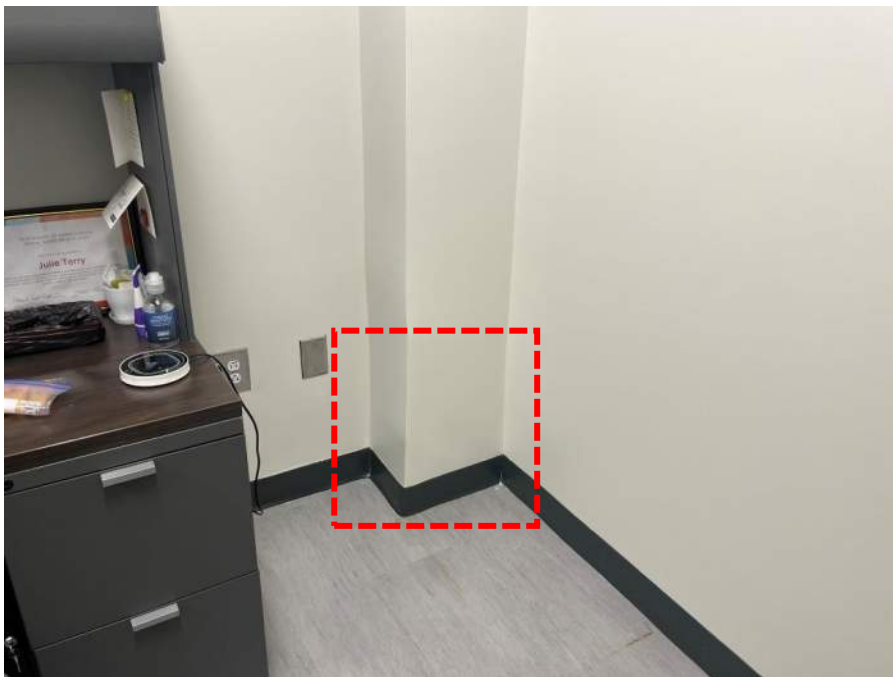
- Previous interior water leakage was reported at the southeast corner of Office P108 (Figure 20), located below grade in the east wing; the south wall of Office P108 is shared with a below grade vault.

Figure 20. Approximate location of previous interior water leakage reported at southeast corner of Office P108.

- Per conversation with building personnel, a new downspout and sealant were installed at grade above the corner experiencing water leakage and a sump pump was installed within the vault to remove standing water. No additional water leakage has been reported since these repairs were performed.

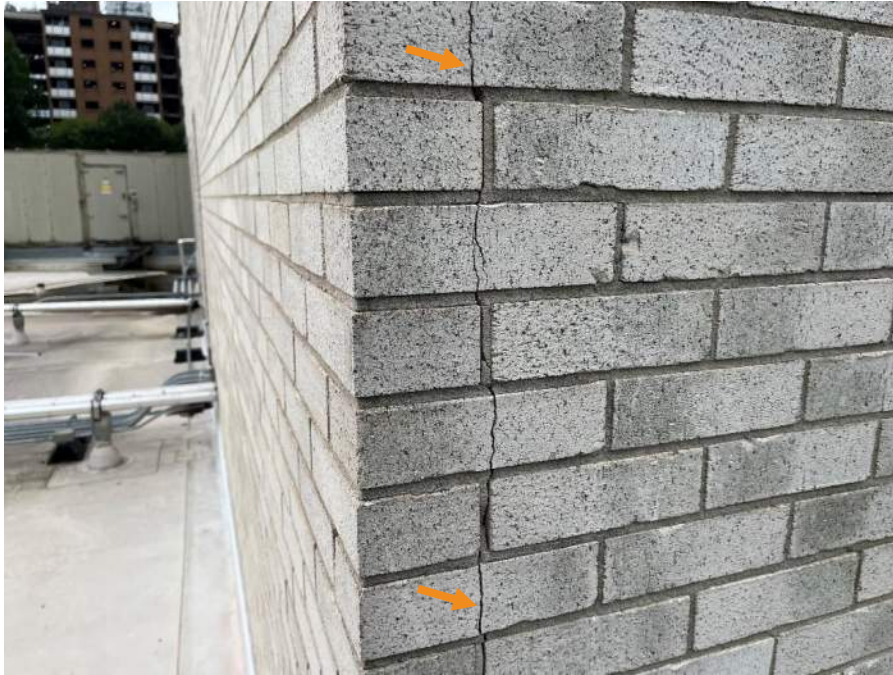
- No horizontal or vertical expansion joints were observed in the masonry veneer throughout the building.
- Full height vertical cracks, generally 15 mils or less, extend through both mortar joints and brick units, at outside corners throughout the building (Figure 23).

Figure 23. Vertical cracking at the northeast building corner viewed from the low roof.

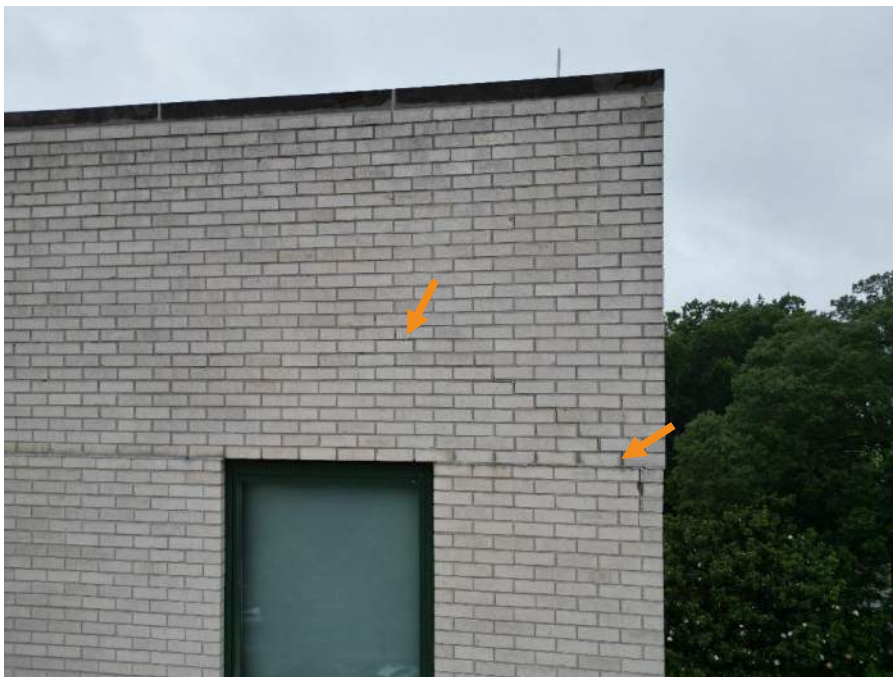
- Stair-stepped cracks through mortar joints extend to building corners at numerous locations, including at the parapet wall above Level 7 on the southeast corner (Figure 24) and from the parapet wall transition at the south end of the east and west mechanical penthouse facades (Figure 25).

- At the stair-stepped crack at the parapet wall at the southeast corner, as shown in Figure 24, the brick above the crack was displaced approximately 1/4-inch. No immediate safety concerns were noted at the brick at this location.

Figure 24. Stair-stepped mortar joint cracking at the main roof southeast building corner.

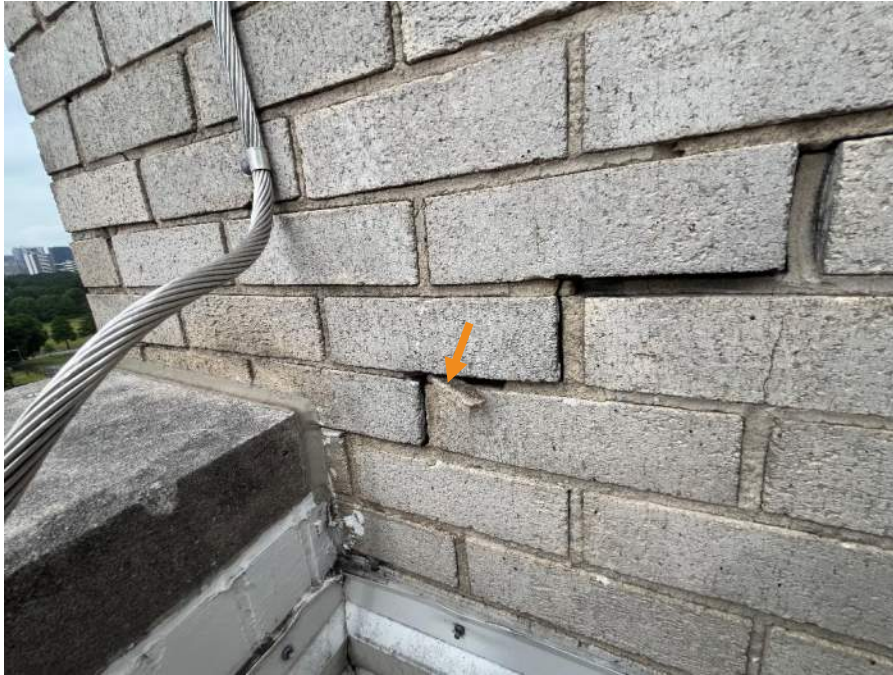
Figure 25. Areas of loose or missing mortar along stair-stepped cracking at mechanical penthouse.

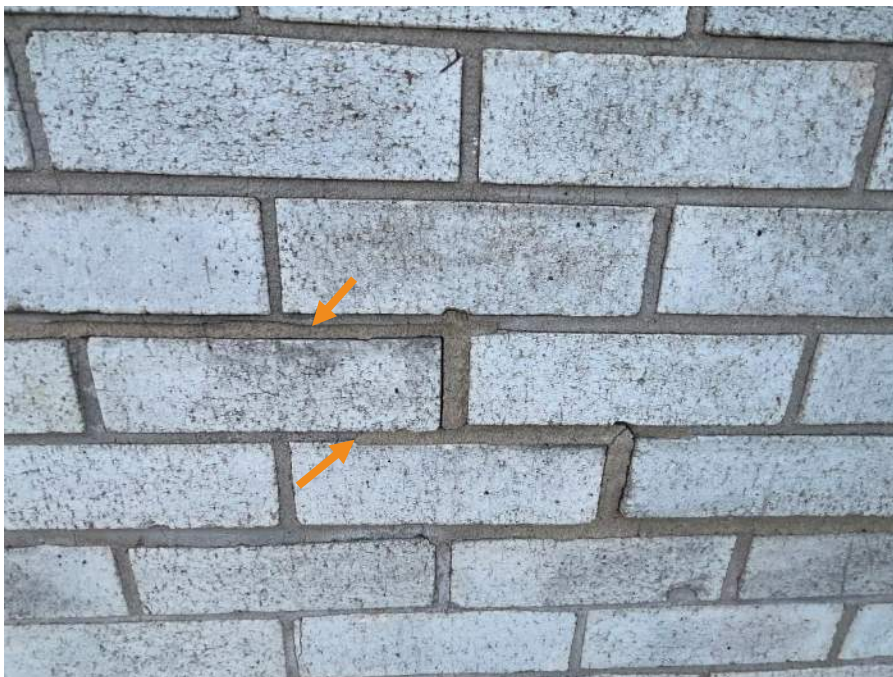
- Numerous colors, textures, and finishes, consistent with previous repointing efforts (Figure 26) were noted in the mortar joints throughout the building. Bond separations (Figure 27), transverse cracks through the mortar (Figure 28) and areas of missing mortar were observed at many of these locations (Figure 29).

Figure 26. Location of varying mortar finishes and colors.

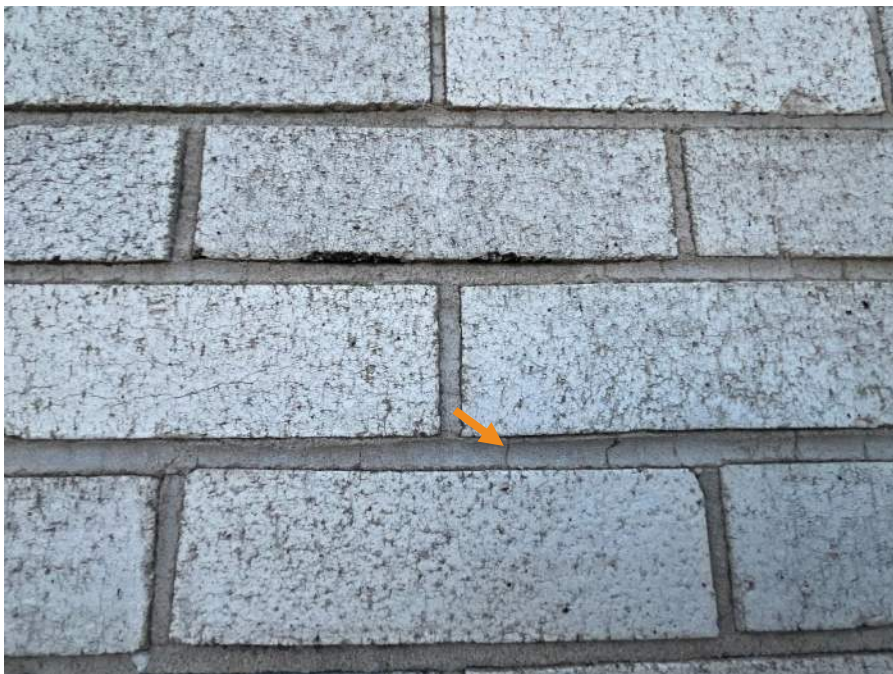
Figure 28. Transverse cracks in mortar joints.

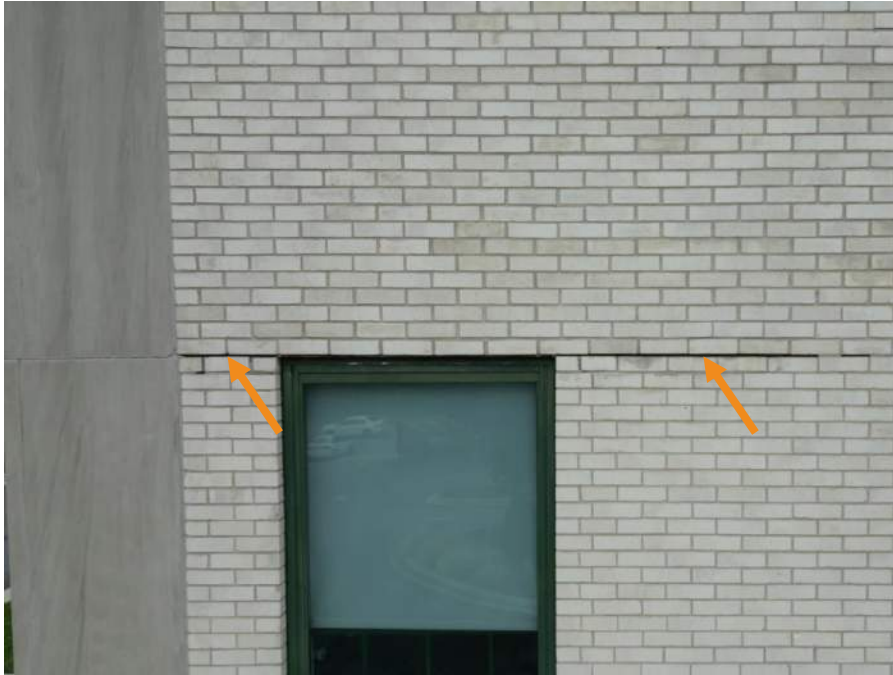
Figure 29. Missing mortar at bed joint level with Level 2 window head.

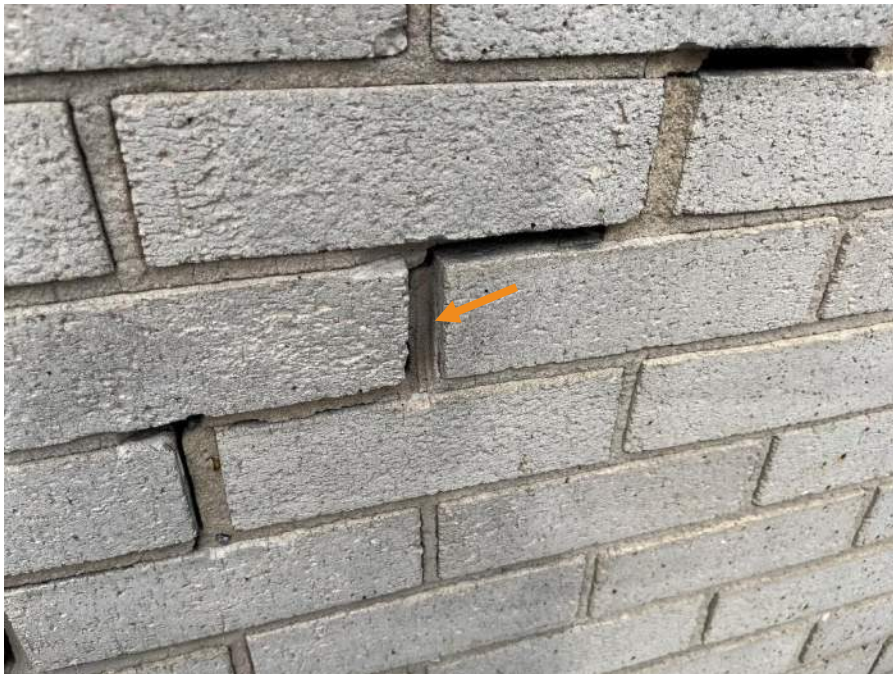
- At areas of missing mortar, half-moon profiles, measuring approximately 1/4-inch deep were observed in the head joints (Figure 30).
- Areas of eroded mortar and discolored brick masonry were noted near the ground level of the north facade (Figure 31 and Figure 32); building staff reported planters had been removed from these locations.

Figure 30. Saw cuts creating crescent profile in head joint.

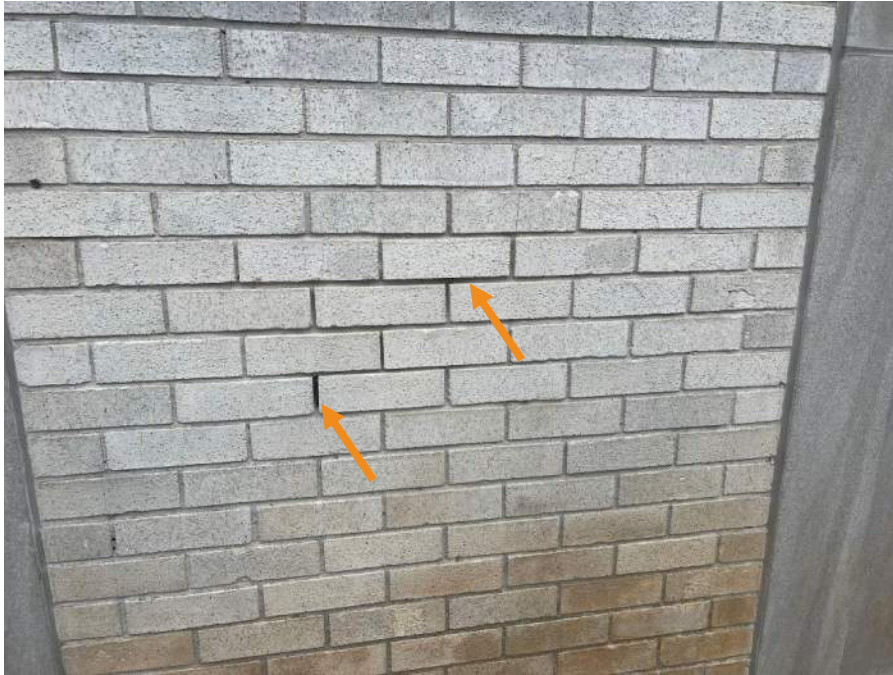
Figure 31. Area of eroded mortar and stained brick masonry.

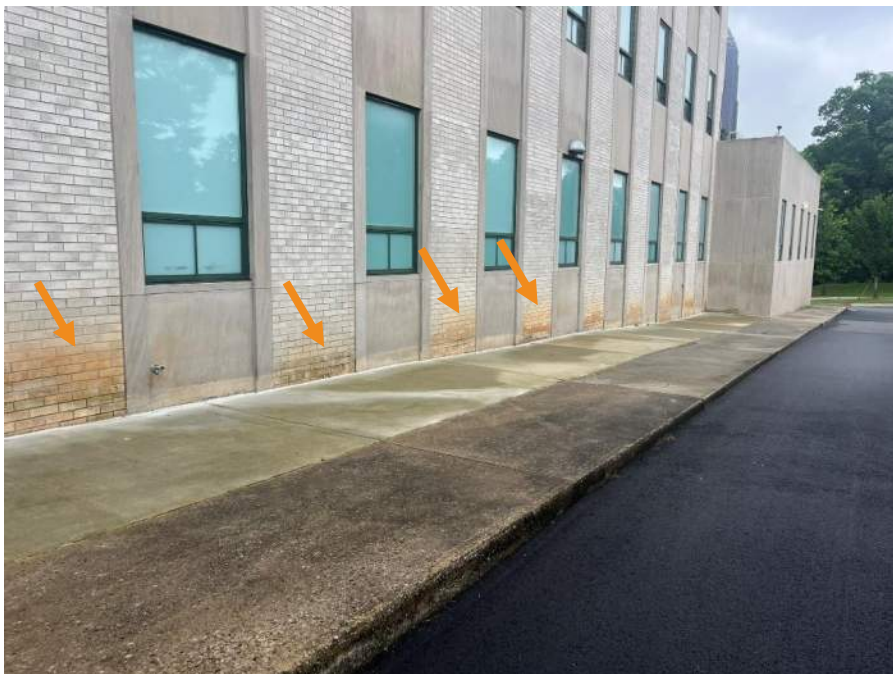
Figure 32. Areas of stained brick masonry at lowest 2 feet along north facade.

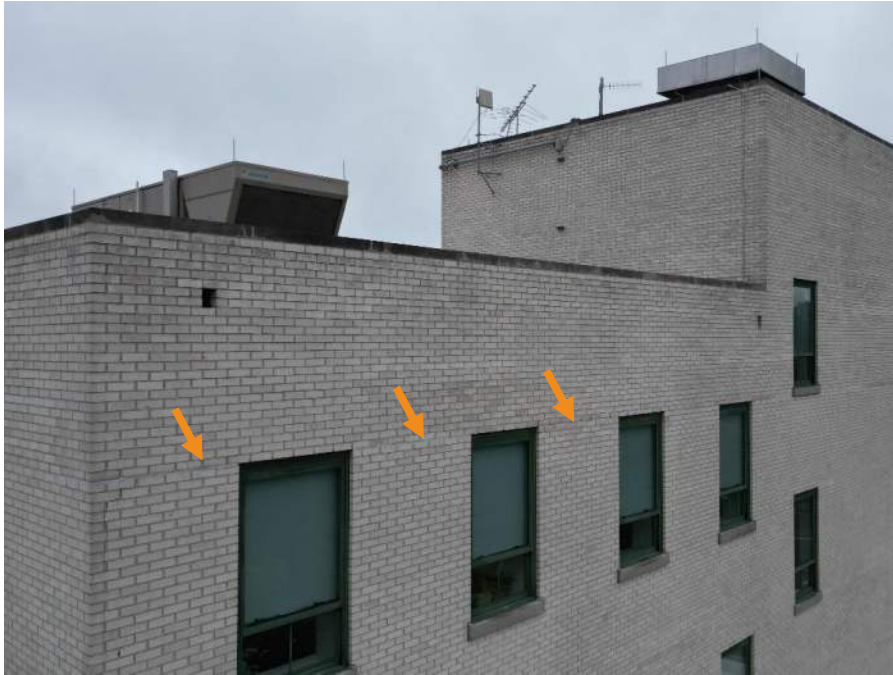
- Sealant was observed in the bed joints aligned with window heads throughout each facade; rope weeps extended through the sealant at varying spacing, generally between 32 and 48 inches at these locations (Figure 33). No weeps were observed at building transitions or base of wall conditions.

Figure 33. Sealant installed at bed joints aligned with window heads.

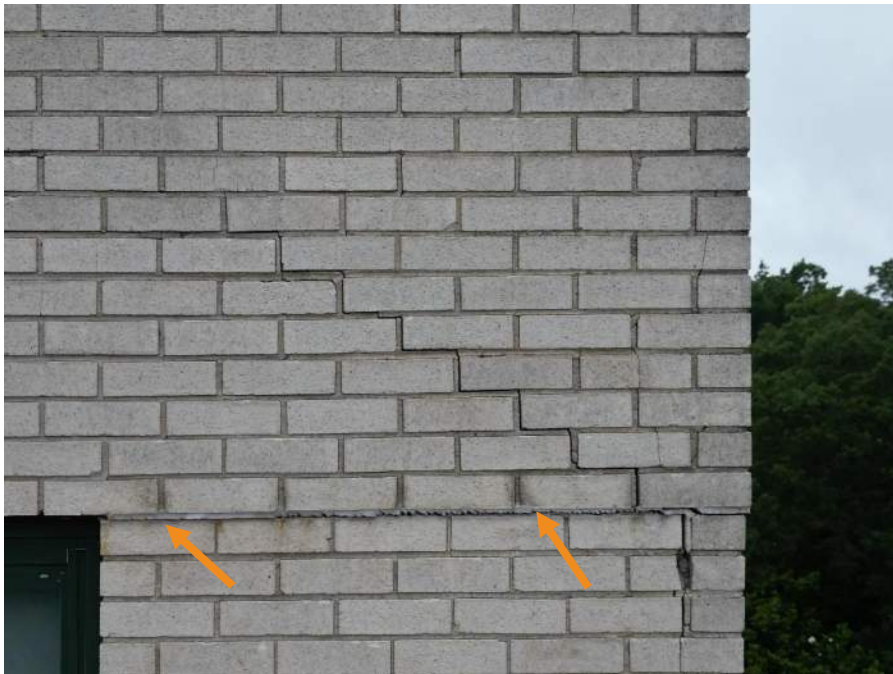
- Discoloration or staining of the sealant and adhesive or cohesive sealant failures were noted throughout the building, including adjacent to stepped cracks (Figure 34), along bed joints aligned with the window heads, and along the base of wall construction at the north facade (Figure 35).

Figure 34. Adhesively and cohesively failed sealant at the bed joint aligned with the window head.

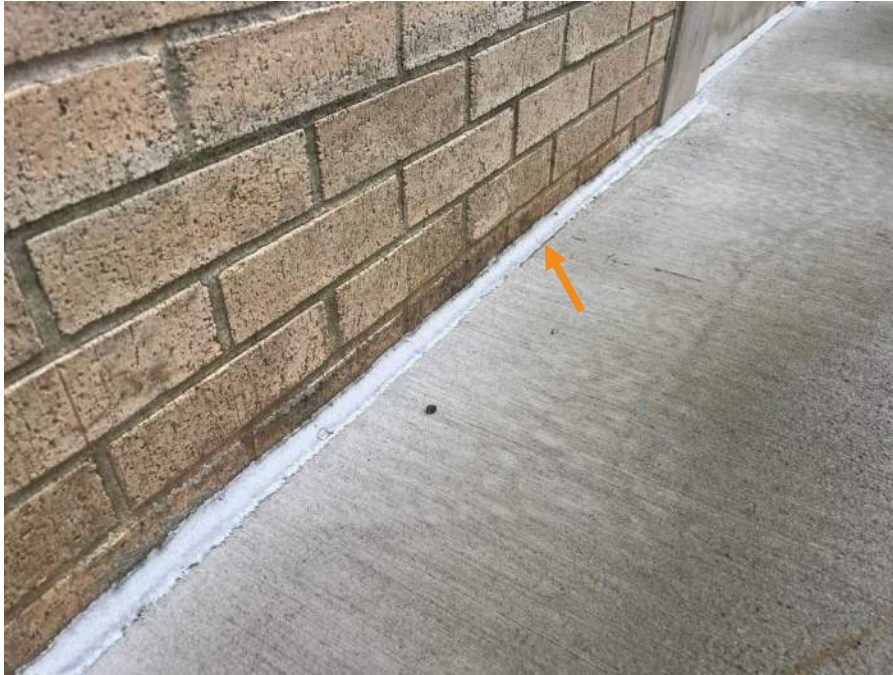
Figure 35. Adhesive failure of sealant installed between brick masonry and grade along north facade.

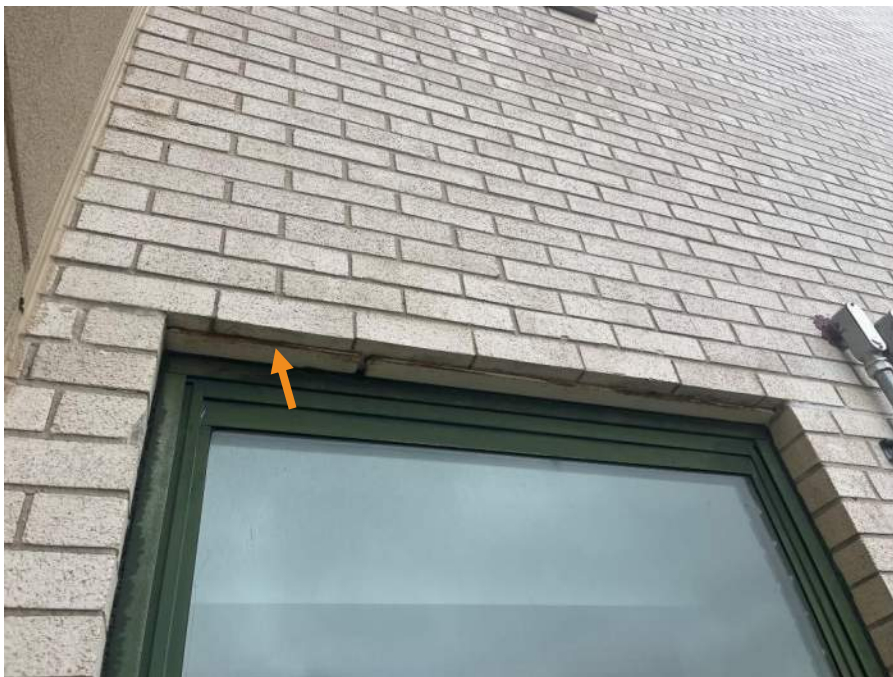
- Light surface corrosion was identified on the underside of the steel angles spanning over window heads (Figure 36).
- Isolated missing or damaged brick units, abandoned penetrations through brick, and abandoned fasteners were observed throughout the property (Figure 37 through Figure 40).

Figure 36. Light surface corrosion on visible surface of steel angles spanning over window.

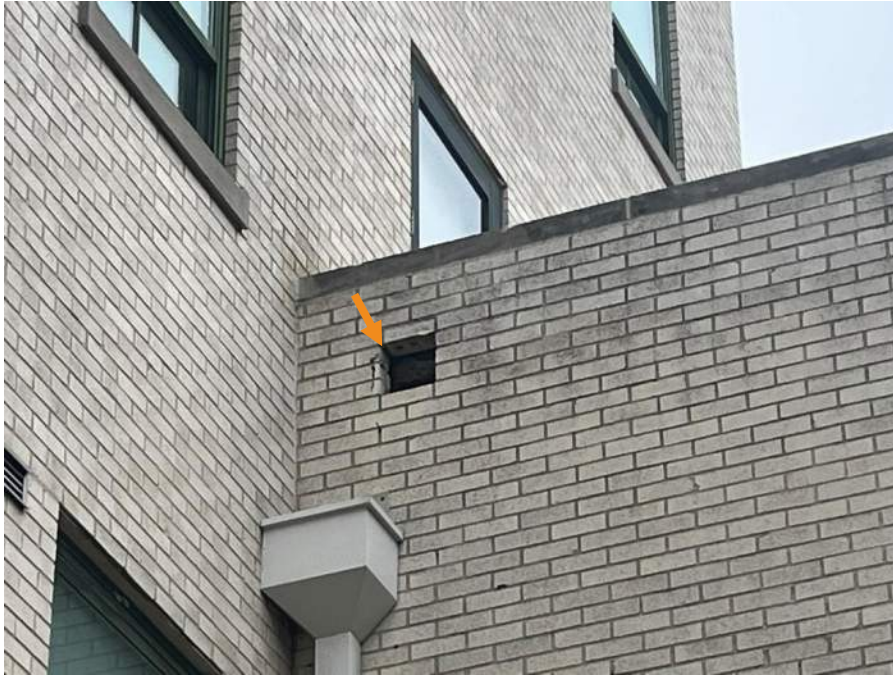
Figure 37. Opening in brick at base of low roof parapet wall.

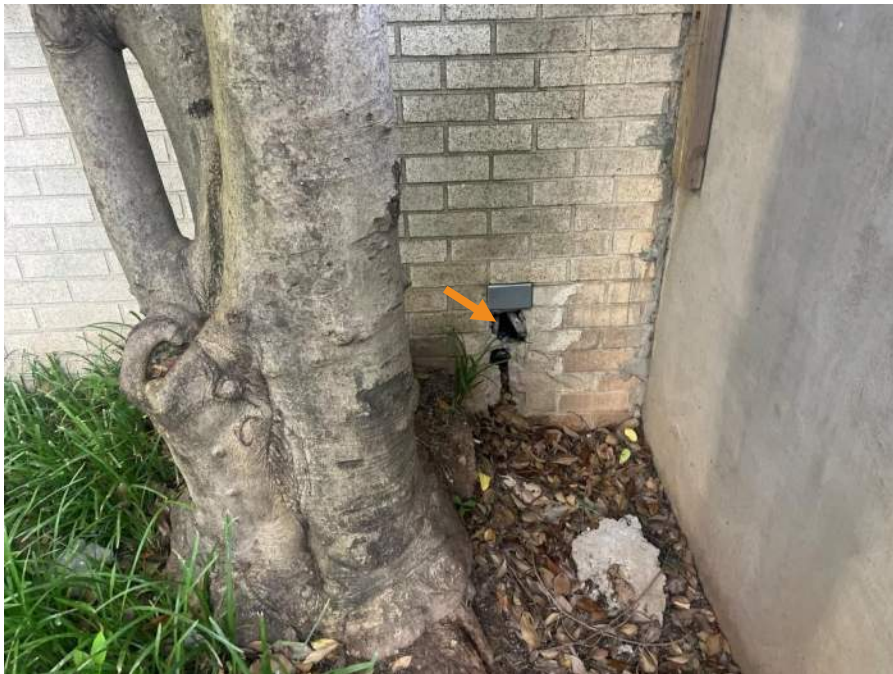
Figure 38. Missing brick units.

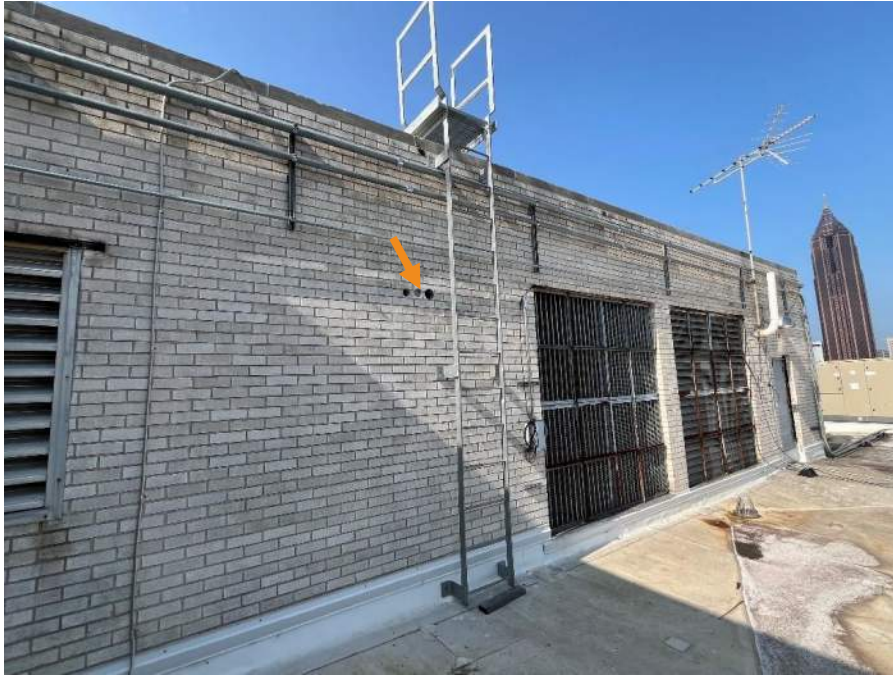
Figure 39. Abandoned penetrations through brick units at the north facade, viewed from the main roof.

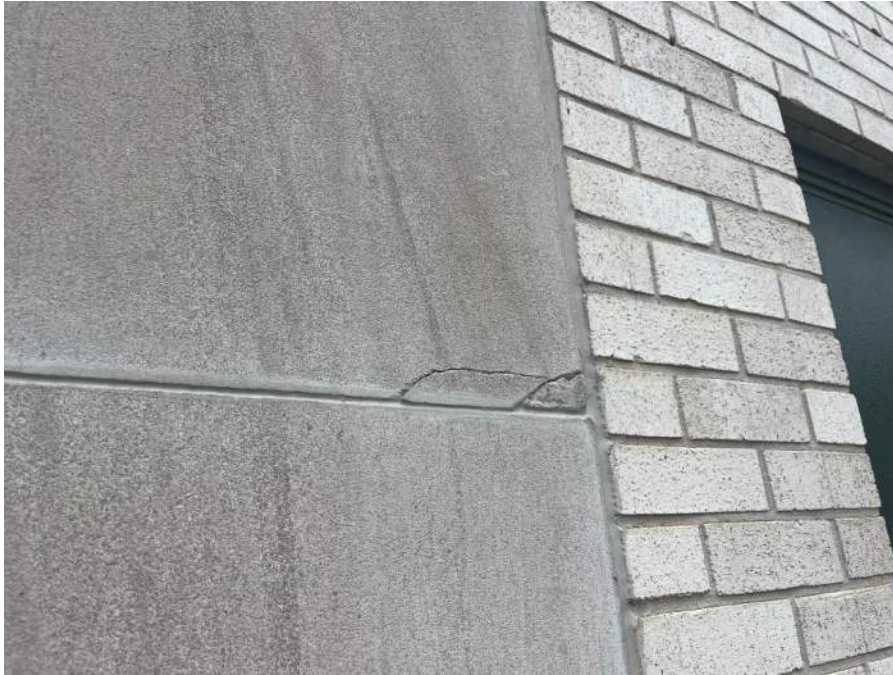
- Half-moon cracks or spalls were observed at panel edges at approximately five percent of the limestone panels; at several locations, corner chips or spalls extended from these cracks (Figure 43 and Figure 44).

Figure 43. Typical half-moon cracking at panel corners.

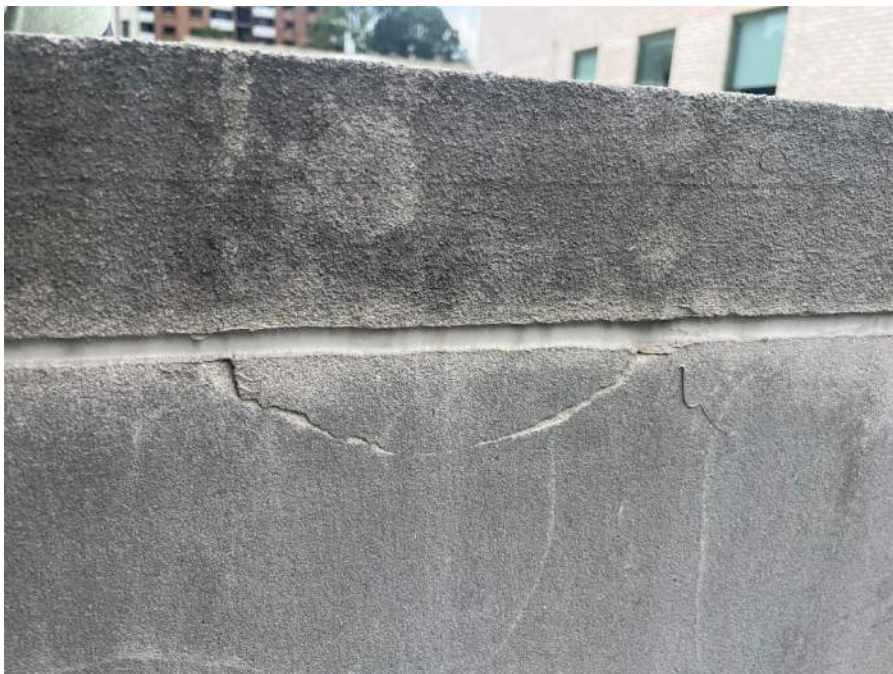
Figure 44. Half-moon cracking below the low roof coping.

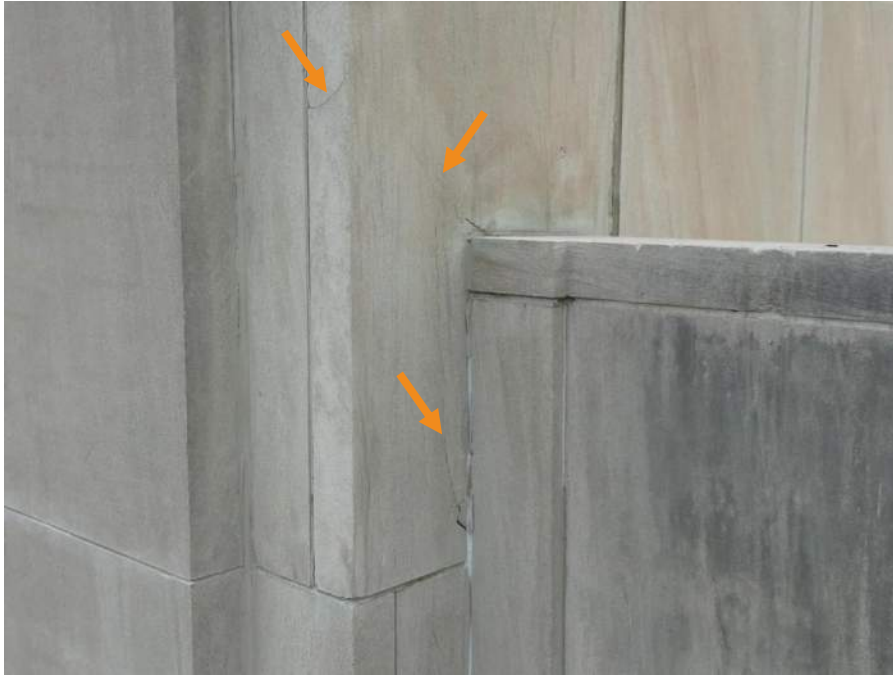
- Cracks, varying in width from hairline up to approximately 15 mils, were noted in 'L' shaped panels, such as the mechanical penthouse to parapet wall transition (Figure 45) and at the east wing employee entrance (Figure 46).

Figure 45. Cracking in field of L-shaped panels at mechanical penthouse to parapet wall transition.

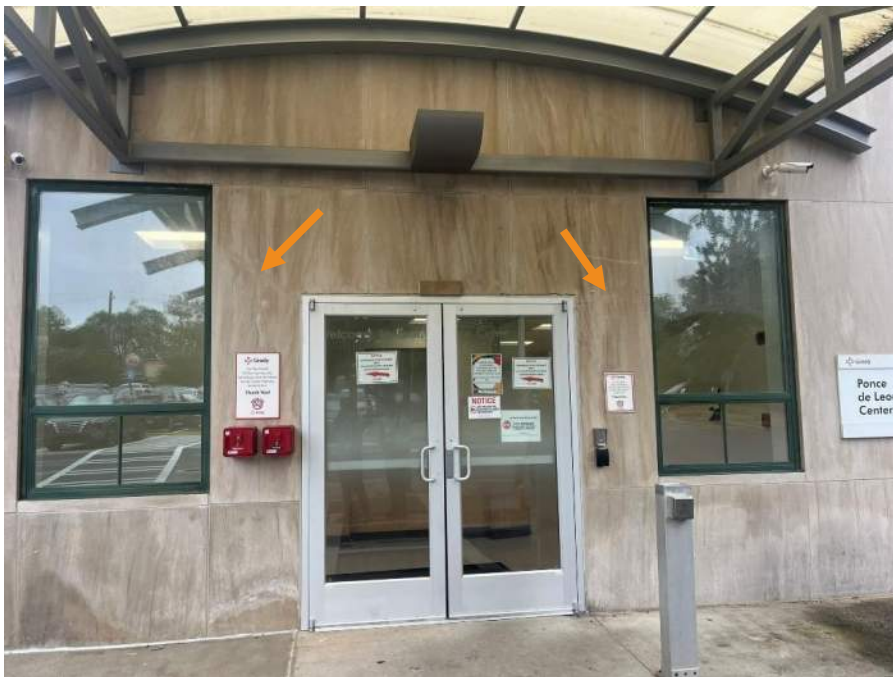
Figure 46. Cracking in L-shaped panels at east wing employee entrance head-to-jamb reentrant corners.

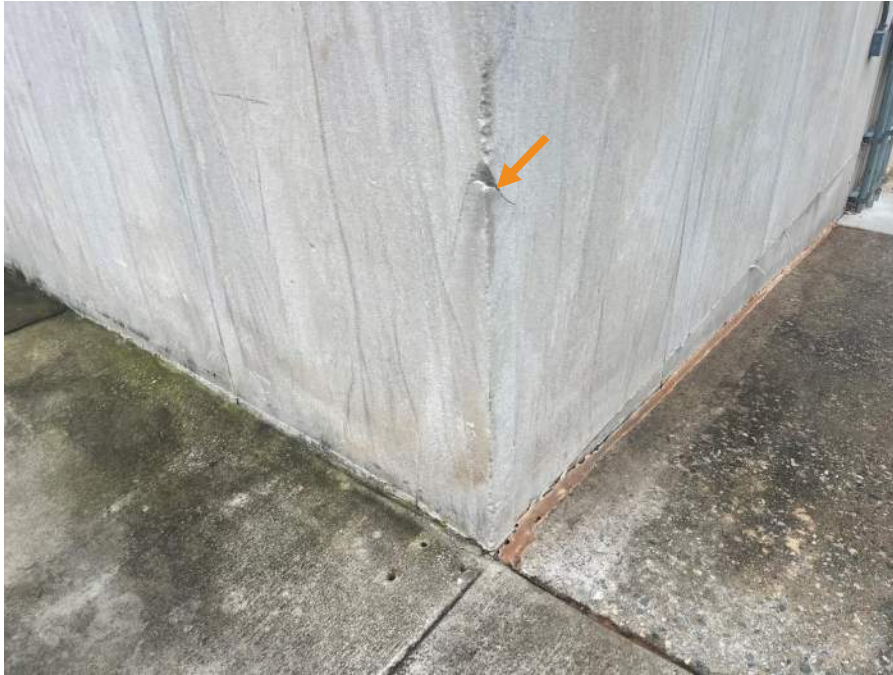
- Isolated hairline, up to 20 mil cracks, were noted throughout the limestone cladding, generally located on the ground level at building corners, high traffic locations, or immediately adjacent to drive aisles (Figure 47 and Figure 48).

Figure 47. Panel cracking at northwest outside building corner

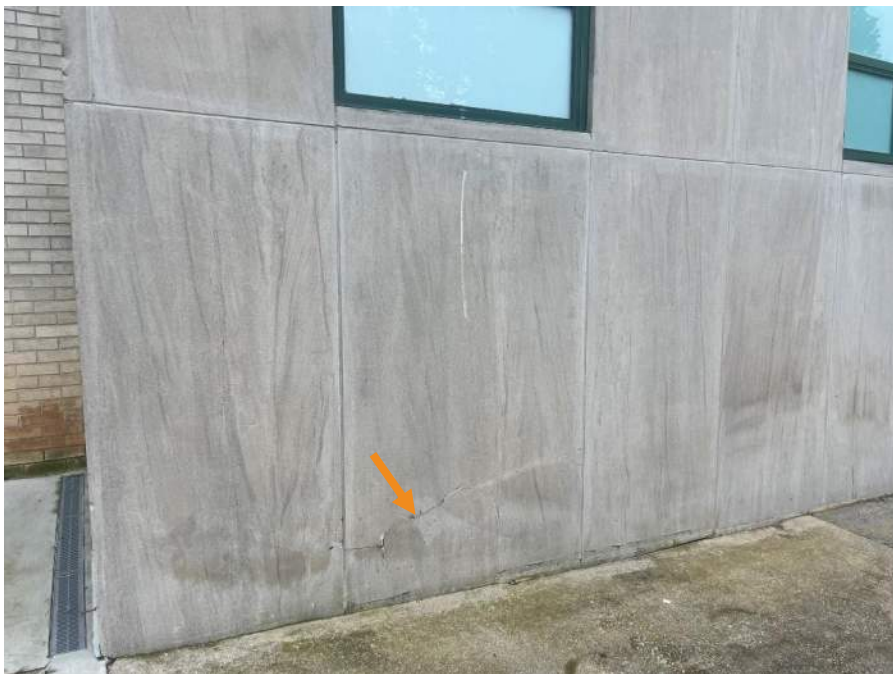
Figure 48. Cracking at north facade panel at grade adjacent to the north drive aisle.

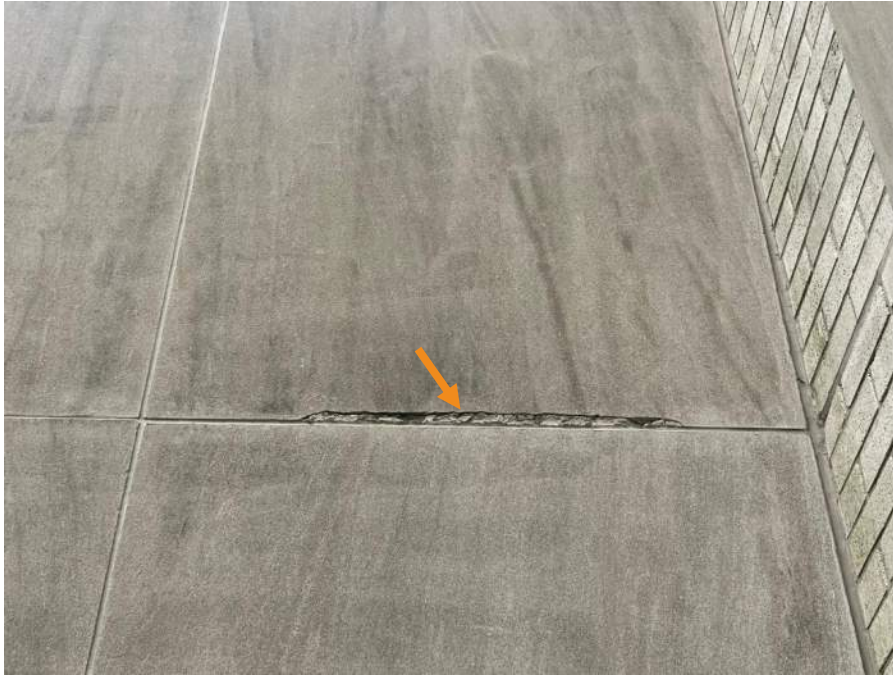
- Shallow surface spalls, chips, and/or localized damage in the limestone panels were noted throughout the facade (Figure 49 and Figure 50).
- Four cracks, measuring approximately 15 to 50 mils wide and varying between vertical and diagonal were noted in the limestone clad steeple at the south facade (Figure 51).

Figure 49. Spalling along panel edge.
