## Ponce De Leon Center

### Visual Condition Assessment

341 Ponce De Leon Avenue NE  
Atlanta, Georgia

July 28, 2025  
WJE No. 2025.1974

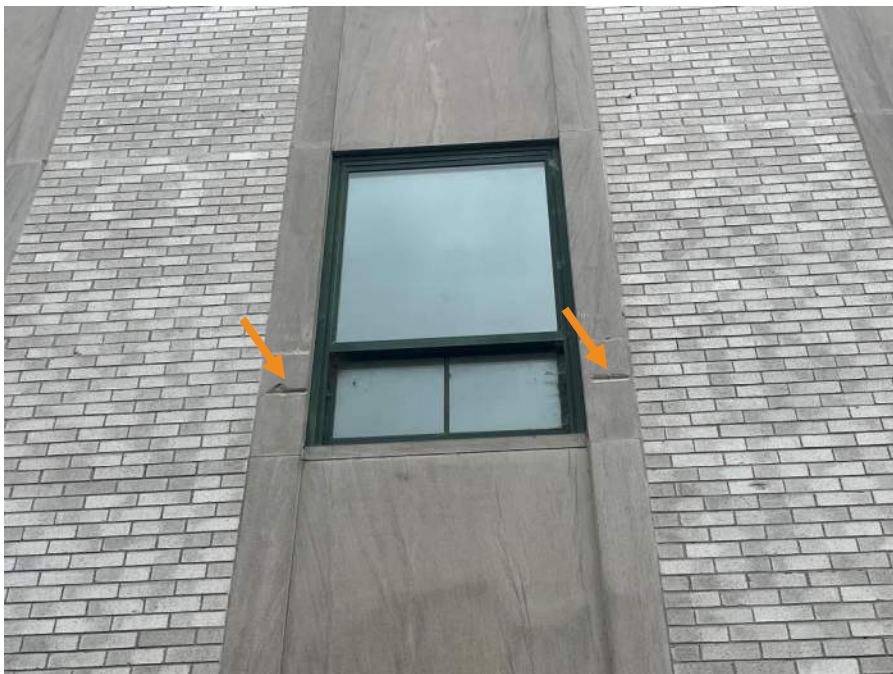
- Shallow surface spalls, chips, and/or localized damage in the limestone panels were noted throughout the facade (Figure 49 and Figure 50).
- Four cracks, measuring approximately 15 to 50 mils wide and varying between vertical and diagonal were noted in the limestone clad steeple at the south facade (Figure 51).

Figure 50. Localized damaged to panels.

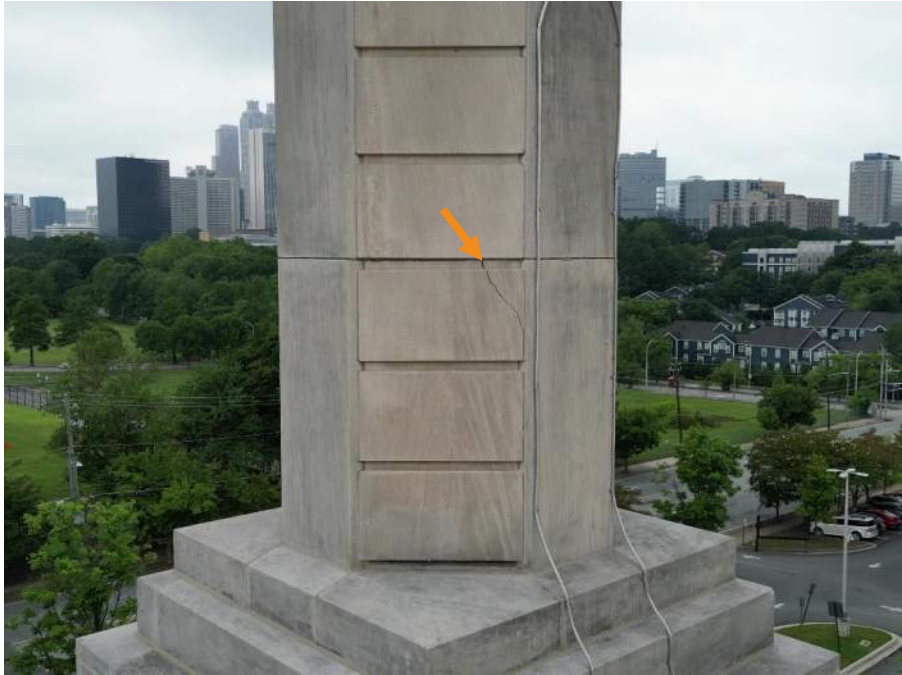
Figure 51. Cracking at south facade steeple panel.

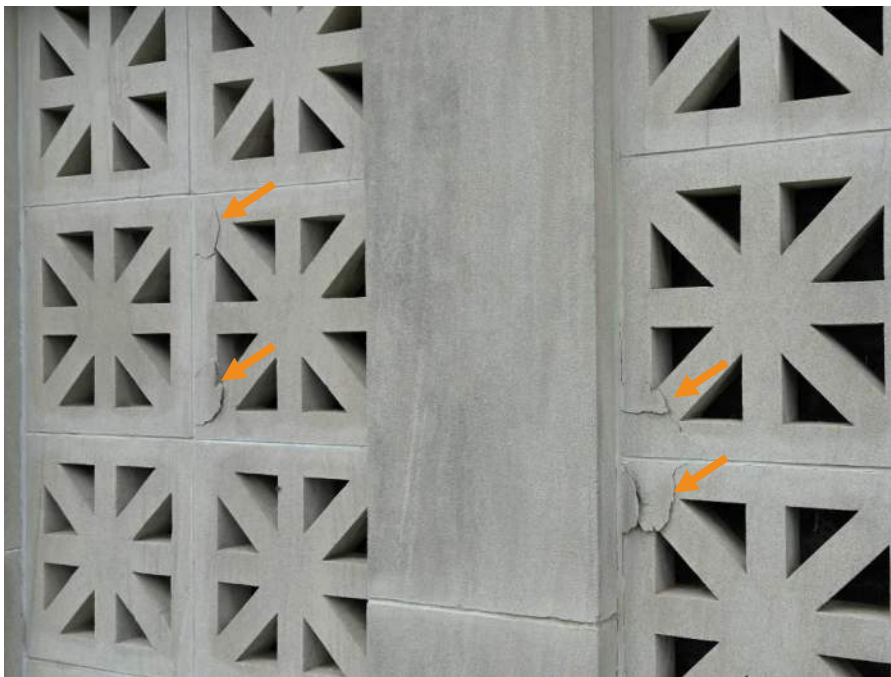
- Several incipient spalls were observed throughout the north facade, including a window sill and decorative infill panels at the penthouse level above the north entrance (Figure 52). The edges of the incipient spalls were adhered with joint sealant between existing elements; the joint sealant was intact at the time of WJE's visit.

Figure 52. Spalling at corners of decorative infill panels at the main roof level of the north facade.

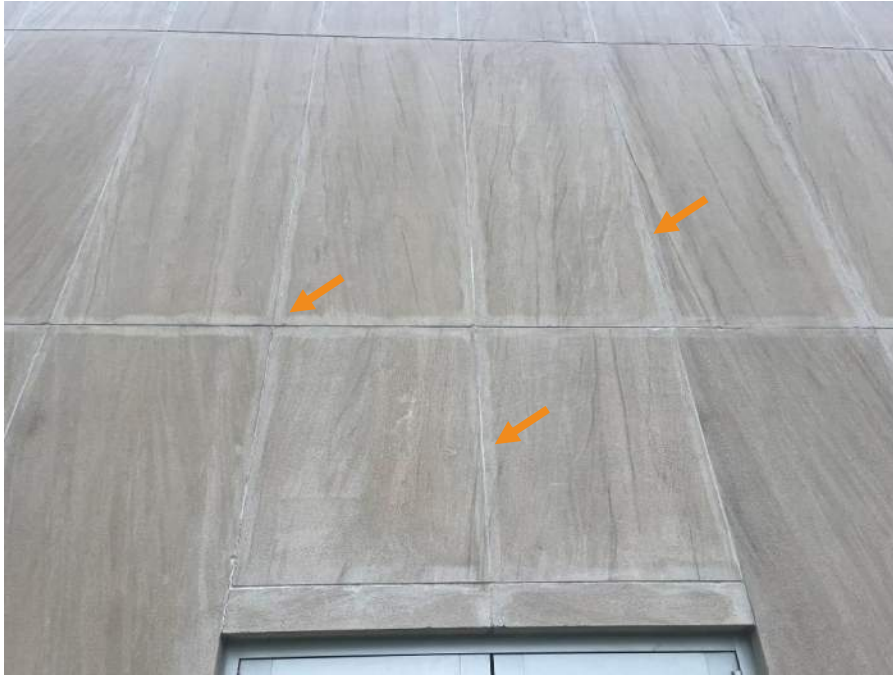
- 
- Throughout the facade, an approximately 2-inch-wide perimeter of the panels were lighter in color than the field of the limestone panel (Figure 53). This condition was most notable at the mechanical penthouse.

Figure 53. No staining present approximately 1 to 2 inches from panel joints.

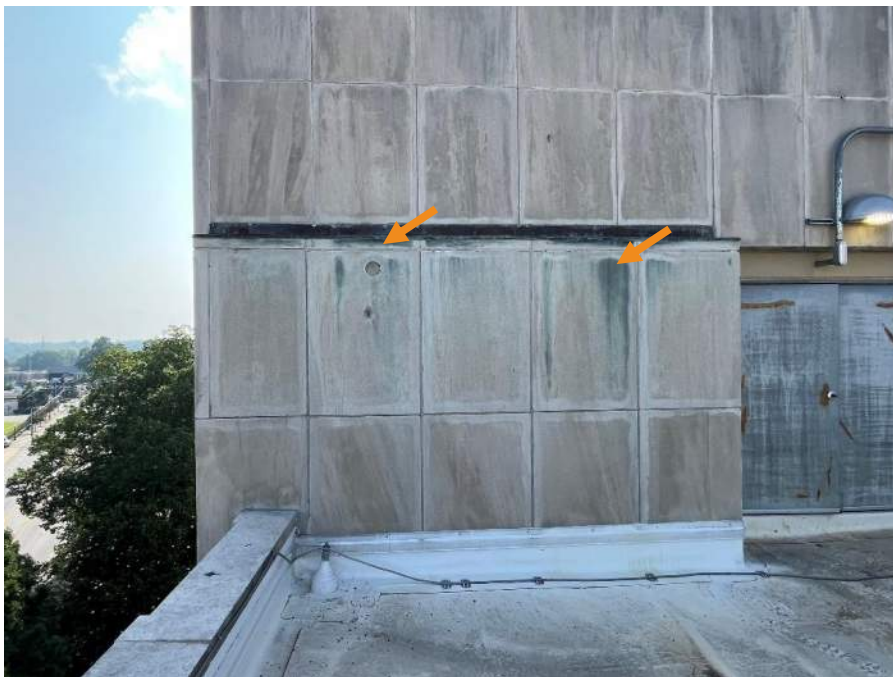
Figure 54. Panels stained green below copper flashing at facade of mechanical penthouse.

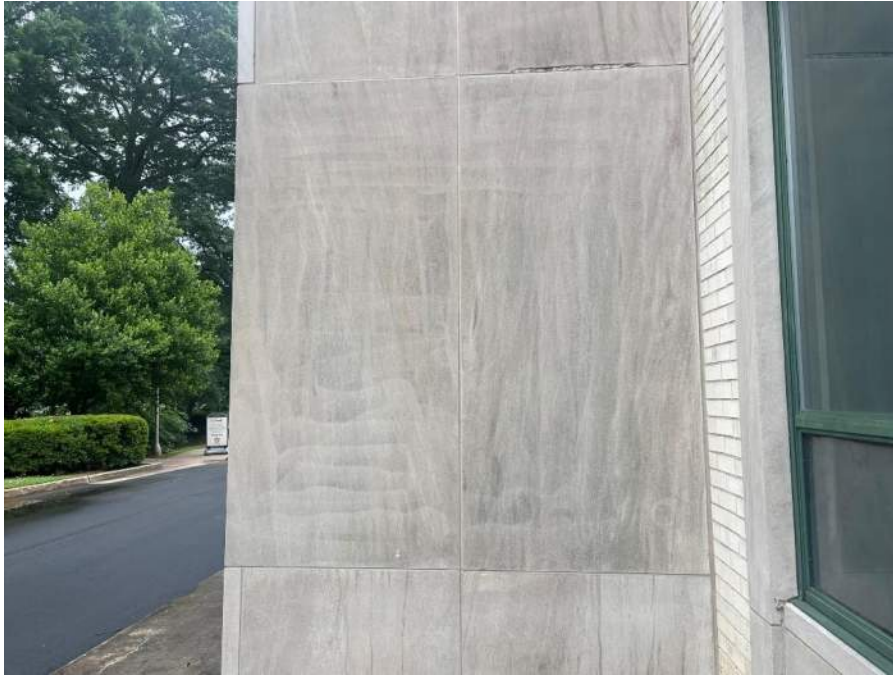
- Uneven panel discoloration and narrow areas of discoloration or etching of the face of the panels was noted at several of the limestone panels accessible from grade (Figure 55).

Figure 55. Uneven panel discoloration at panels accessible from grade.

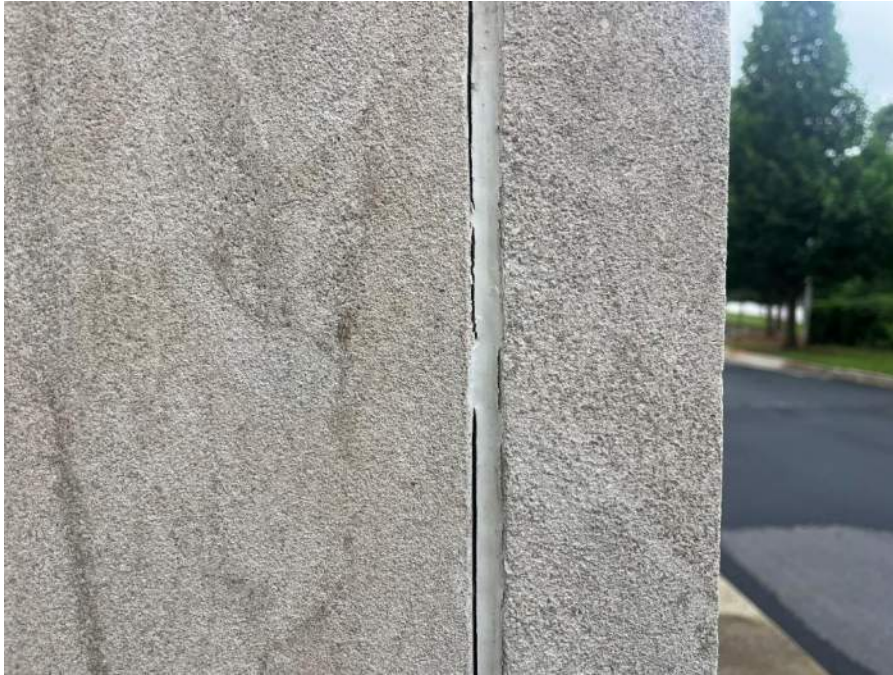
- The sealant had failed adhesively and/or was missing at limestone panel joints throughout the building (Figure 57 and Figure 58).
  - Similar to the brick masonry, sealant was installed between the wall panels and concrete sidewalk was failed adhesively, cohesively, and/or missing throughout the building perimeter (Figure 59 and Figure 60). Weep tubes were observed through the sealant at the limestone panels remaining beneath the porcelain panels at the main entrance (Figure 61).

Figure 57. Adhesively failed sealant at limestone panel joint.

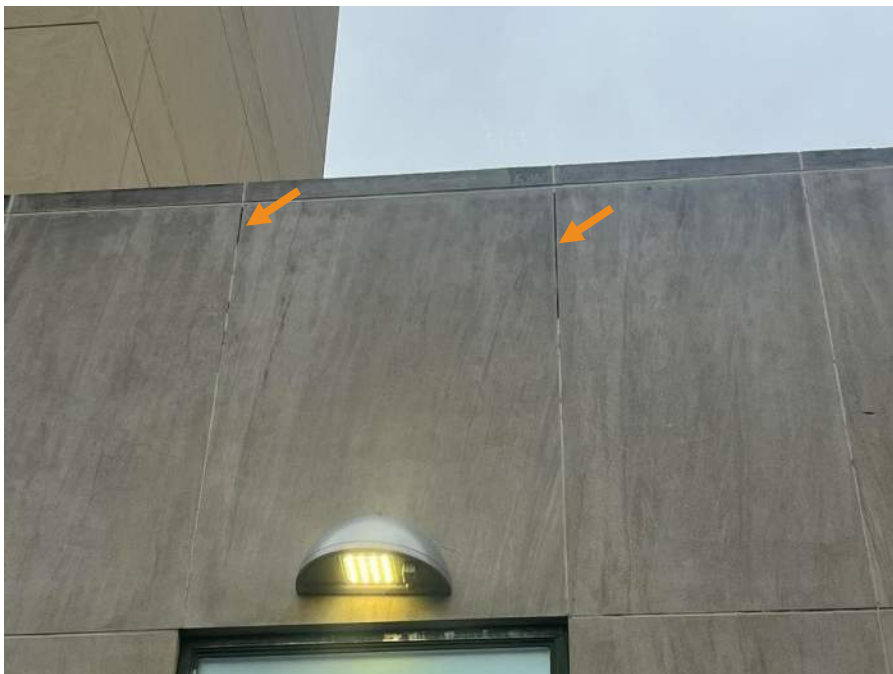
Figure 58. Missing sealant at limestone panel joints.

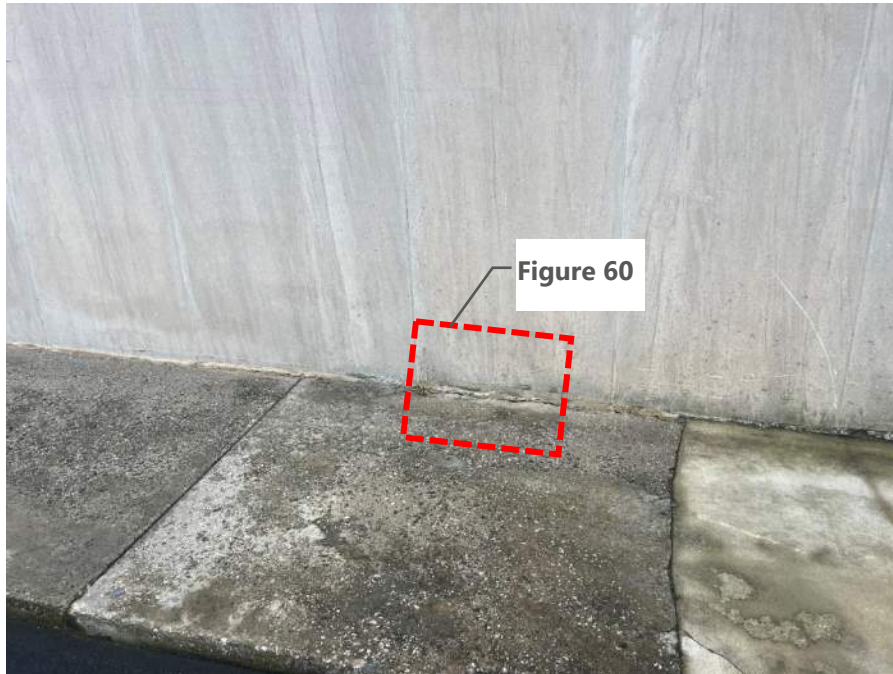
Figure 59. Adhesive and cohesive failure of sealant installed between limestone panels and grade.

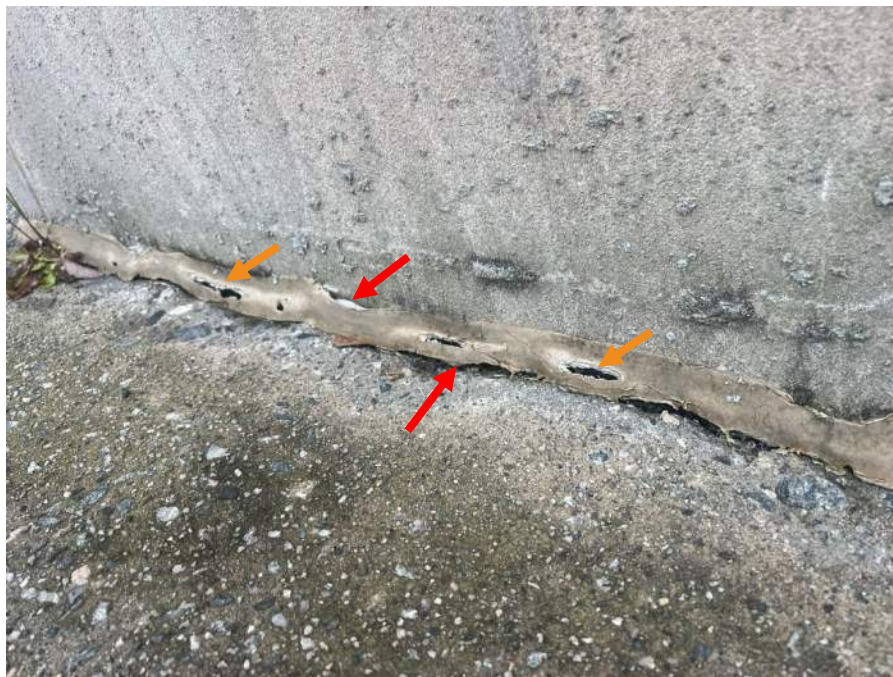
Figure 60. Close-up view of adhesive (red arrows) and cohesive (orange arrows) failure of sealant installed between limestone panels and grade.

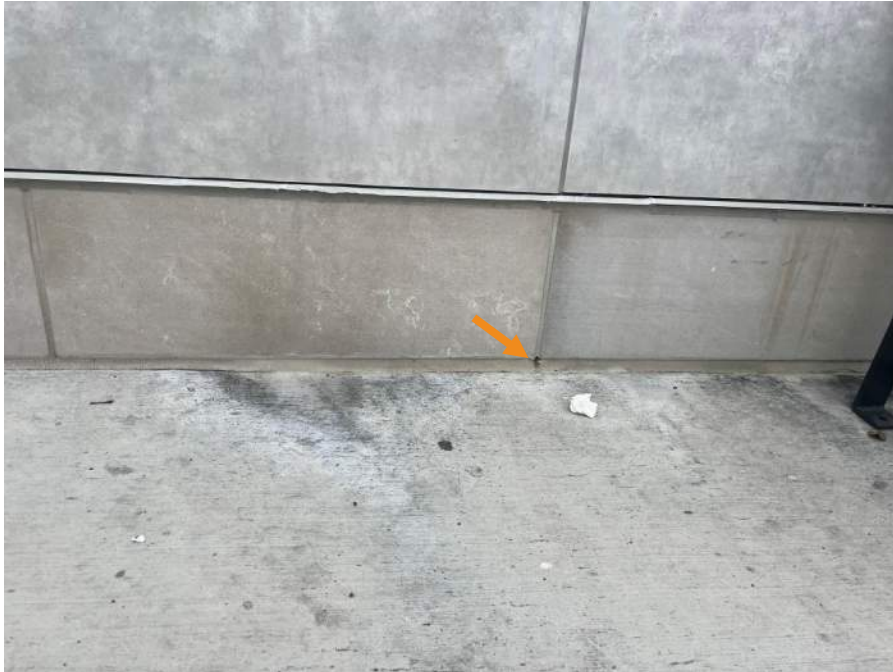
Figure 61. Sealant with exposed tube weeps installed between the limestone panels and concrete sidewalk at grade.

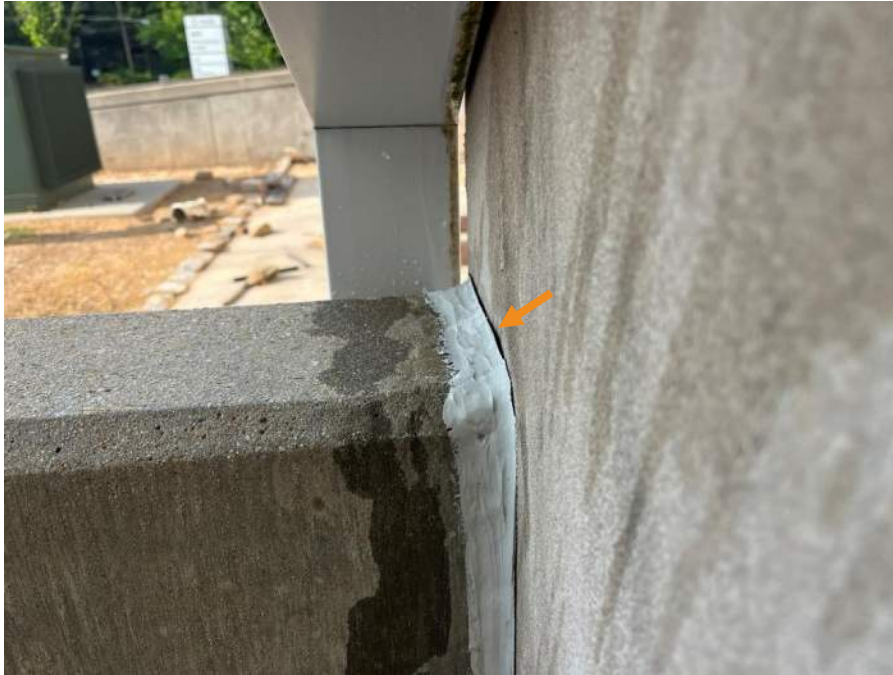
- Sealant installed between the concrete knee wall and limestone panels adjacent to the east employee entrance, at the location reportedly installed to address water leakage into Office P108, was adhesively failed (Figure 62 and Figure 63).

Figure 63. New sealant adhesively failed between the concrete knee wall and limestone panels.

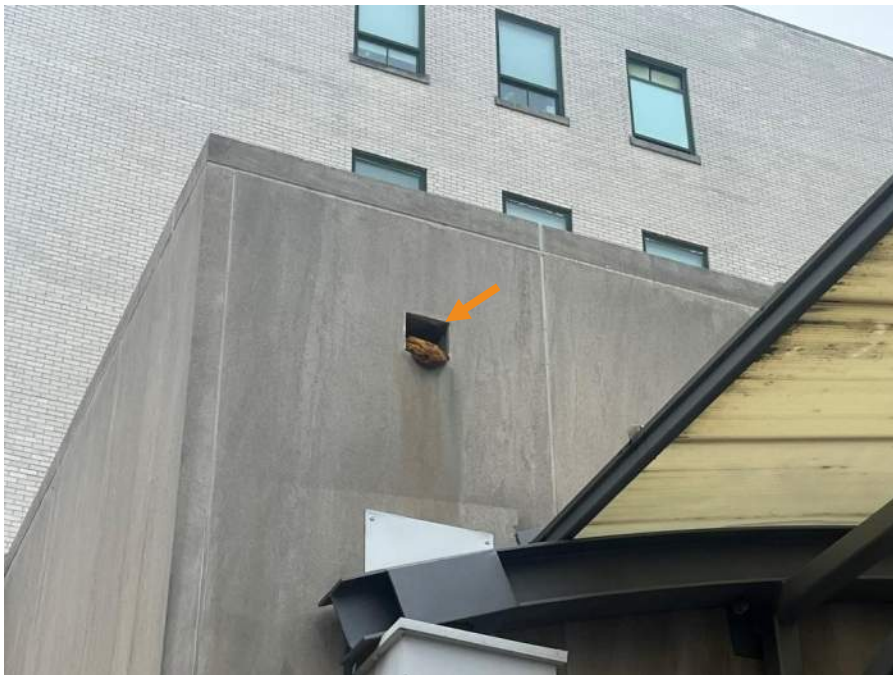
- Similar to the brick masonry, abandoned penetrations through the limestone and abandoned fasteners were observed at numerous wall panels and coping units throughout the building (Figure 64 through Figure 66).

Figure 64. Openings in the limestone panel at the base of roof parapet walls.

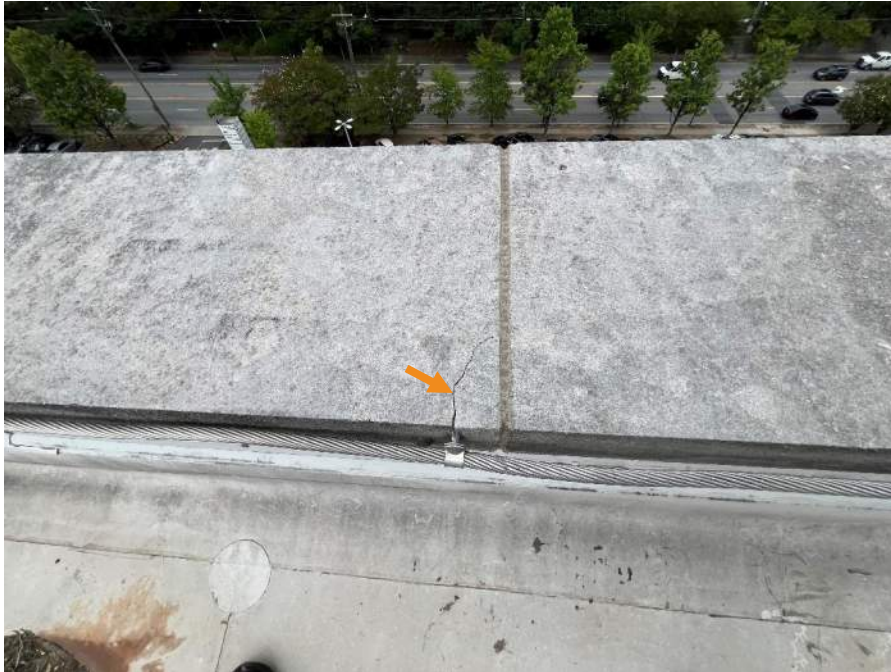
- Cracks and/or shallow surface spalls were noted at locations where fasteners located within 1 inch of the panel or coping stone edges (Figure 67 and Figure 68).

Figure 67. Cracking in the coping at lighting protection anchors.

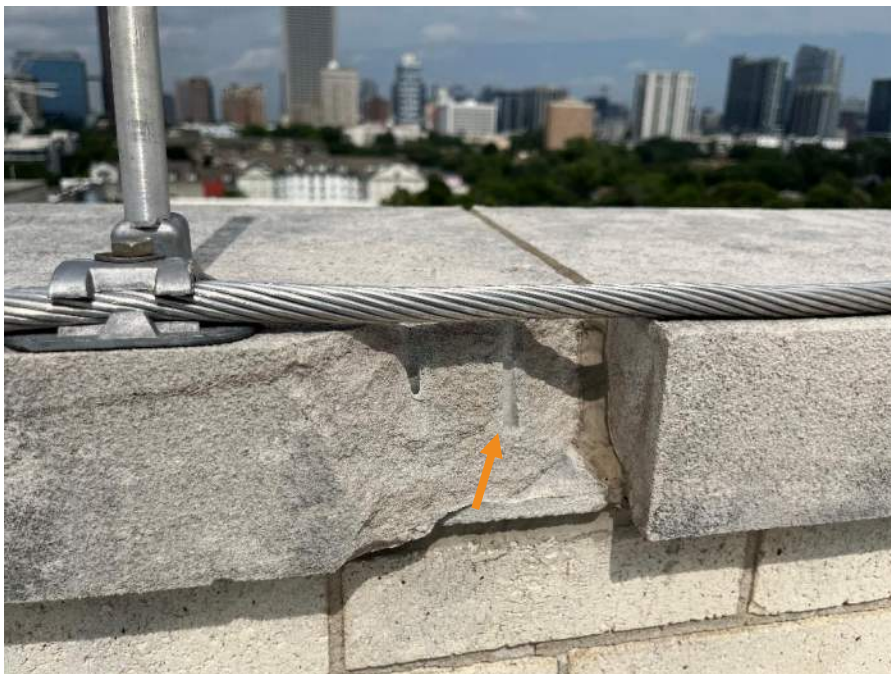
Figure 68. Spalls in the coping at previously installed anchors.

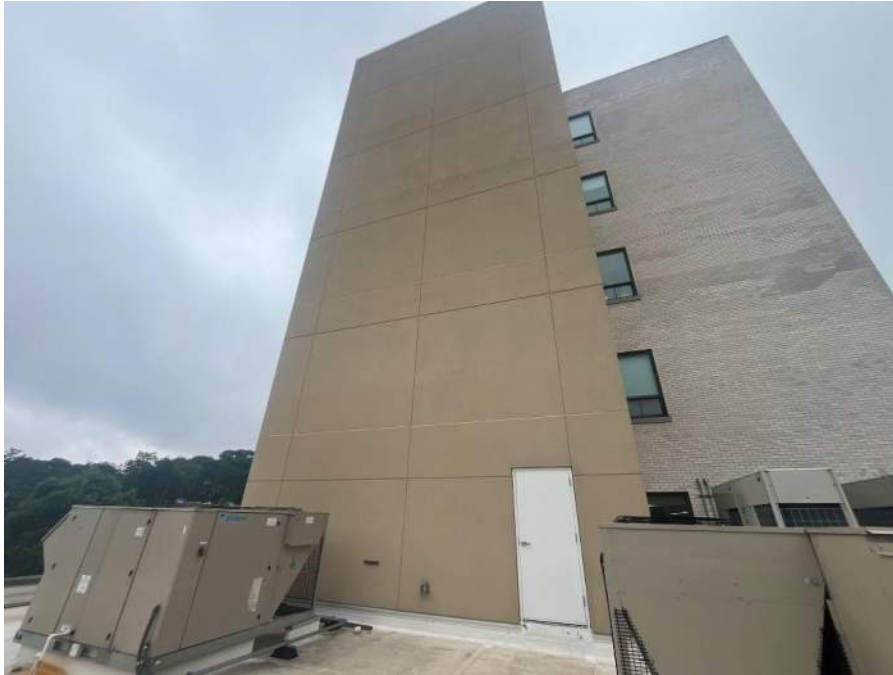
- The EIFS cladding at the west facade elevator tower and mechanical penthouse walls was generally observed to be free of cracking or staining in the field of the wall (Figure 69 and Figure 70).
- An isolated area of impact damage, measuring less than 4 square inches, was noted at the base of the mechanical penthouse (Figure 71).
- An open, unsealed joint was observed in the sheet metal expansion joint cover at the transition from the elevator tower to the main roof area (Figure 72). The underlying expansion joint material was concealed and inaccessible.
- An area of exposed EIFS mesh and insulation was noted adjacent to an abandoned Unistrut channel at the west wing low roof at the elevator tower (Figure 73 and Figure 74).
- Several unsealed joints or penetrations were noted at the mechanical penthouse walls (Figure 75 and Figure 76).

Figure 69. Overview of EIFS at west elevator tower

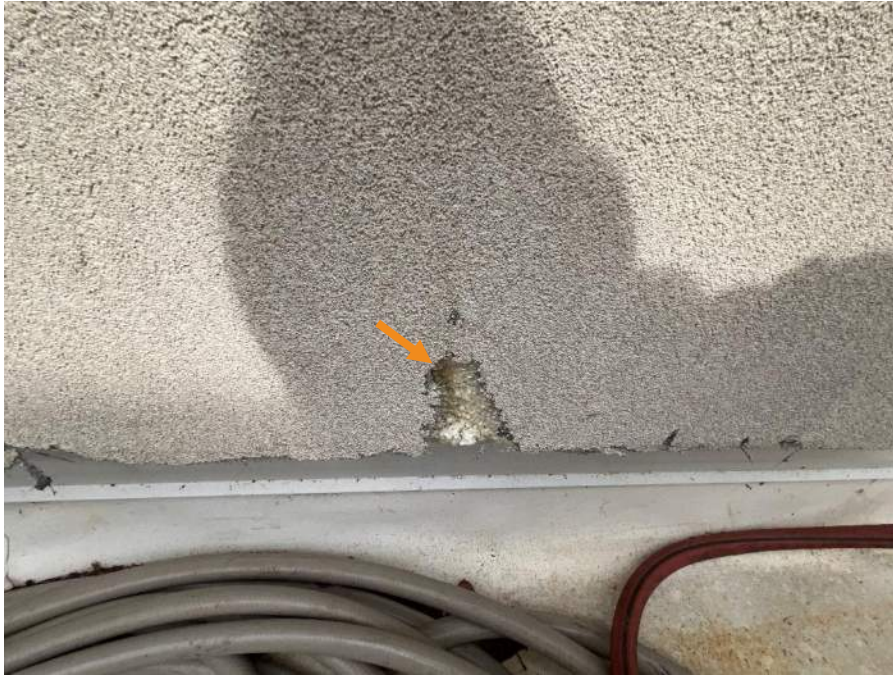
Figure 71. Isolated impact damage exposing the insulation board and mesh.

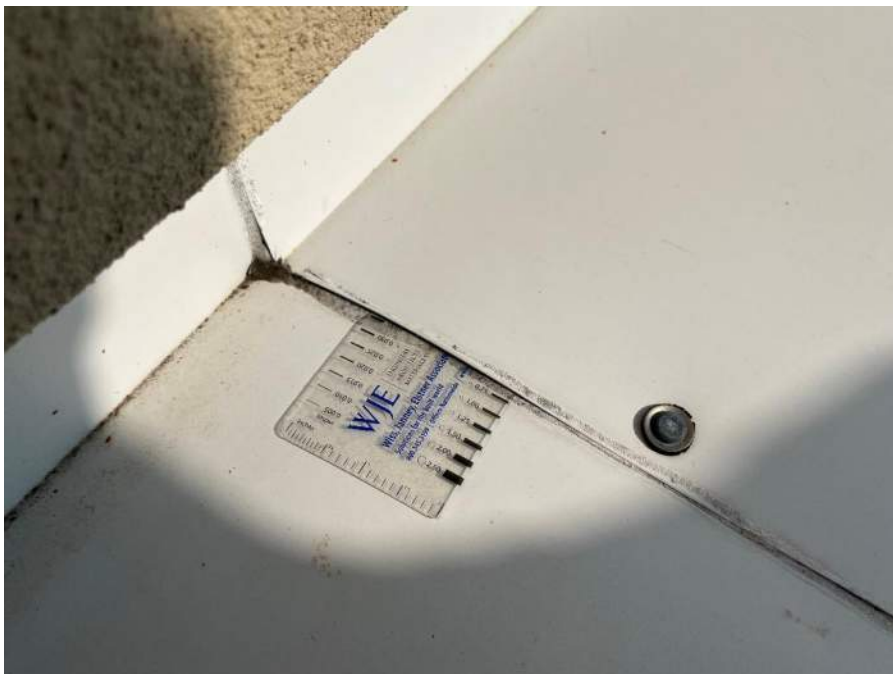
Figure 72. Open gap at the flashing joint.

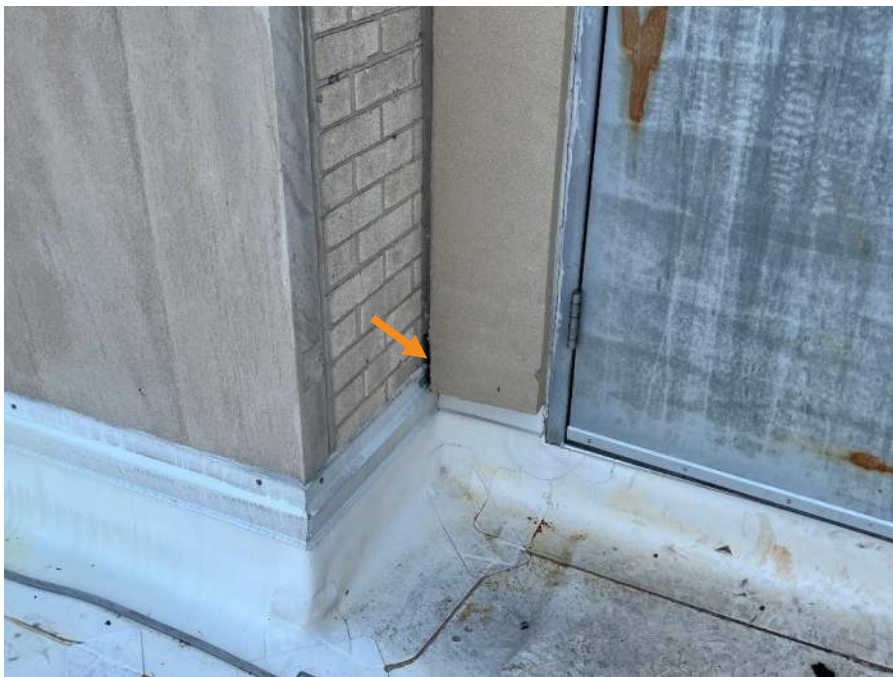
Figure 76. Missing sealant at the joint between the EIFS and adjacent brick return at the west facade.

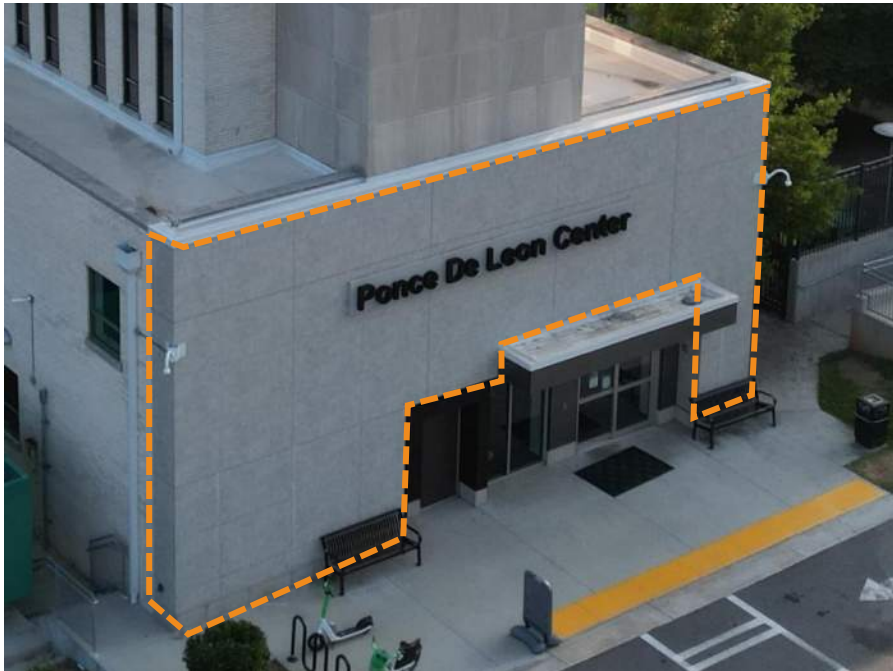
- The majority of the main entrance cladding appears to be adhered porcelain tiles. No delaminations or displacement of the main entrance porcelain tiles were observed (Figure 77).
- Cracked mortar was identified at isolated tile joints (Figure 78).
- White staining, consistent with efflorescence, was emanating from the sealant joints (Figure 79 and Figure 80).
- Metal flashing daylighted at the bottom of the porcelain tile cladding, located one limestone panel course above grade (Figure 81).

Figure 77. Porcelain tiles installed at main building entrance

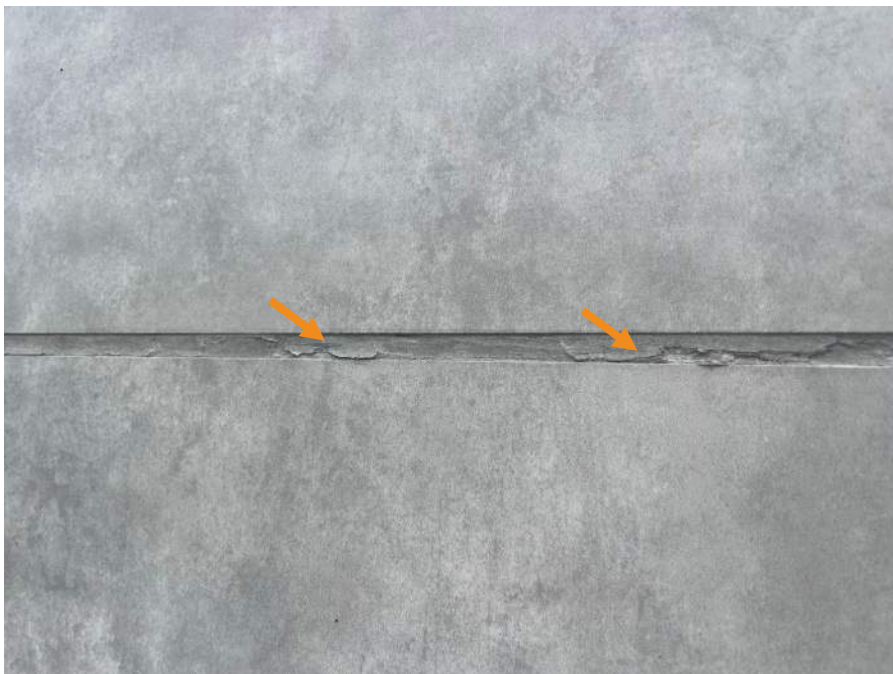
Figure 78. Cracked mortar joints at the main entrance tiles

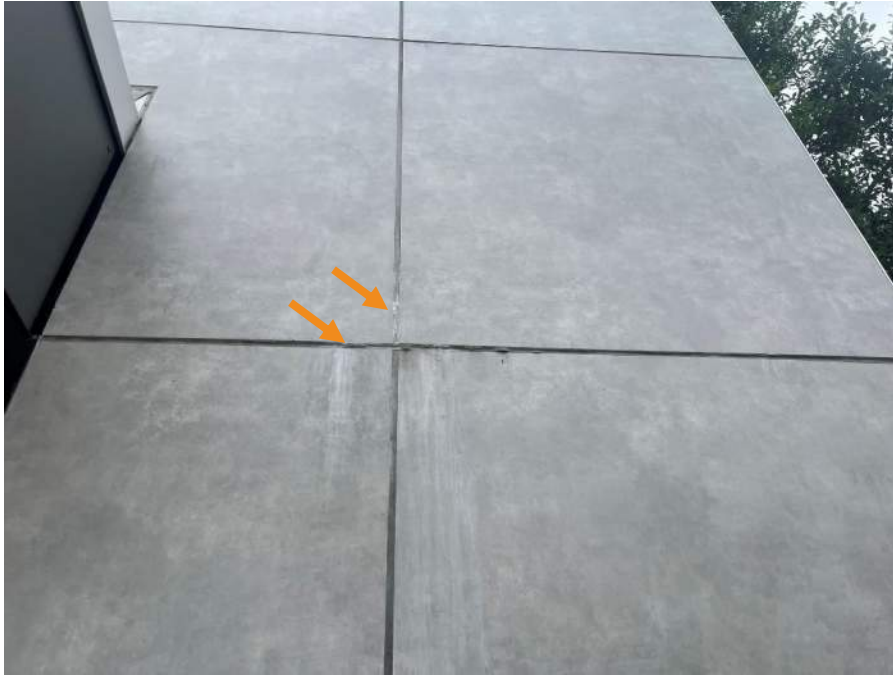
Figure 79. White staining emanating from the sealant bed joint on the east side of the main entrance.

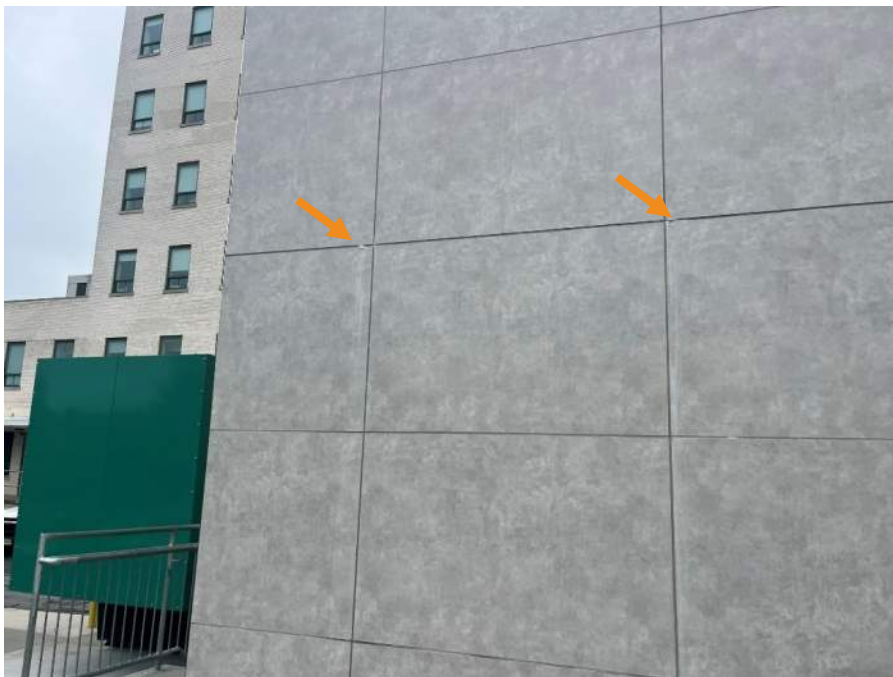
Figure 80. White staining emanating from the sealant bed joint on the west side of the main entrance.

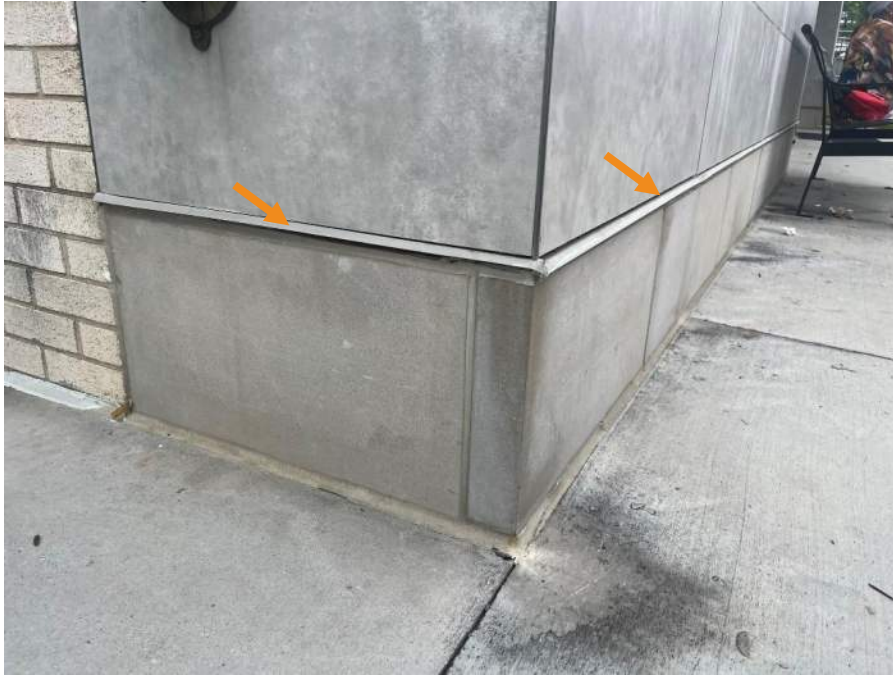
Figure 81. Flashing daylighted one course above grade.

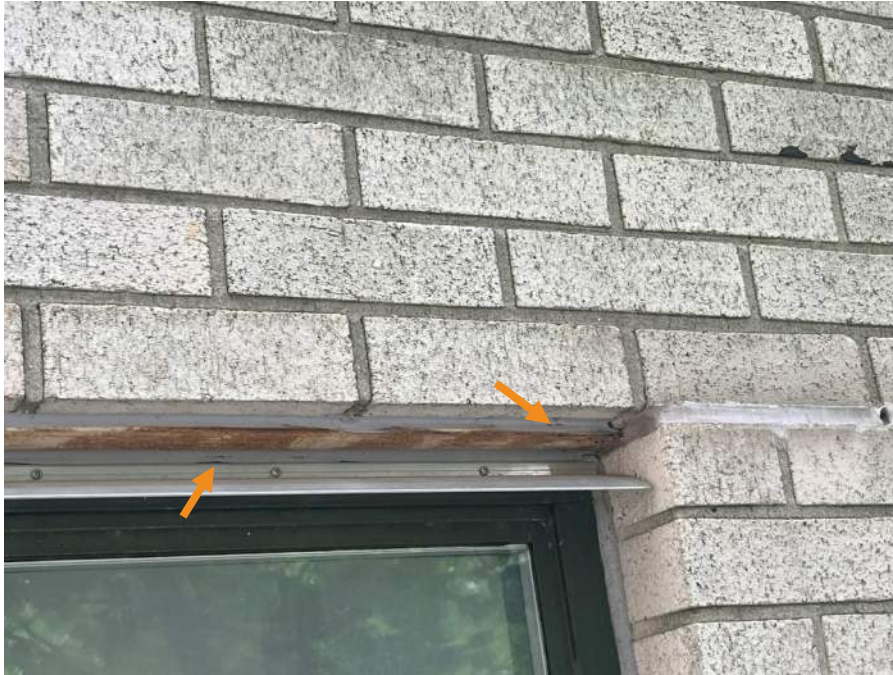
- At the courtyard west facade window units (four in total), sealant was also installed along the exposed lintel (Figure 86).
  - Adhesive and cohesive failures were identified at these sealant applications (Figure 87).

Figure 87. Adhesive and cohesive failures of sealant at a courtyard window.

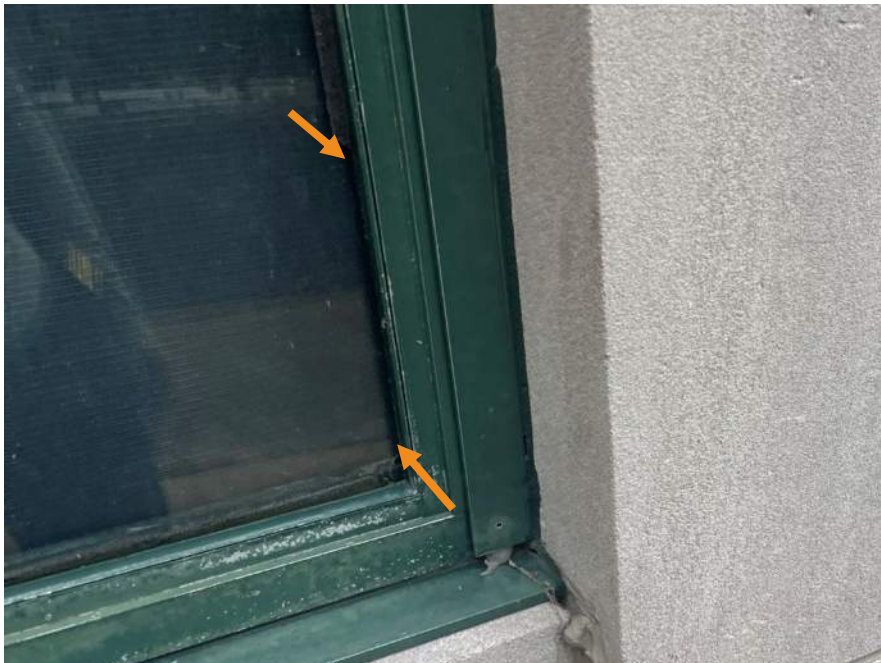
- The glazing gaskets were cracked, shrunk, and/or had portions missing at isolated ground floor units (Figure 88).
- Building personnel reported one window unit at the tower east facade was open; this window was not accessible, as the unit was currently concealed by interior wall finishes. From the exterior, the upper sash was down, and the interior wall framing/finishes were visible at the top of the opening (Figure 89).

Figure 88. Missing portion of glazing gasket at north facade ground floor unit

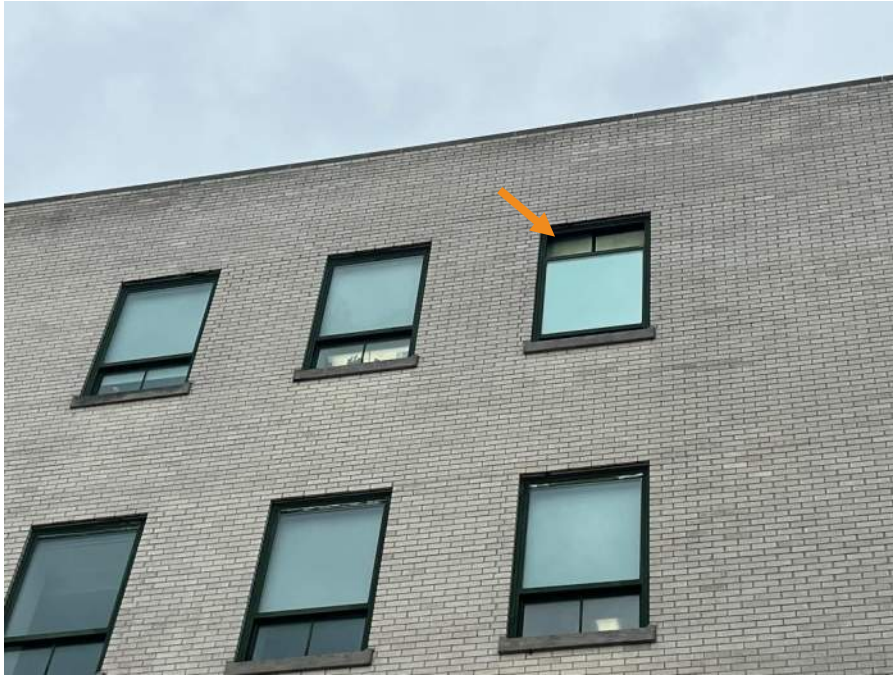
Figure 89. Open window at the east facade.

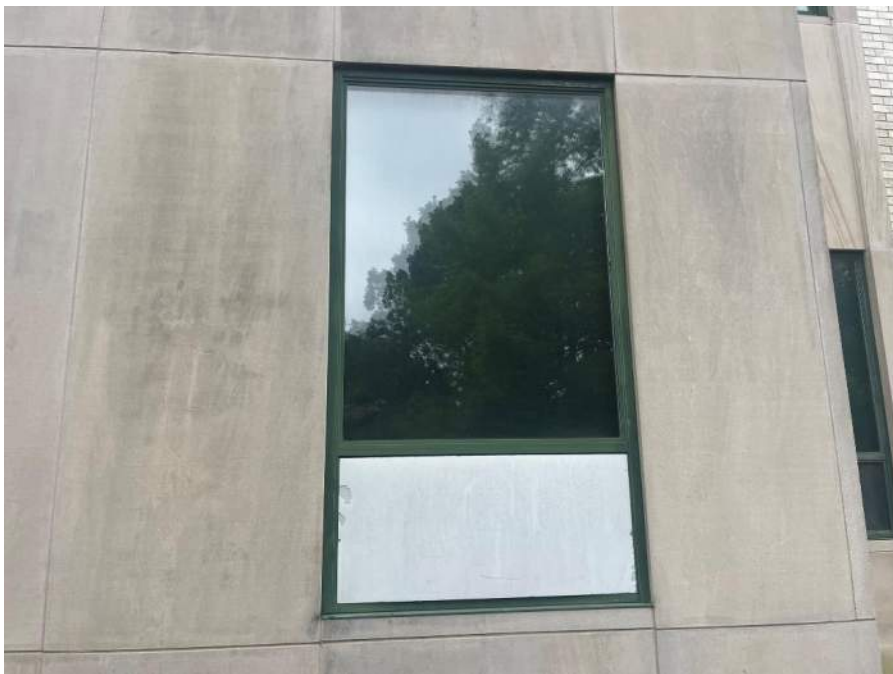
- At the north facade of the east wing, one broken lite was covered with a foam panel (Figure 90 and Figure 91).
- Sealant was applied to the glazing to metal joints at three ground floor window units at the north facade (Figure 92).

Figure 90. A foam panel covered a broken lite on the north side of the east wing

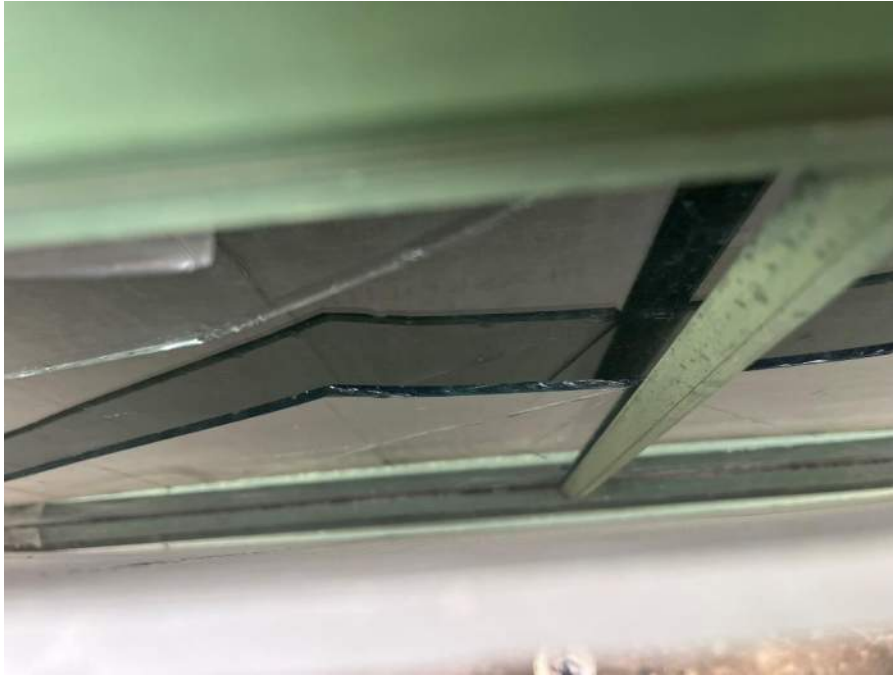
Figure 91. Broken lite on the north side of the east wing.

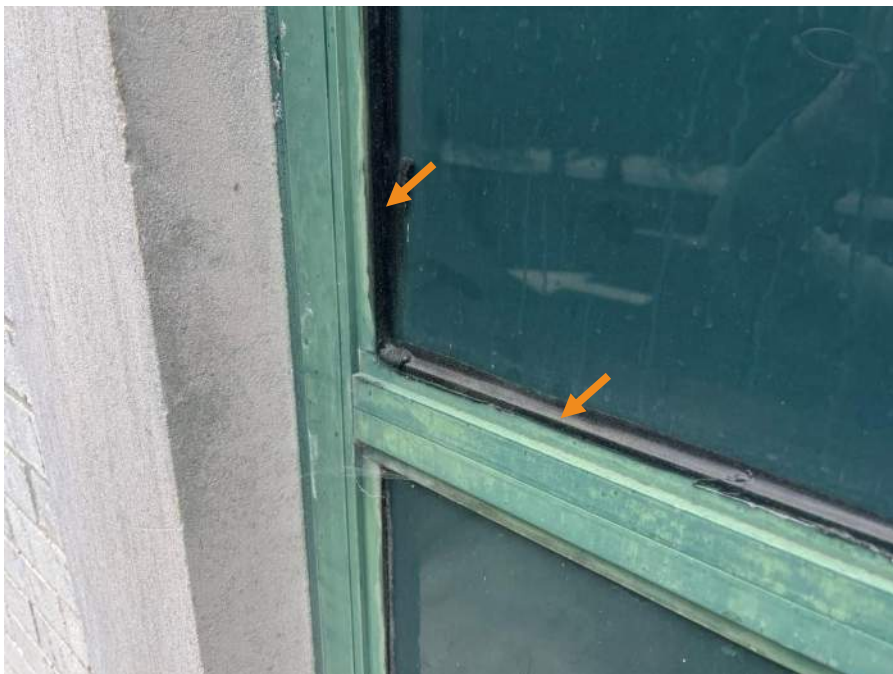
Figure 92. Sealant installed at glazing-to-metal transitions at north facade window

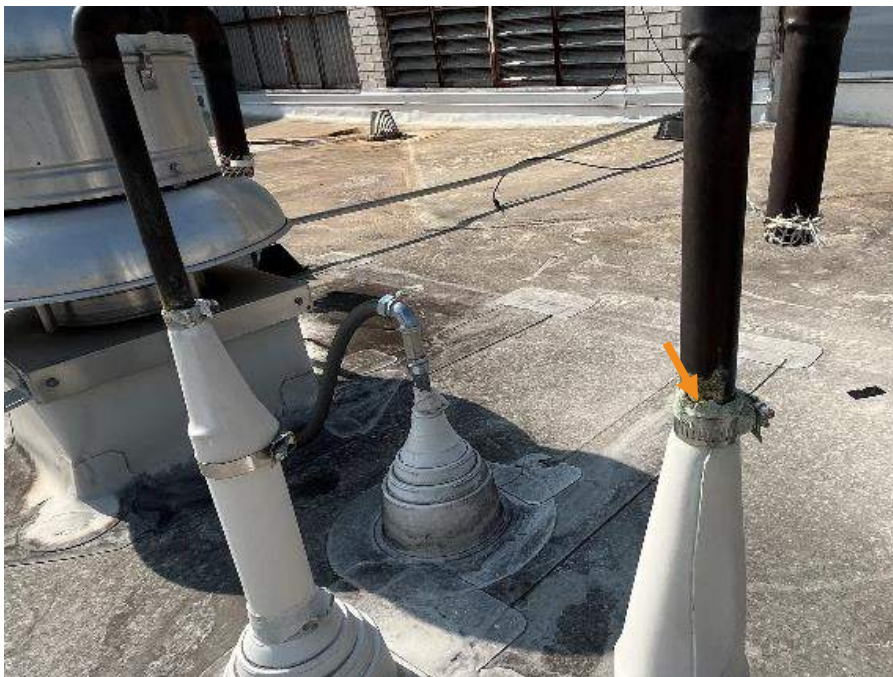
- The TPO roofing membrane was terminated at the interior face of the parapet. The roof counterflashing was sealed to the face of the brick masonry parapet wall (Figure 104). At most locations where the termination was one course or more below the coping stone, the interior brick face was coated (Figure 105). Roof termination flashings at rooftop mechanical units, curbs, and/or pipe penetrations were generally sealed; isolated adhesive sealant failures were noted at these locations (Figure 106).

Figure 106. Sealant adhesively failed at copper pipes

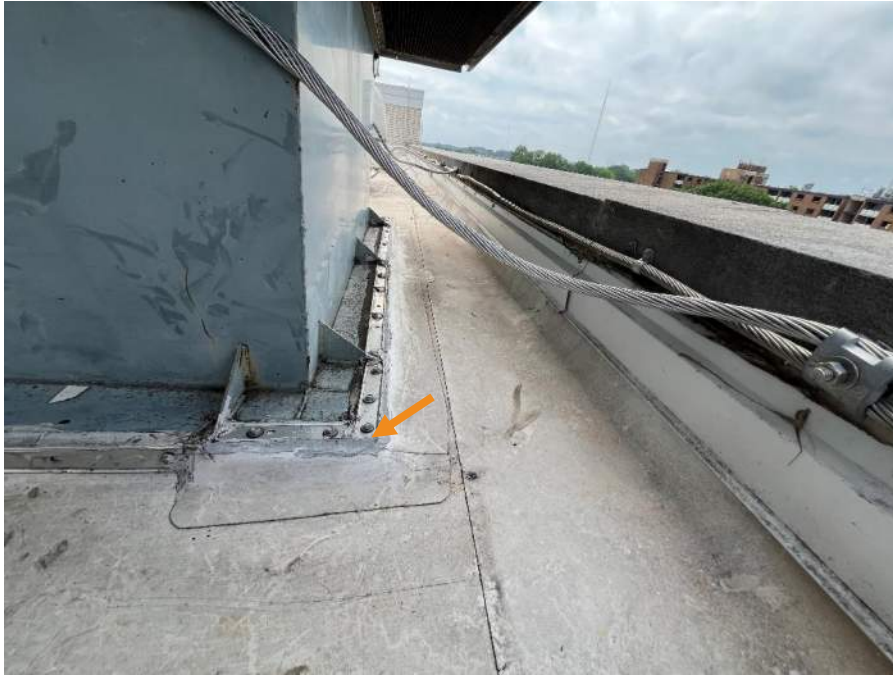
- At the mechanical penthouse roof, the curb height varied from approximately 4 inches to flush with the roof surface (Figure 107).
- At the east wing low roof area, directly above the identified stained ceiling tiles at the Infusion Hallway, the TPO membrane was terminated onto a rooftop mechanical system (Figure 108 and Figure 109).

Figure 107. Low curb height on mechanical penthouse roof

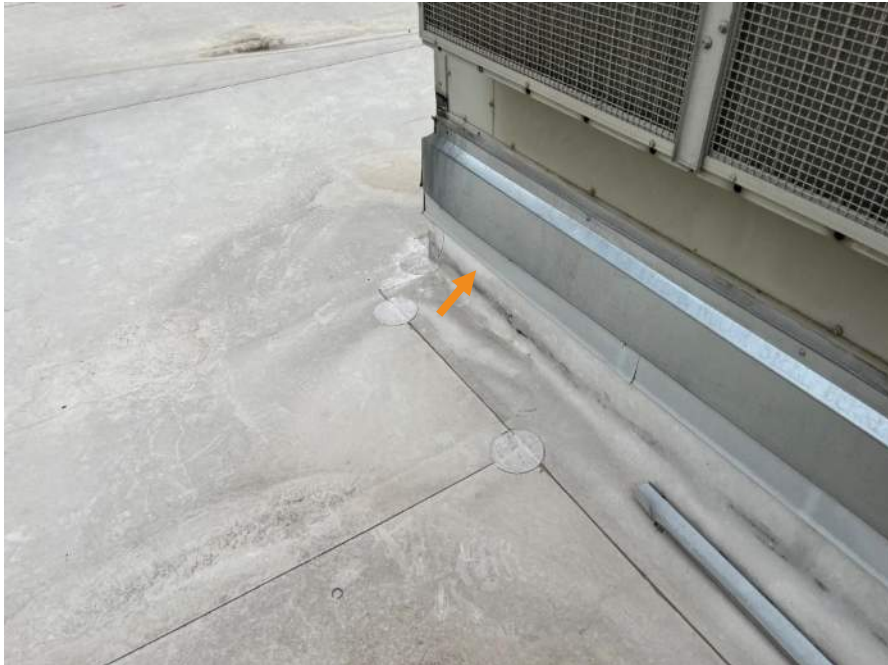
Figure 109. TPO membrane terminated onto mechanical system curb
