## Ponce De Leon Center

### Visual Condition Assessment

341 Ponce De Leon Avenue NE  
Atlanta, Georgia

July 28, 2025  
WJE No. 2025.1974

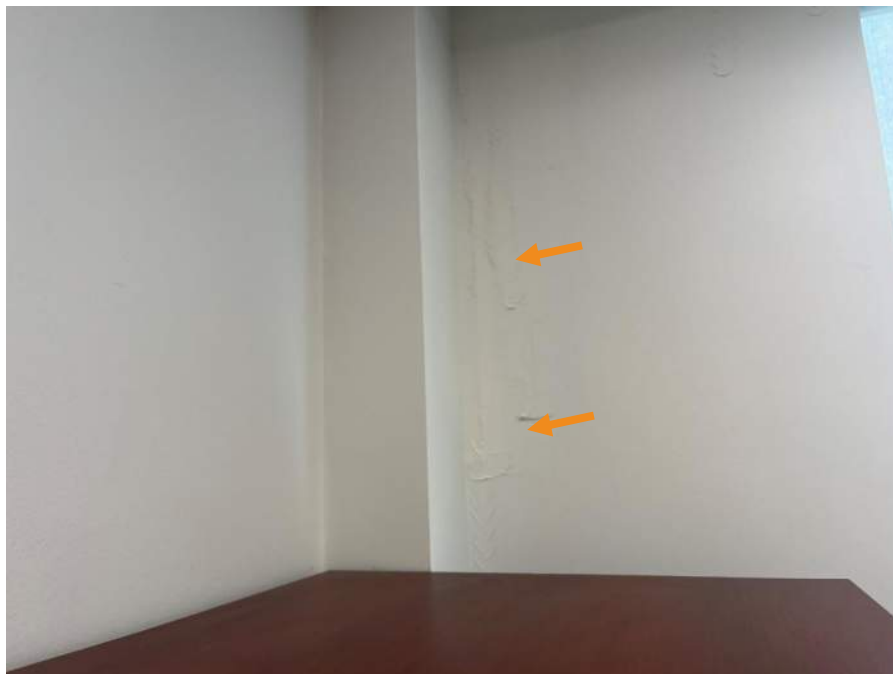
- The interior finish was peeling at the northwest corner of Office 6022 (Figure 7 through Figure 9), adjacent to a window and immediately below the northwest corner of the main roof.

Figure 8. Close-up view of peeling interior finished in Office 6022

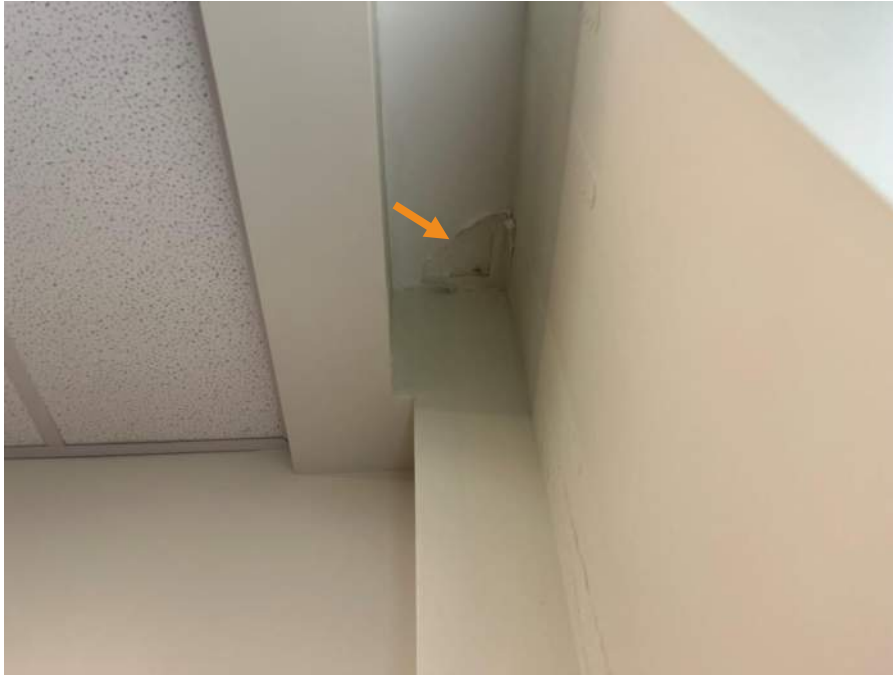
Figure 9. Interior finish coating peeling at northwest corner of Office 6022.

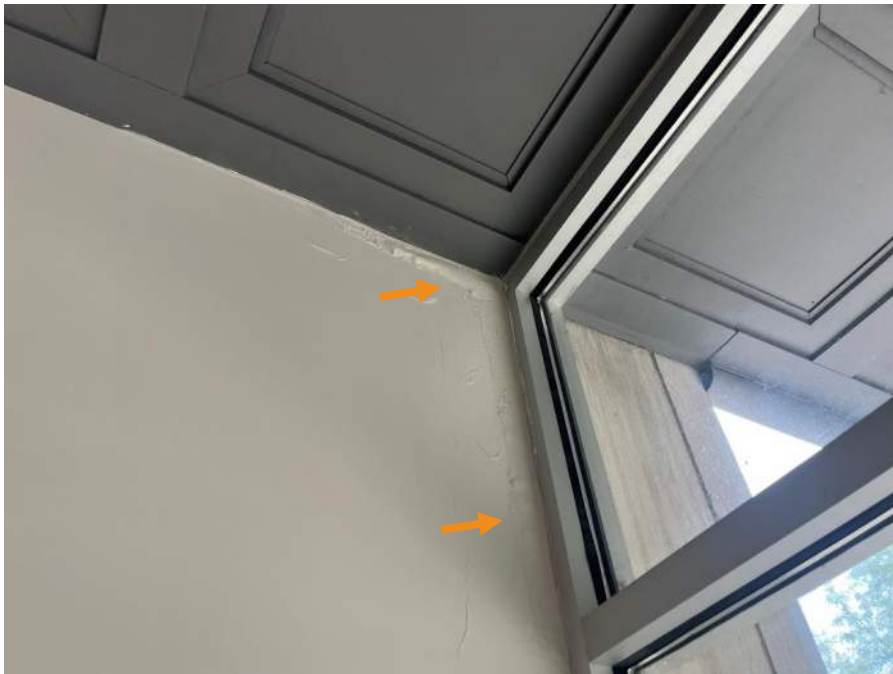
- Interior finishes were bubbled and peeling adjacent to the storefront assembly at the north building entrance (Figure 10), immediately below the low roof to building wall transition termination.

Figure 10. Bubbled and peeling interior finishes adjacent to storefront assembly at north building entrance.

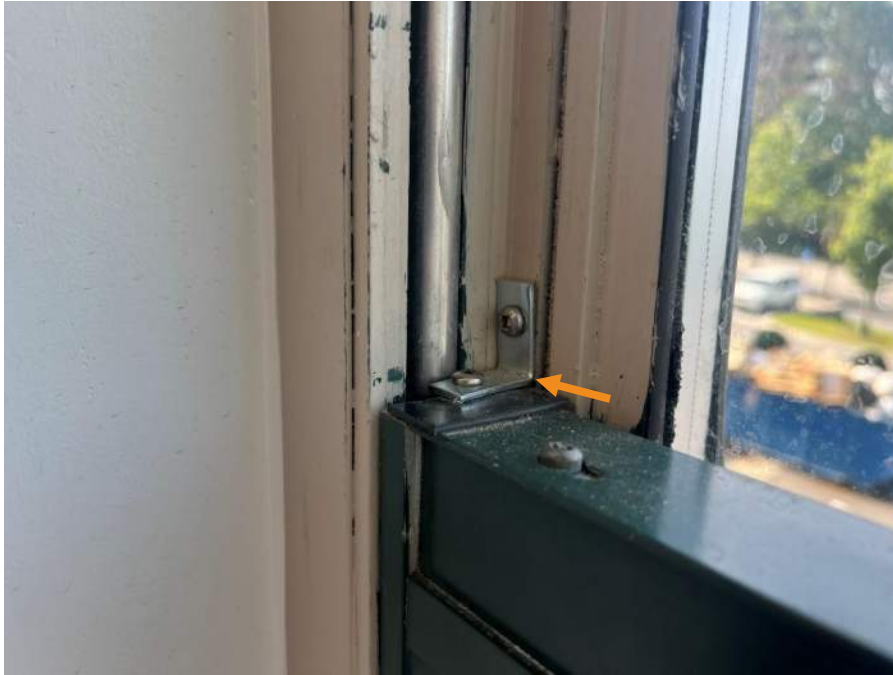
- At two east stairwell windows, daylight was visible between the window head-jamb corner and the interior finishes (Figure 14).
- Most window units were fastened closed (Figure 15); building staff reported all windows on the second floor and above were fastened closed for safety purposes. However, the operable top sashes

Figure 15. Window unit fastened shut.

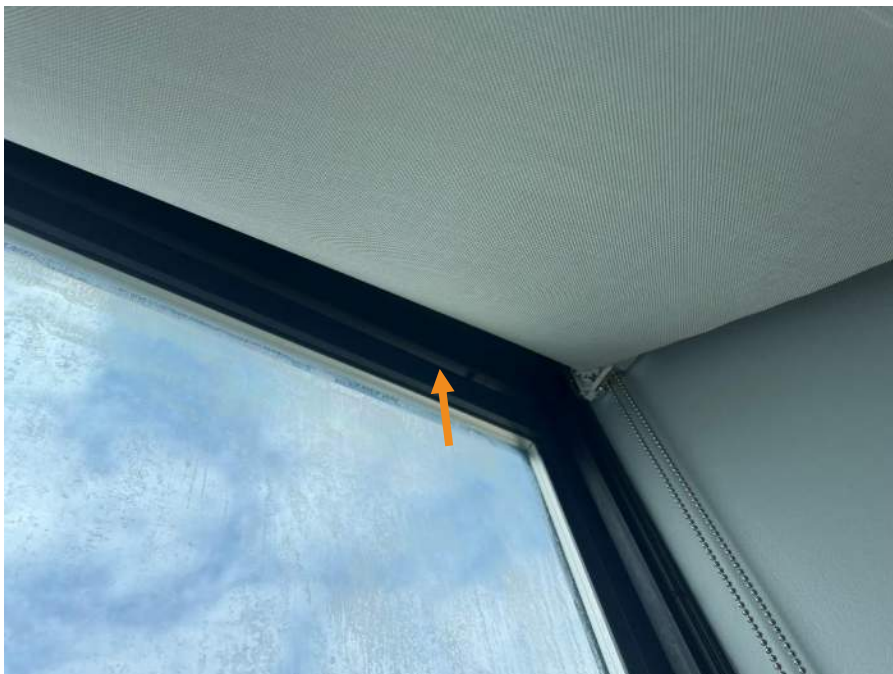
were reportedly unable to be fully closed at two locations: Office 1033 and Group Room 6041 (Figure 16).

Figure 16. Visible daylight at window upper sash in Group Room 6041

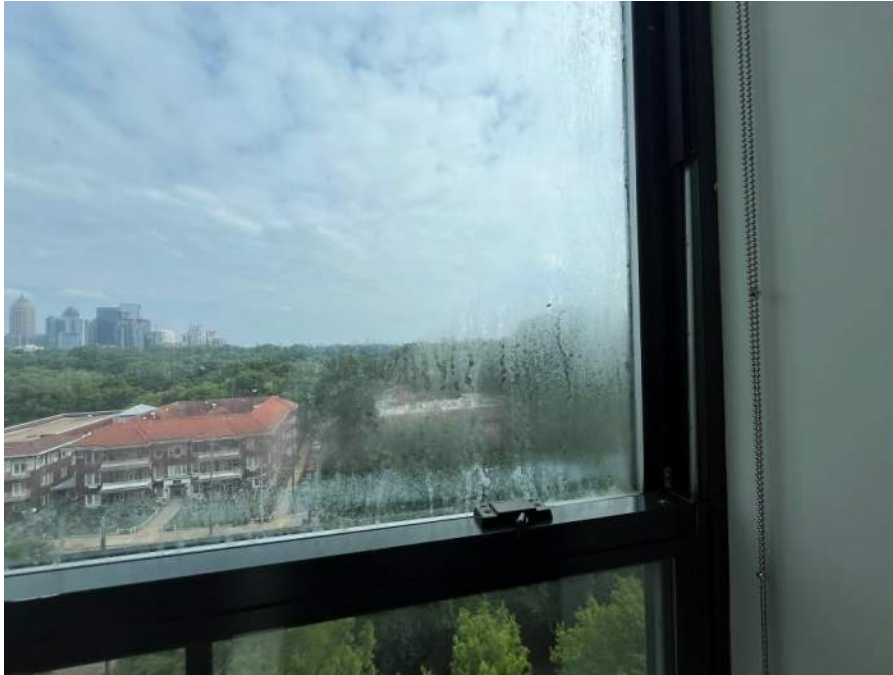
- Several fogged insulated glass units (IGUs) were observed throughout the visual survey (Figure 17). A 1993 date stamp was noted on the aluminum spacer within the IGUs throughout the building.

Figure 17. Fogged IGU at window assembly.

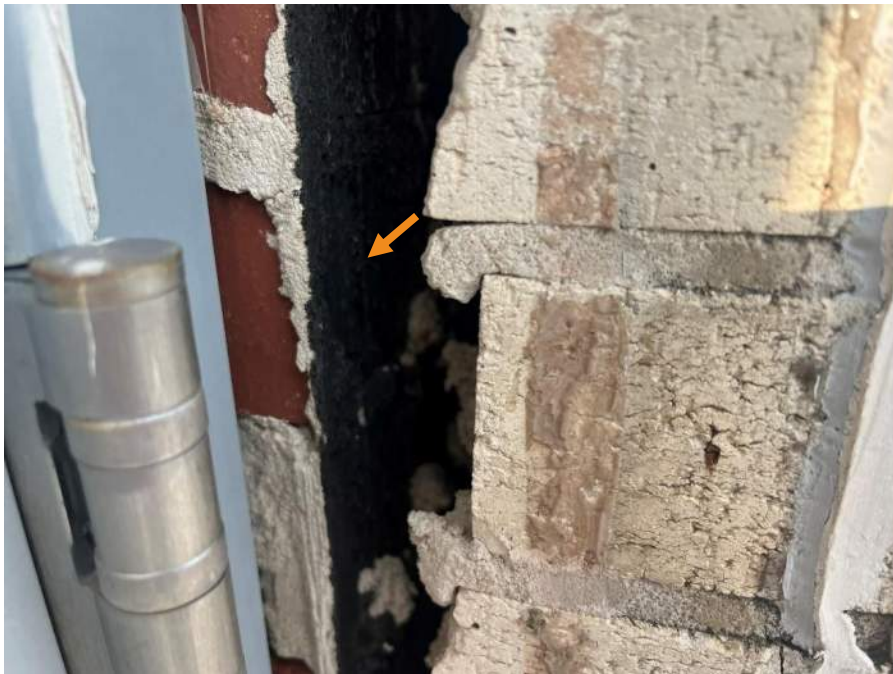
- The masonry wall assembly consists of brick veneer, a two-inch wide drainage cavity, and dampproofing applied to a brick masonry backup wall (Figure 21 and Figure 22).

Figure 22. Exposed two-inch drainage cavity and dampproofing (orange arrow) applied to brick masonry backup wall.

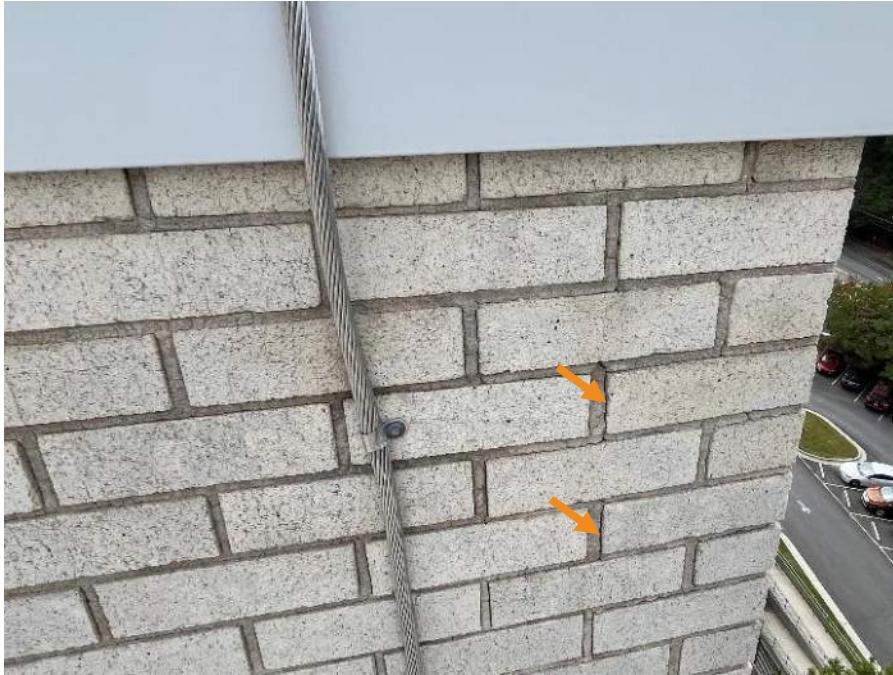
- Numerous colors, textures, and finishes, consistent with previous repointing efforts (Figure 26) were noted in the mortar joints throughout the building. Bond separations (Figure 27), transverse cracks through the mortar (Figure 28) and areas of missing mortar were observed at many of these locations (Figure 29).

Figure 27. Area of mortar joint bond separation.

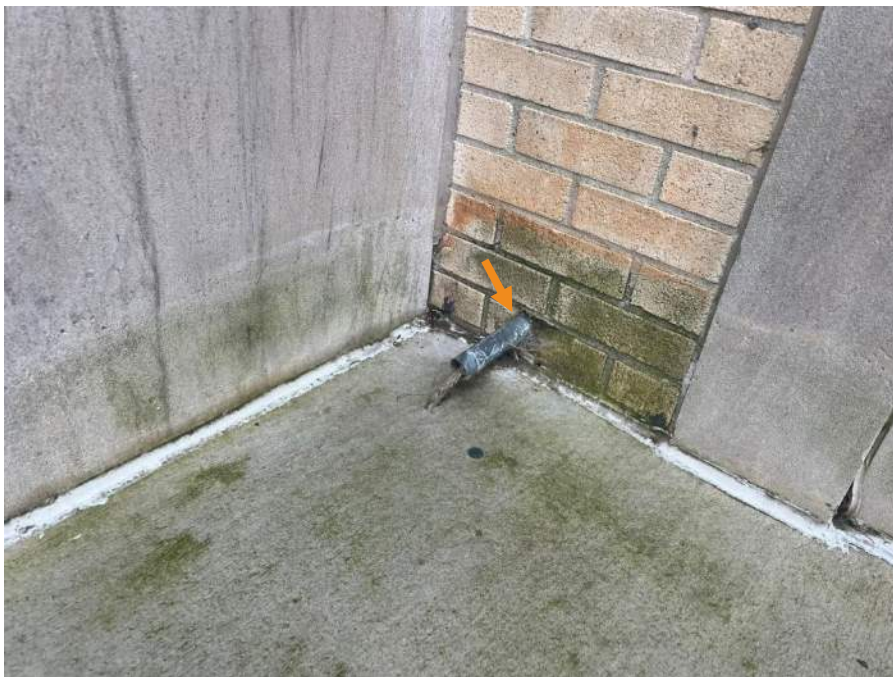
- Light surface corrosion was identified on the underside of the steel angles spanning over window heads (Figure 36).
- Isolated missing or damaged brick units, abandoned penetrations through brick, and abandoned fasteners were observed throughout the property (Figure 37 through Figure 40).

Figure 40. Mechanical penetration on the north facade at grade.

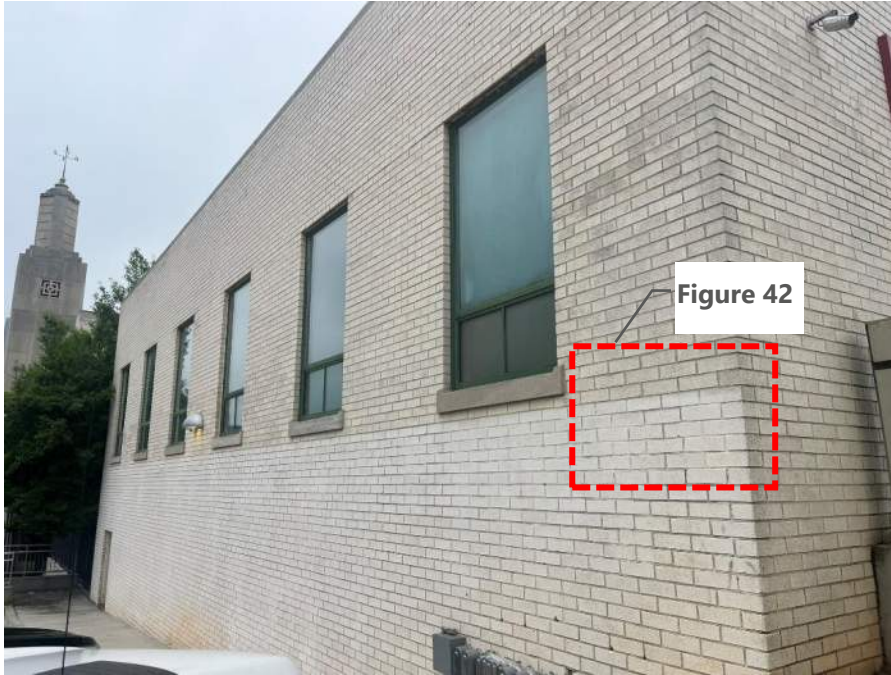
- At the south facade of the east wing, a coating had been applied to the brick face below the Level 2 floor line (Figure 41 and Figure 42).

Figure 41. Coating applied to brick face from Level 2 floor line and below.

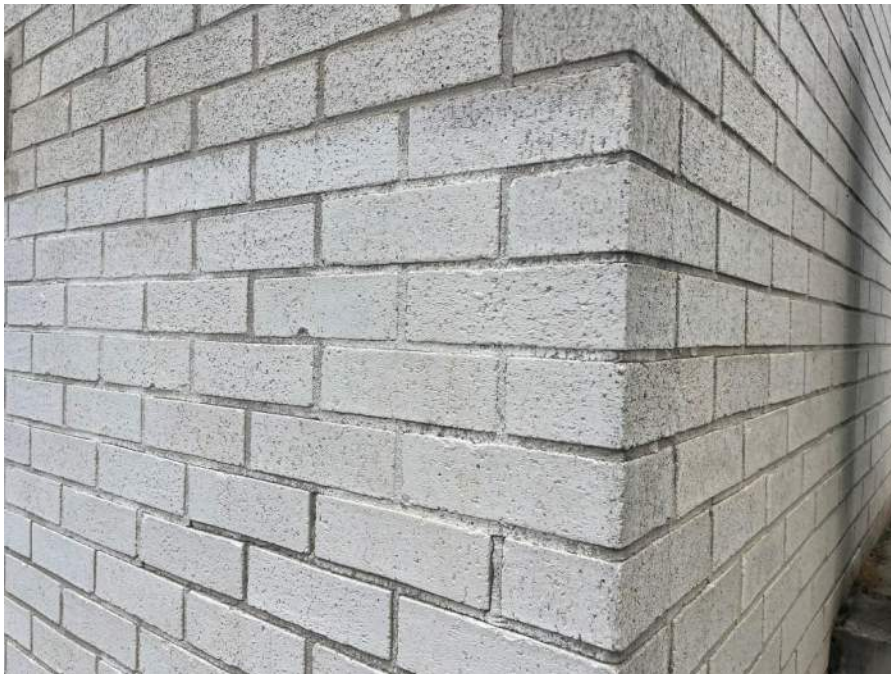
Figure 42. Close-up view of white coating applied to east wing south facade

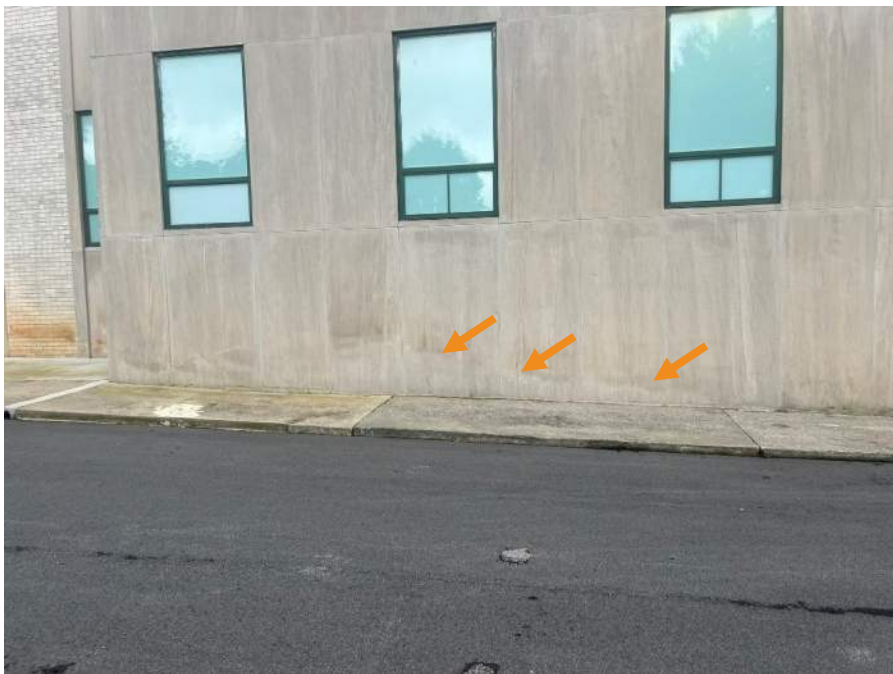
- At the west end of the north facade, the lower 12 to 36 inches of panels in contact with or extending below the concrete sidewalk were discolored (Figure 56).

Figure 56. Panels discolored along base of facade at panels extending below grade level.

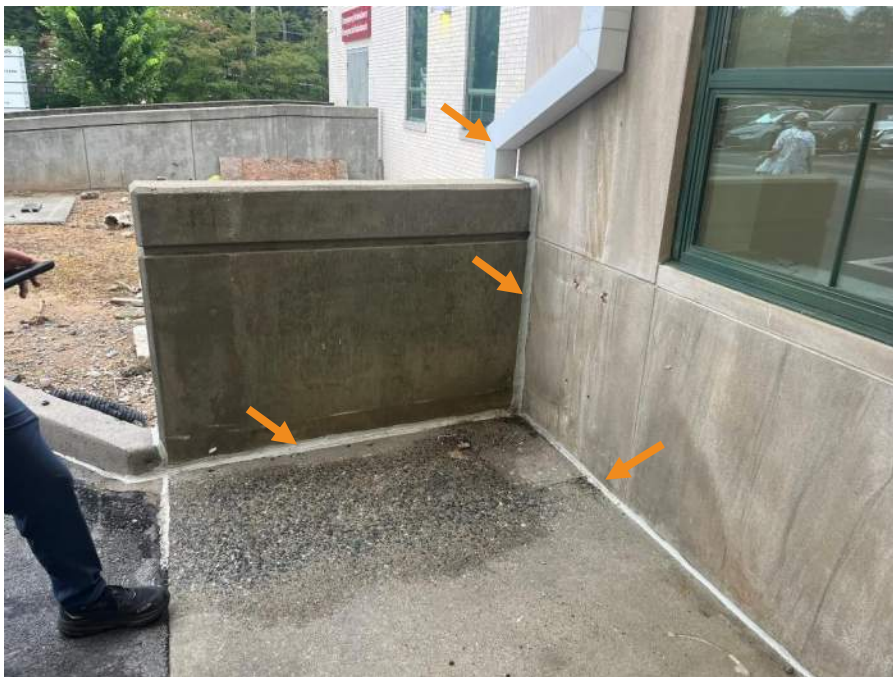
- Sealant installed between the concrete knee wall and limestone panels adjacent to the east employee entrance, at the location reportedly installed to address water leakage into Office P108, was adhesively failed (Figure 62 and Figure 63).

Figure 62. Downspout and sealant installation adjacent to the east facade employee entrance.

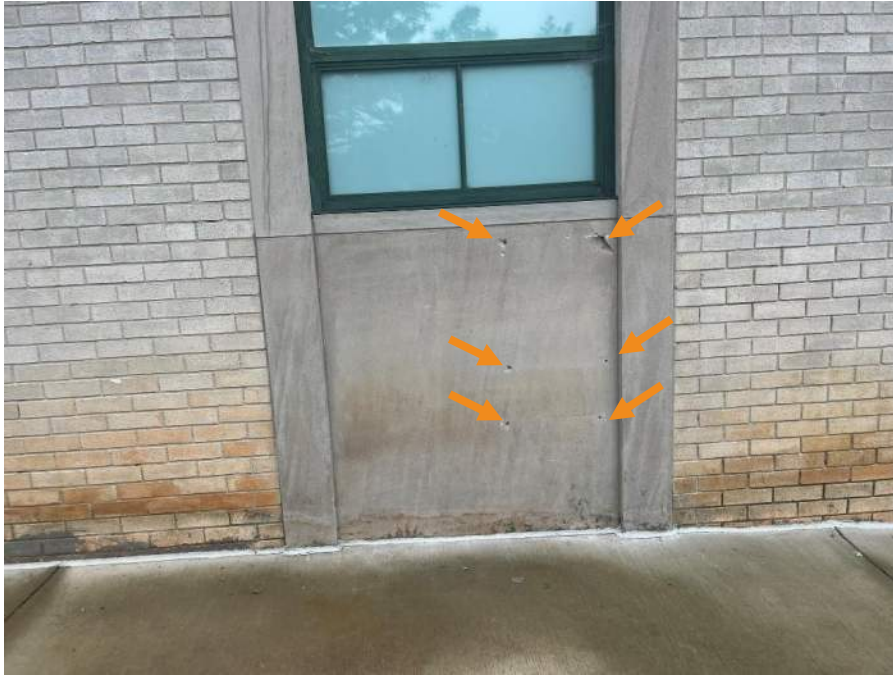
- Similar to the brick masonry, abandoned penetrations through the limestone and abandoned fasteners were observed at numerous wall panels and coping units throughout the building (Figure 64 through Figure 66).

Figure 65. Six abandoned anchors at one wall panel at grade on the north facade.

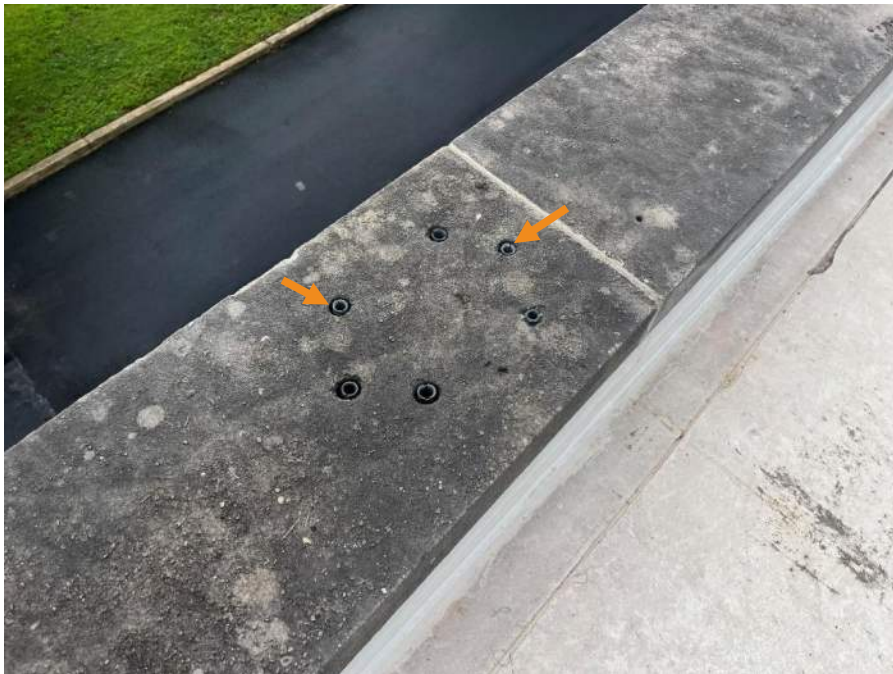
Figure 66. Abandoned anchors in the coping.

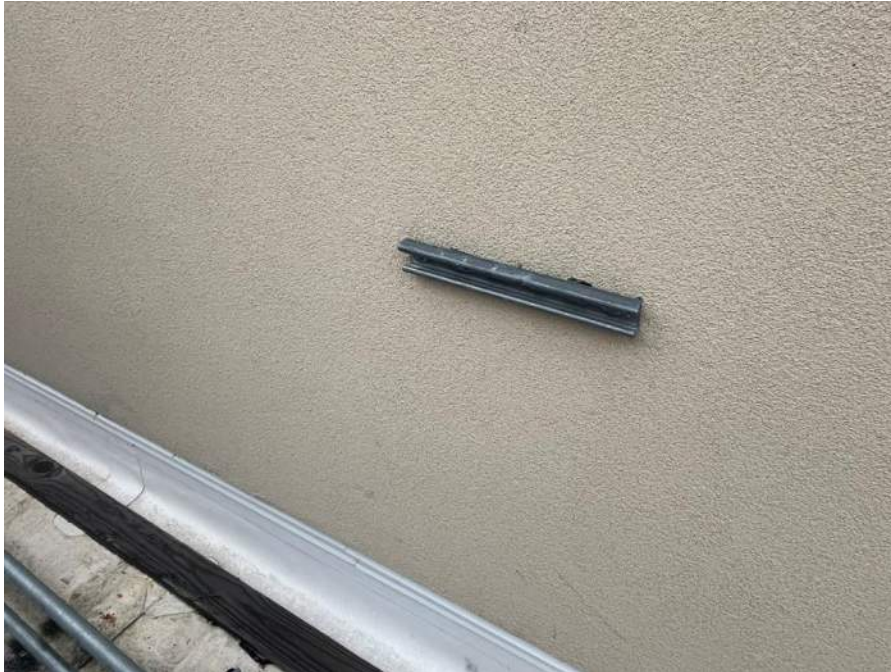
Figure 73. Abandoned Unistrut channel at the west wing low roof.

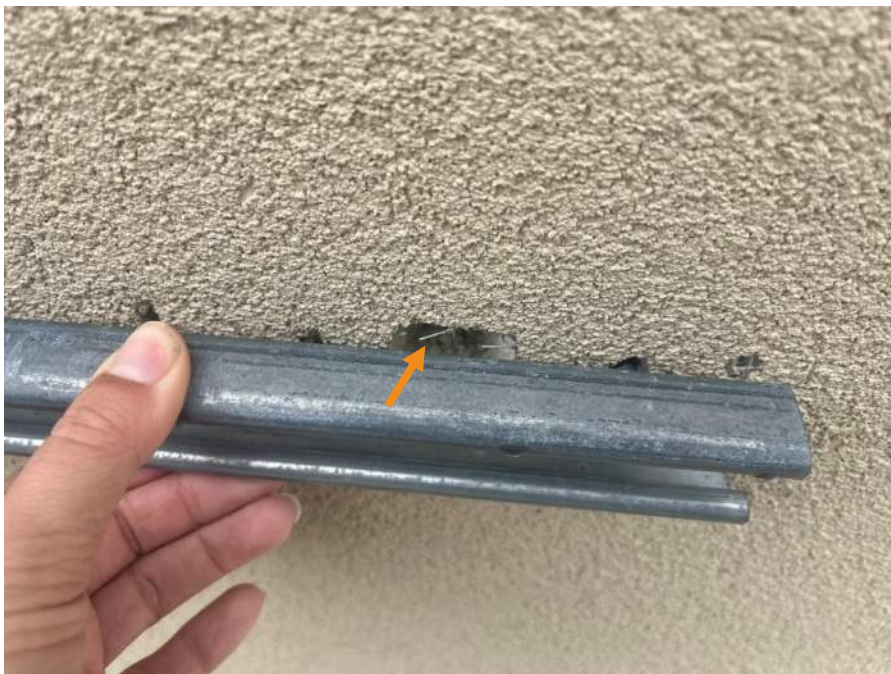
Figure 74. Abandoned Unistrut channel concealing exposed EIFS mesh and insulation.

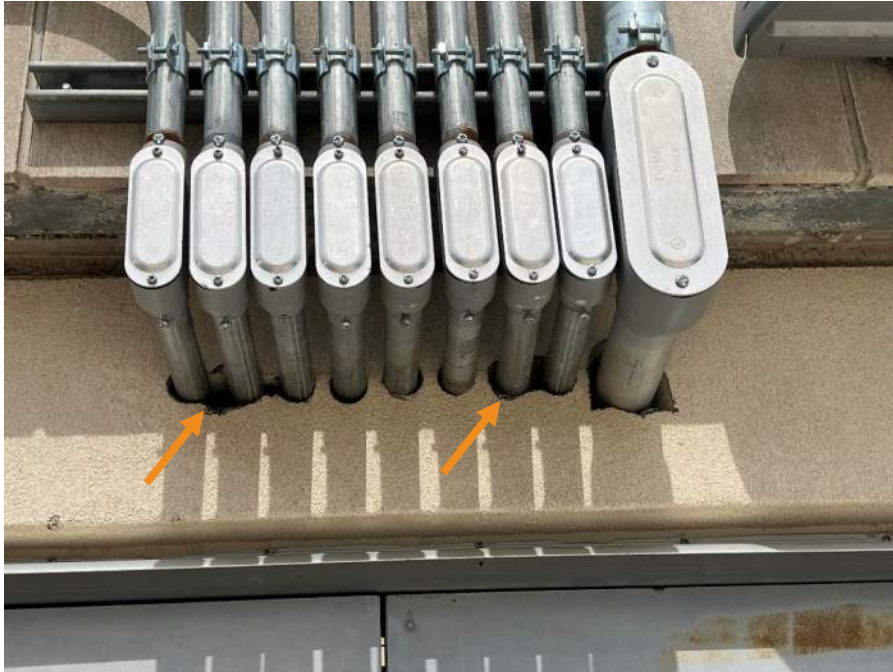
Figure 75. Open and unsealed electrical conduit penetrations through EIFS at the east facade.

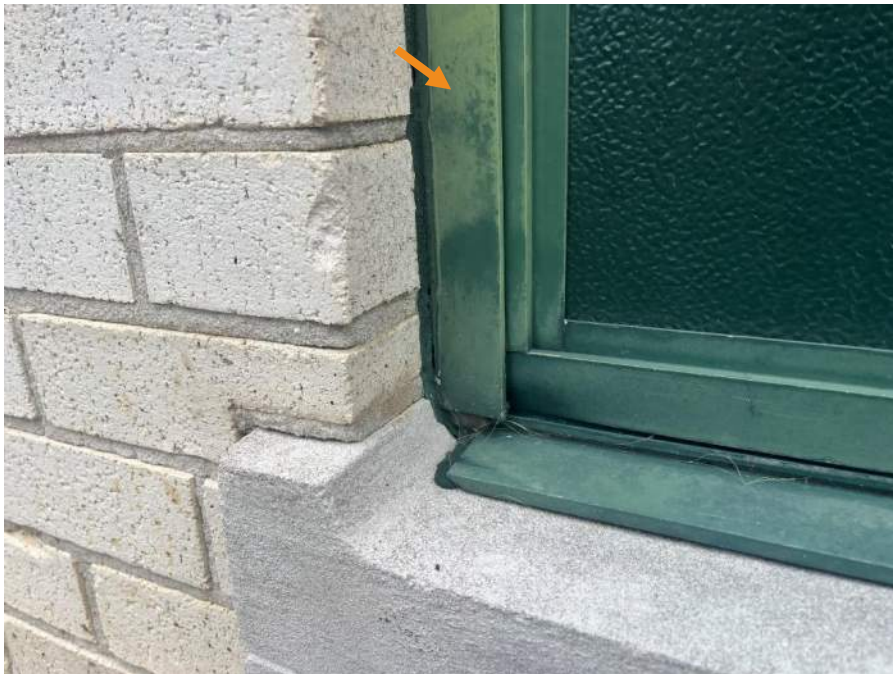
Figure 82. Weathered window frame coating.

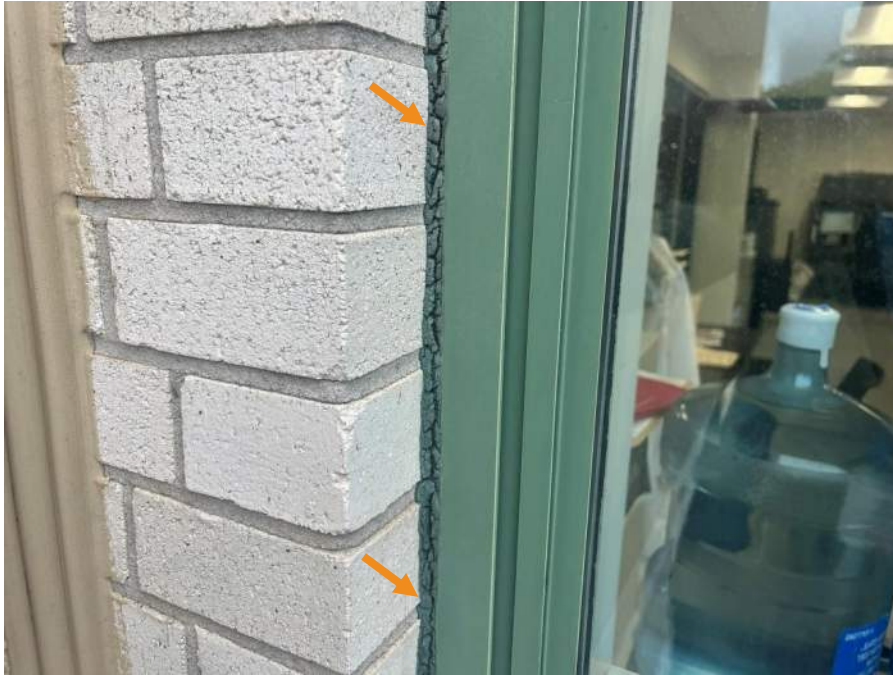
Figure 83. Crazed window perimeter sealant.

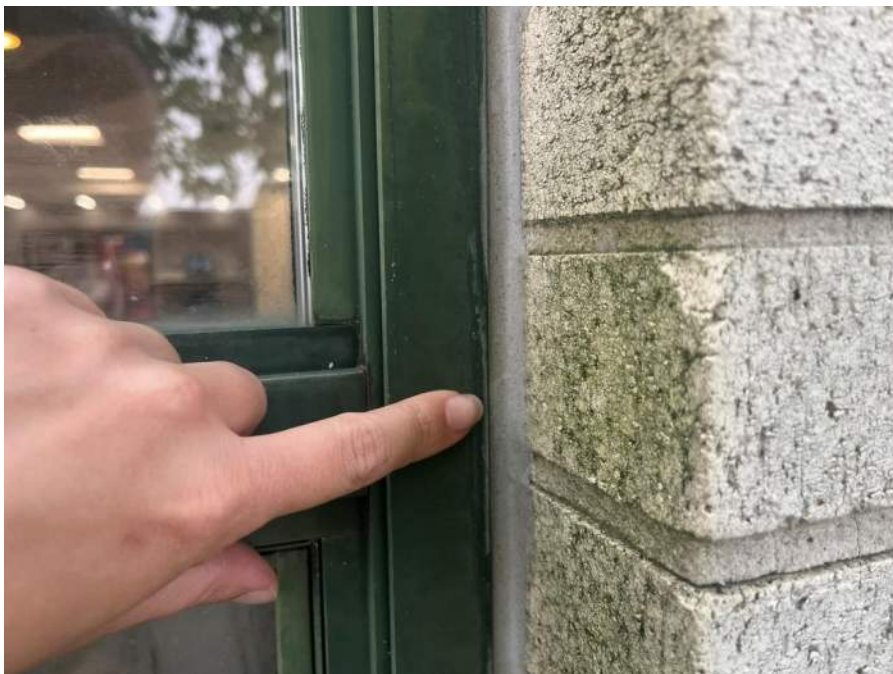
- At the courtyard, the window perimeter sealants were gray-colored sealant; no significant weathering or sealant failures were observed at the gray-colored sealants (Figure 84).

Figure 84. Gray-colored window perimeter sealant in the courtyard.

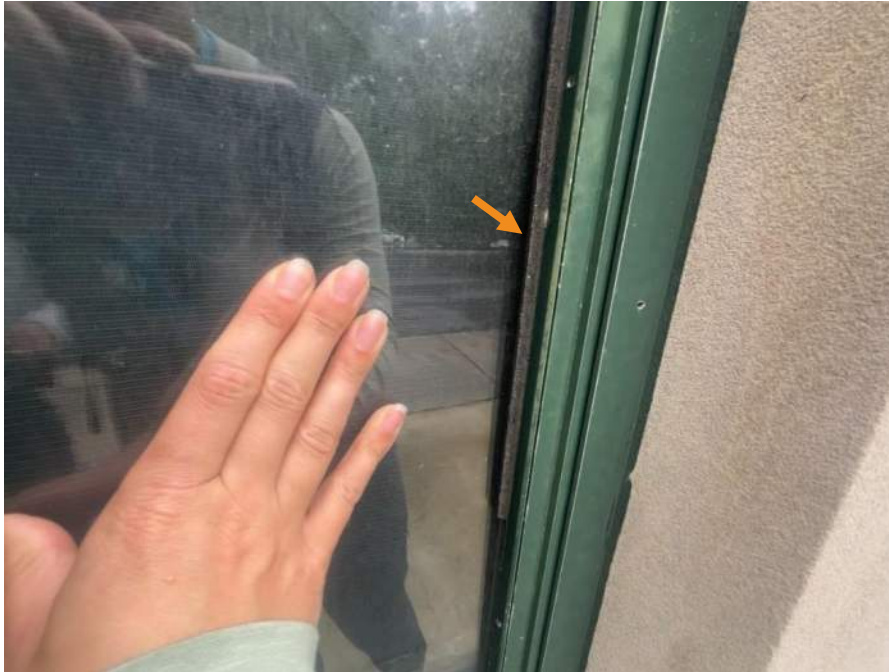
Figure 93. Acrylic panel at north facade ground floor window unit able to be displaced inward

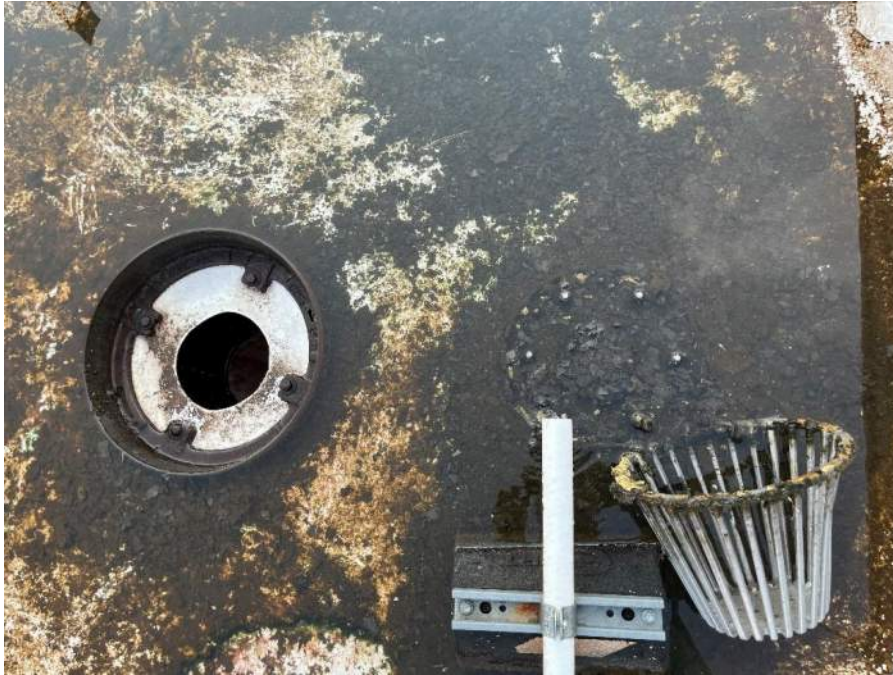
Figure 95. Ponding water at the western half of the main roof and east low roof was concentrated around obstructed roof drains

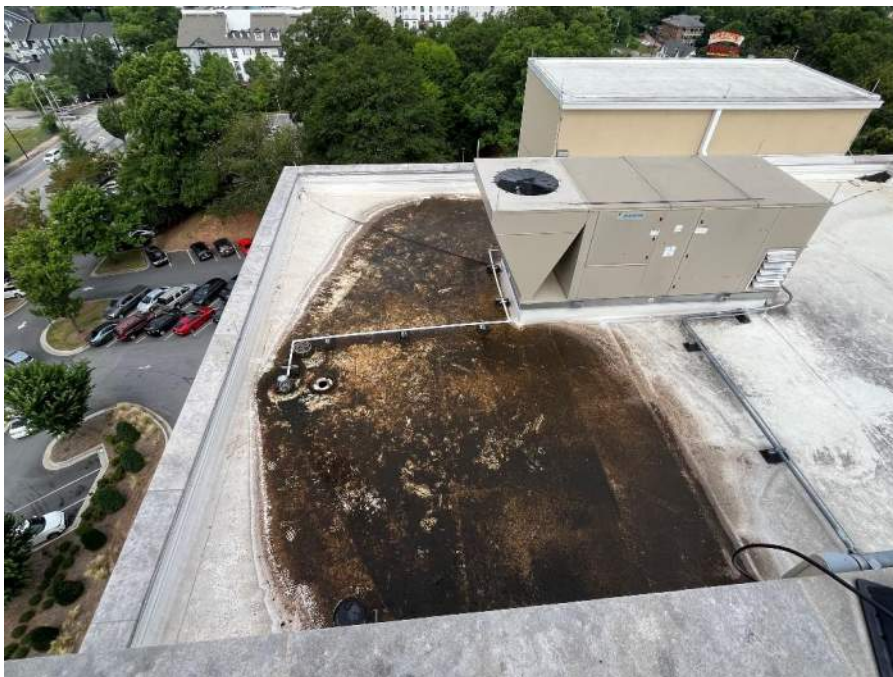
Figure 96. Ponding water at the western half of the main roof and east low roof was concentrated around obstructed roof drains

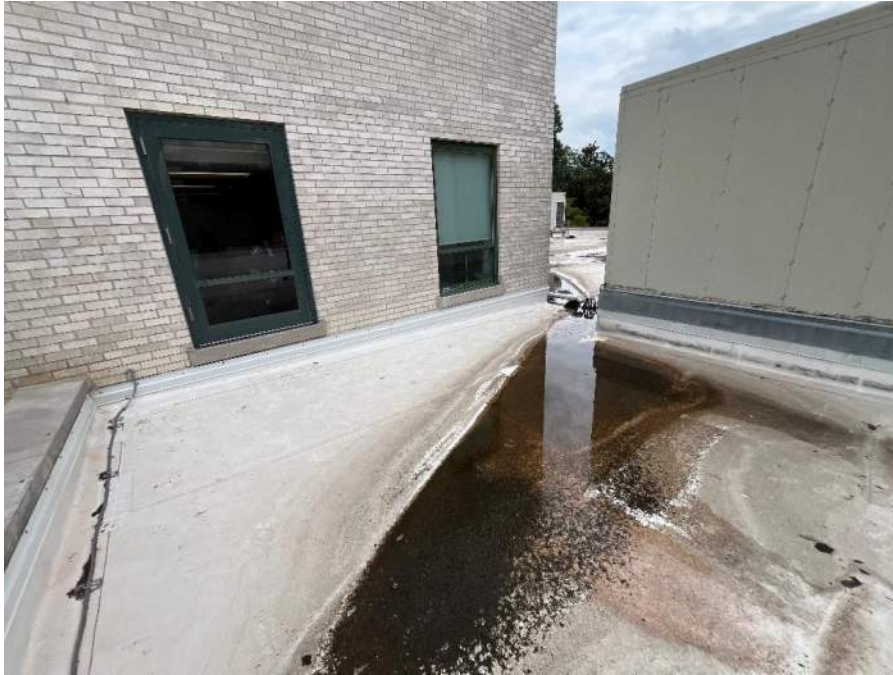
Figure 97. Ponding water at the western half of the main roof and east low roof was concentrated around obstructed roof drains

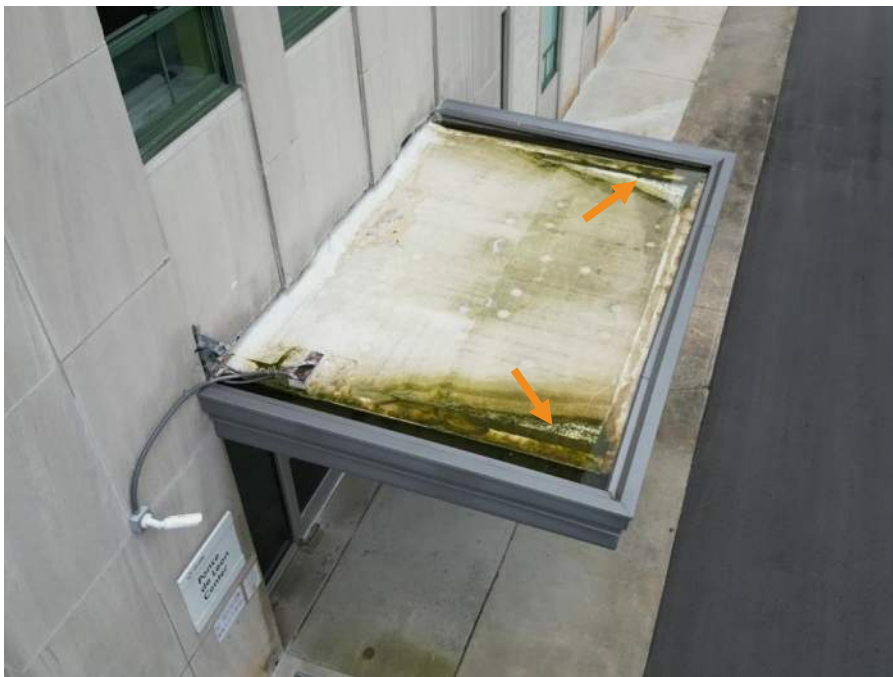
Figure 98. Ponding water on the north entrance canopy.

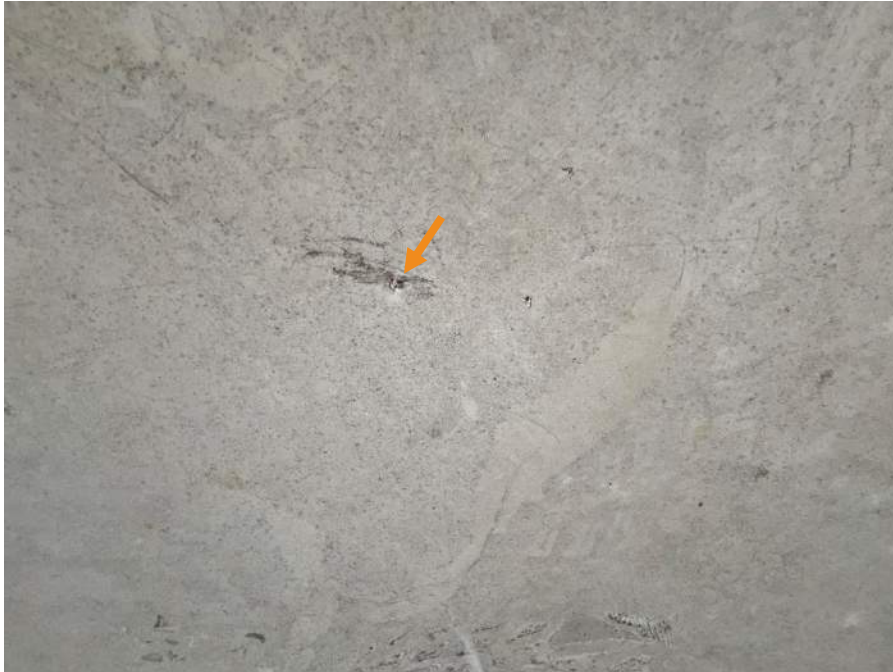
Figure 99. Punches and scratches on the roof membrane

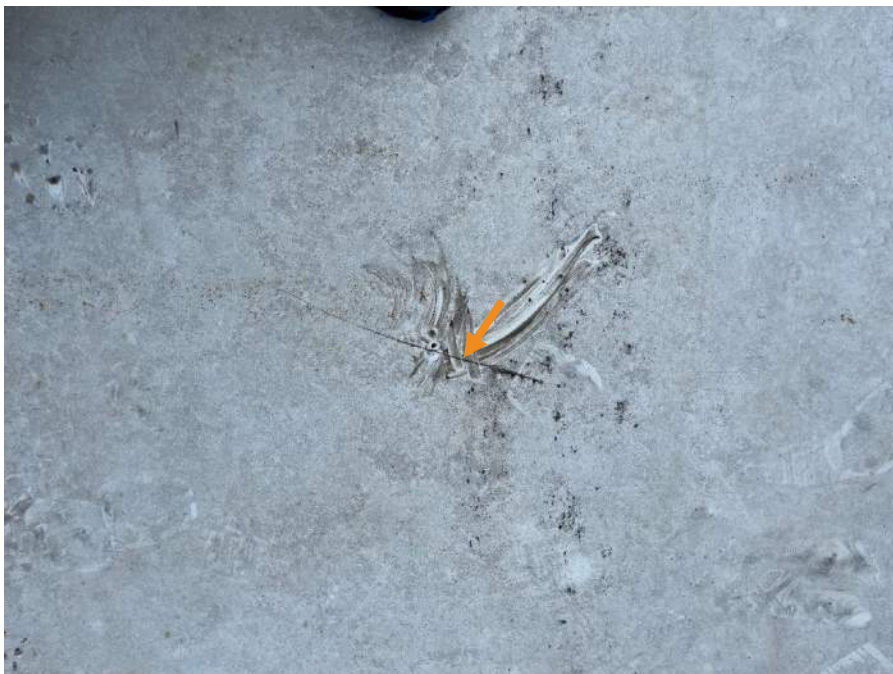
Figure 100. Punches and scratches on the roof membrane

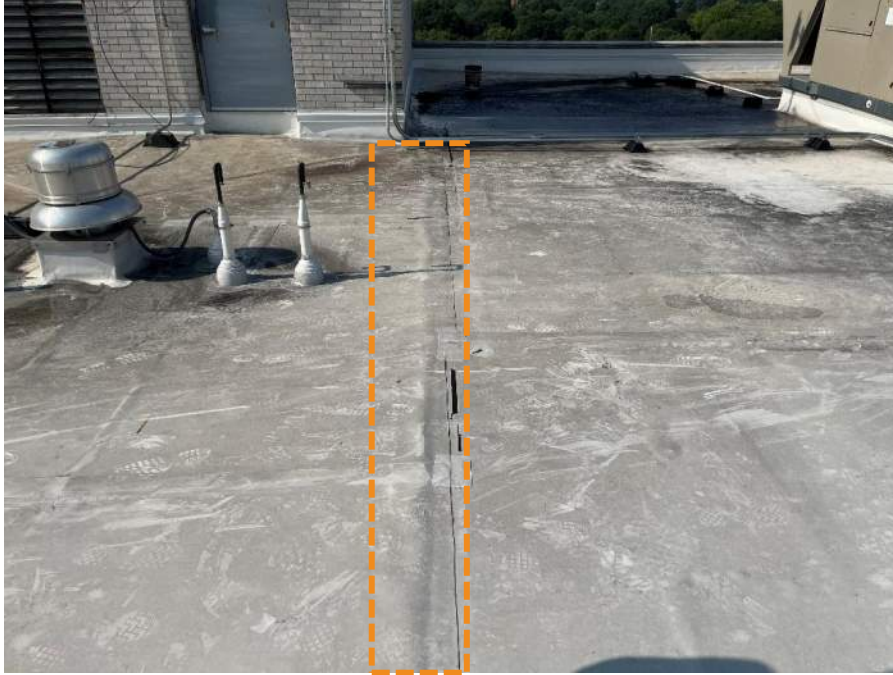
Figure 101. Isolated blisters at the membrane lap

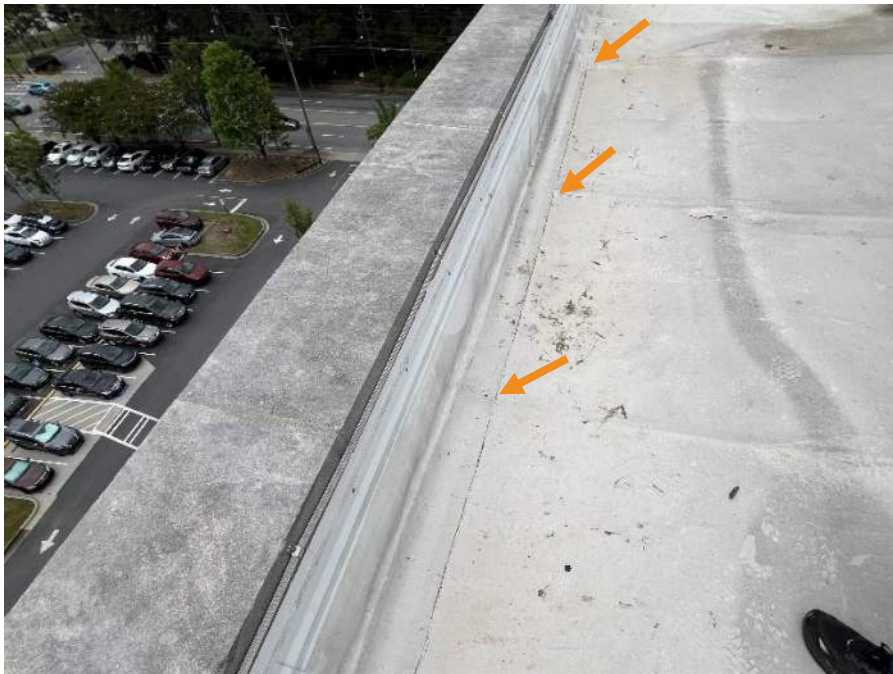
Figure 102. Isolated blister at the coping transitions

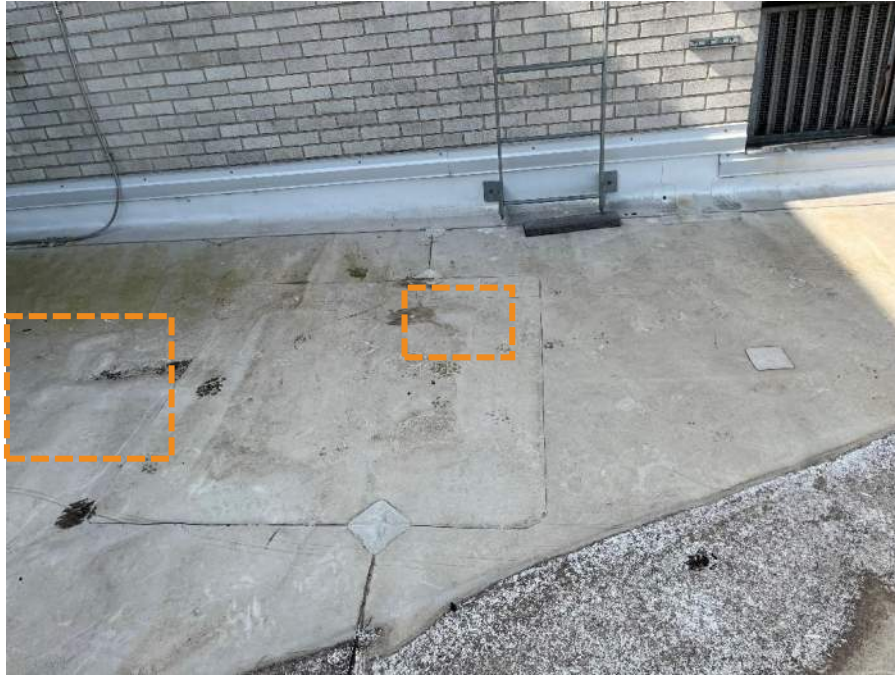
Figure 103. Isolated blisters at crickets

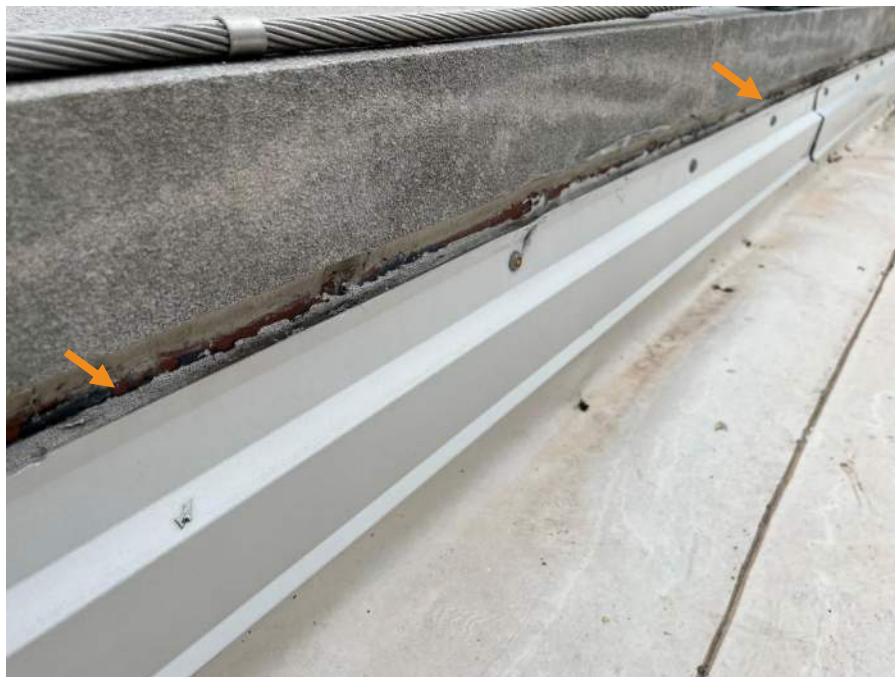
- The TPO roofing membrane was terminated at the interior face of the parapet. The roof counterflashing was sealed to the face of the brick masonry parapet wall (Figure 104). At most locations where the termination was one course or more below the coping stone, the interior brick face was coated (Figure 105). Roof termination flashings at rooftop mechanical units, curbs, and/or pipe penetrations were generally sealed; isolated adhesive sealant failures were noted at these locations (Figure 106).

Figure 104. Roof membrane counter flashing termination at the interior face of the brick at the parapet.

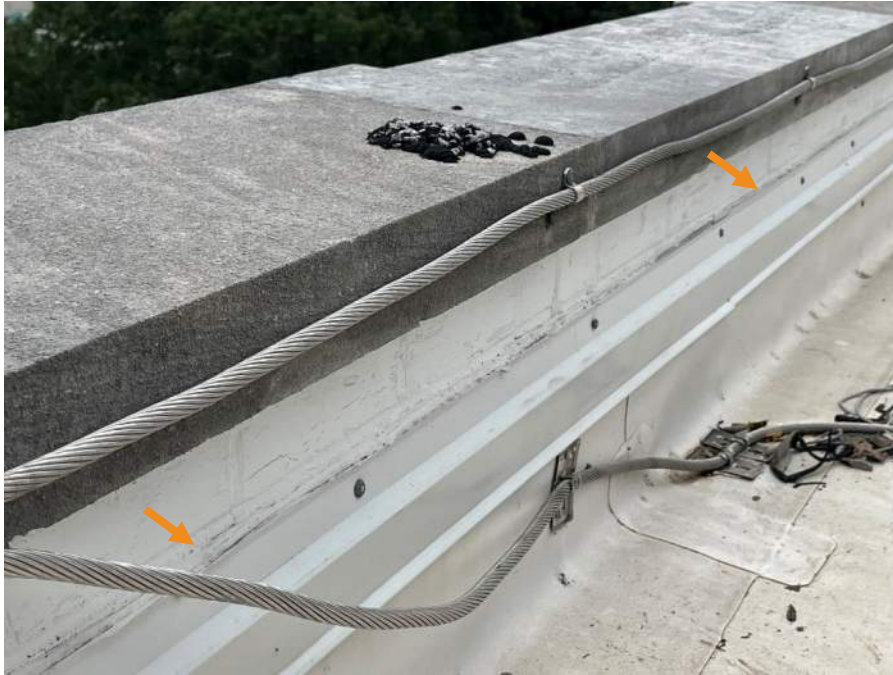
Figure 105. Roof membrane counter flashing termination at the interior face of the parapet with coated brick.

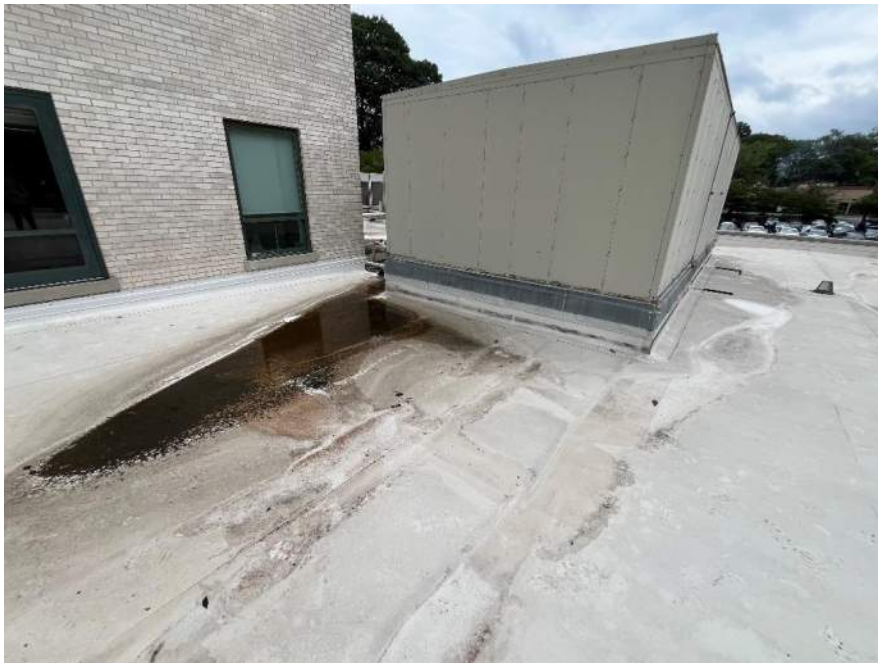
- At the mechanical penthouse roof, the curb height varied from approximately 4 inches to flush with the roof surface (Figure 107).
- At the east wing low roof area, directly above the identified stained ceiling tiles at the Infusion Hallway, the TPO membrane was terminated onto a rooftop mechanical system (Figure 108 and Figure 109).

Figure 108. Overview of mechanical system at east wing low roof, located above stained ceiling tiles observed at Level 1 ceiling

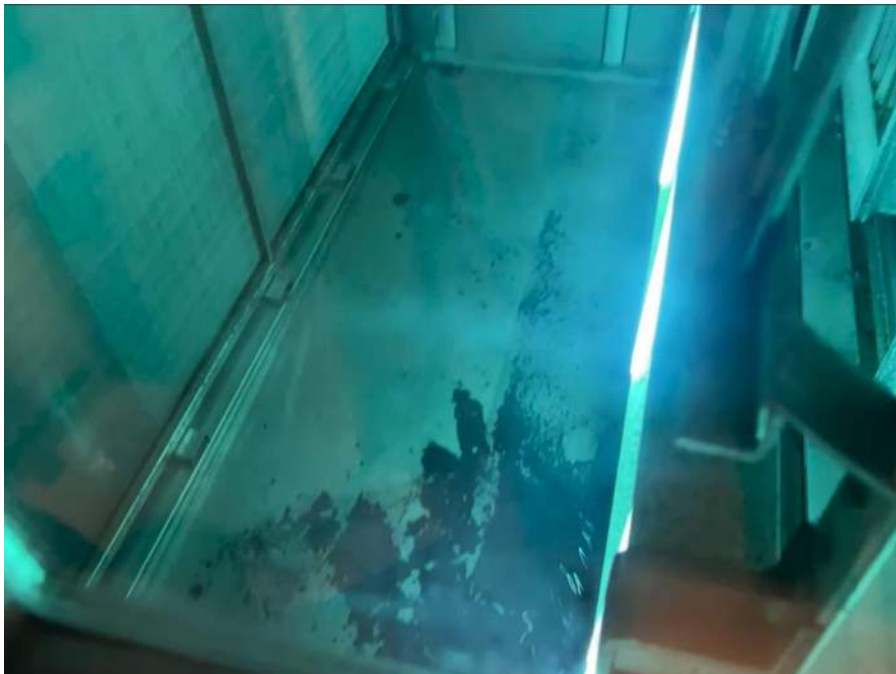
- Within the mechanical unit, condensation/standing water was observed at inaccessible portions of the mechanical system interior (Figure 110). Openings in portions of the mechanical system elevated floor exposed a built-up roof assembly below (Figure 111). Water and pipe penetrations through the built-up roof assembly were observed in the interstitial space between the mechanical system elevated floor and roof assembly below (Figure 112).

Figure 110. Inaccessible area of mechanical system with standing water at floor
