## Ponce De Leon Center

### Visual Condition Assessment

341 Ponce De Leon Avenue NE  
Atlanta, Georgia

July 28, 2025  
WJE No. 2025.1974

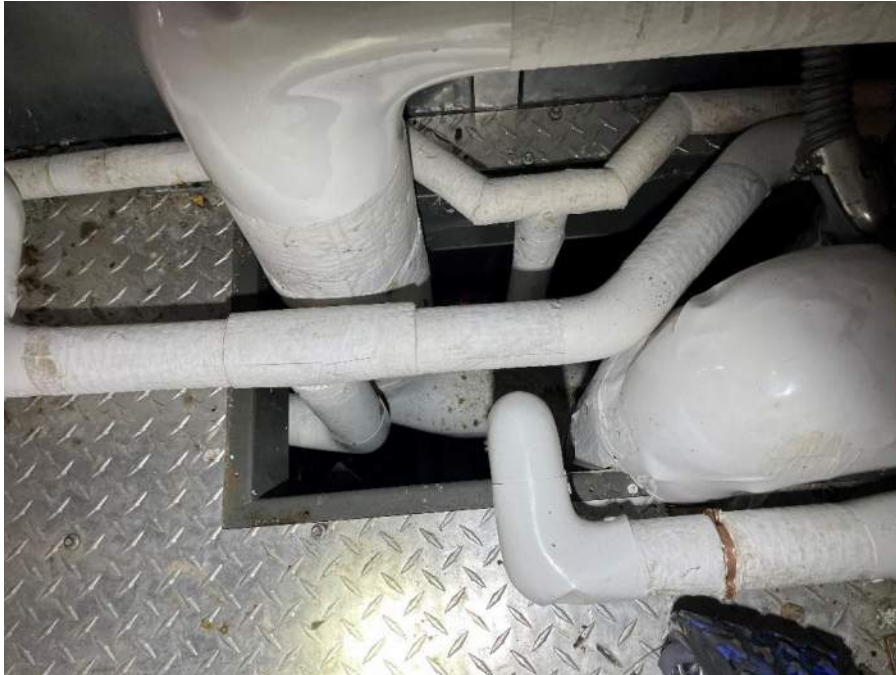
- Within the mechanical unit, condensation/standing water was observed at inaccessible portions of the mechanical system interior (Figure 110). Openings in portions of the mechanical system elevated floor exposed a built-up roof assembly below (Figure 111). Water and pipe penetrations through the built-up roof assembly were observed in the interstitial space between the mechanical system elevated floor and roof assembly below (Figure 112).

Figure 111. Mechanical and plumbing lines extending into the interstitial space between the mechanical system and roof below

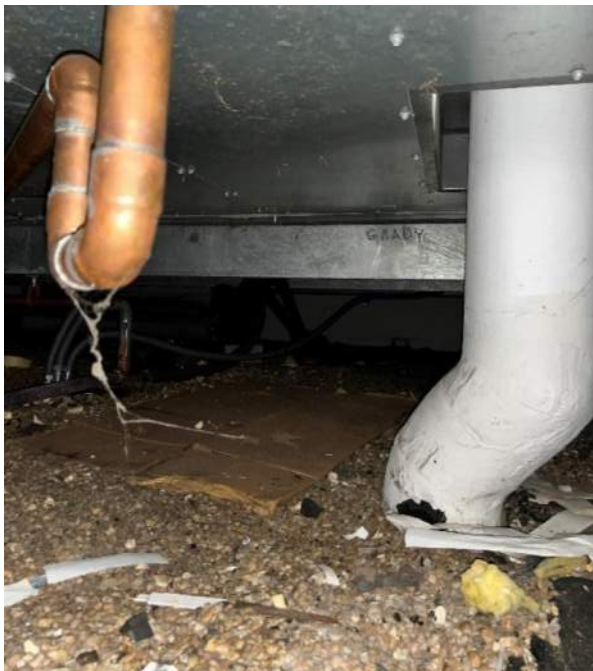
Figure 112. View from interstitial space between the mechanical system and roof below, exposing built-up roofing assembly and pipe penetrations below
